# Performance of the New Orleans Flood Control System: Hurricane Katrina

Presented to the Senate Committee on Homeland Security and Governmental Affairs

November 2, 2005 Washington DC

#### Levee Assessment Team

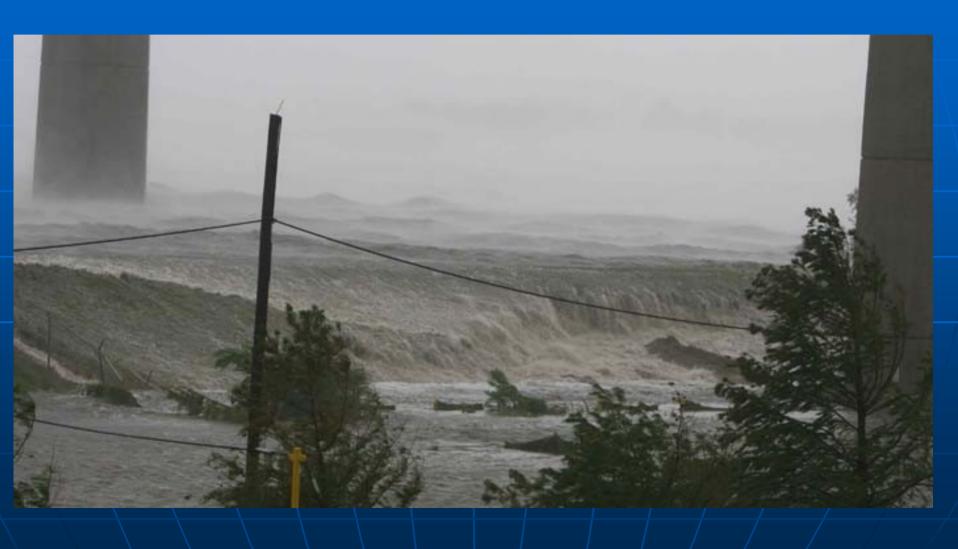
#### **Embankment Overtopping**

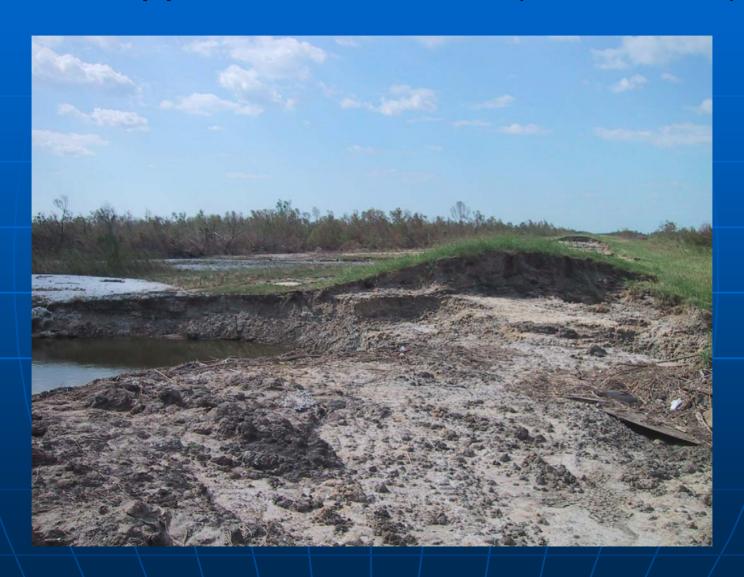
#### Overtopped Embankment (Sand Core)

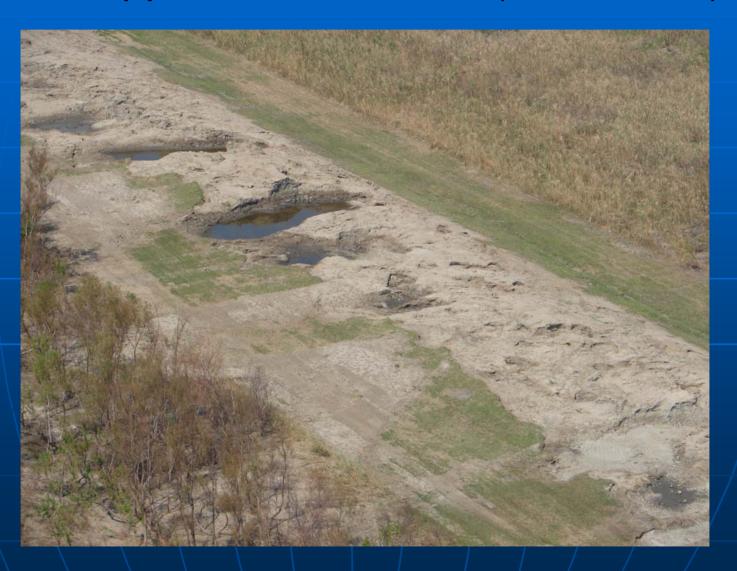
#### Overtopped Embankment (Sand Core)

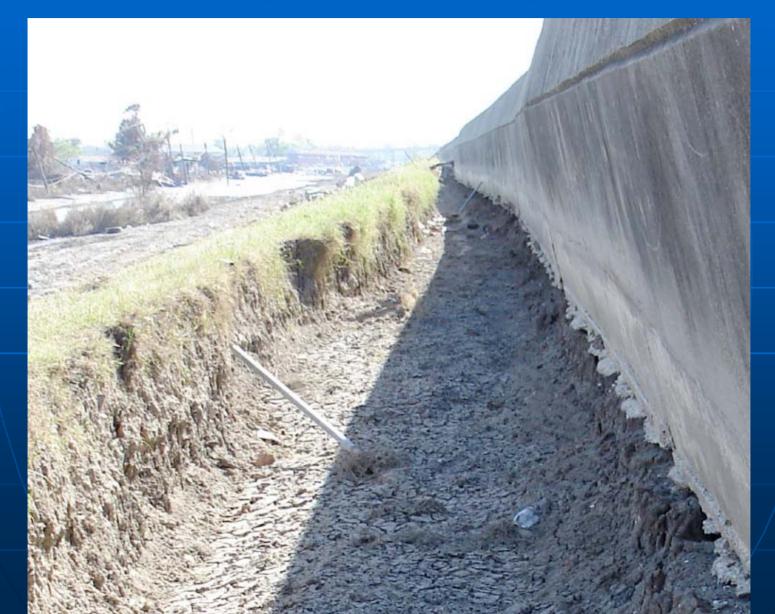
## Inner Harbor Navigation Channel Back Scour at Lower 9th Ward

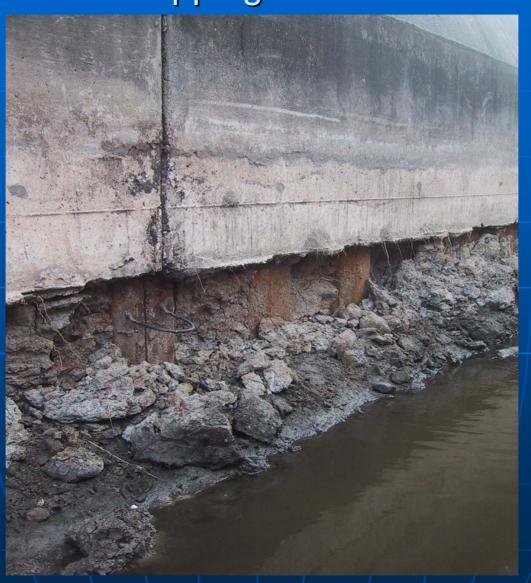
# MRGO, North Bank (New Orleans East): Overtopping Back Scour

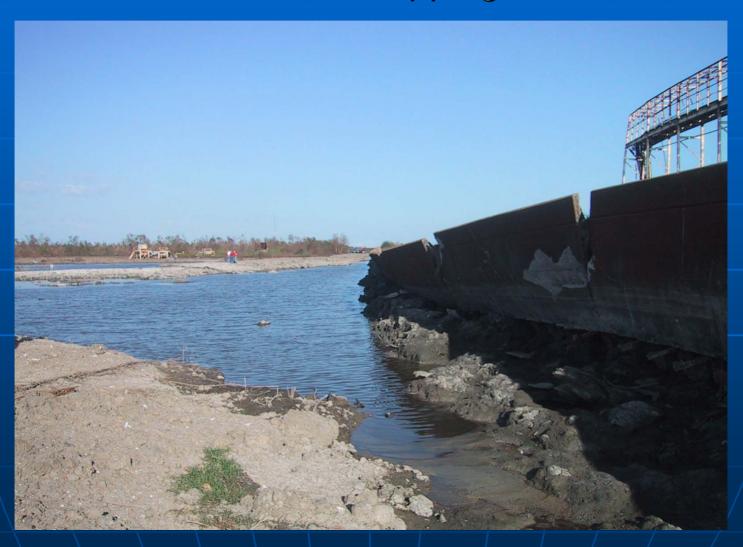
### MRGO, North Bank (New Orleans East): Floodwall Overtopping Failure

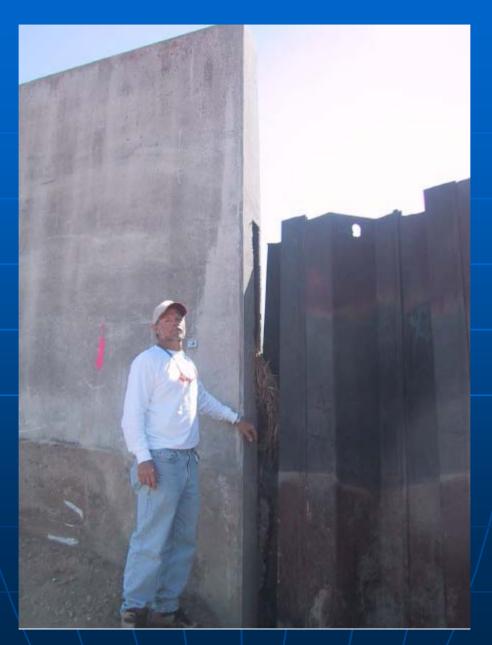
#### **Common Transition Problems**

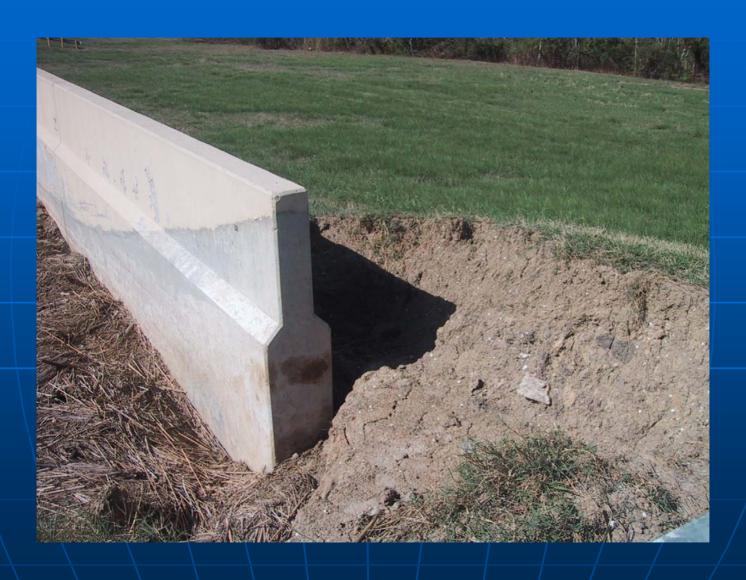
#### Common Transition Failures

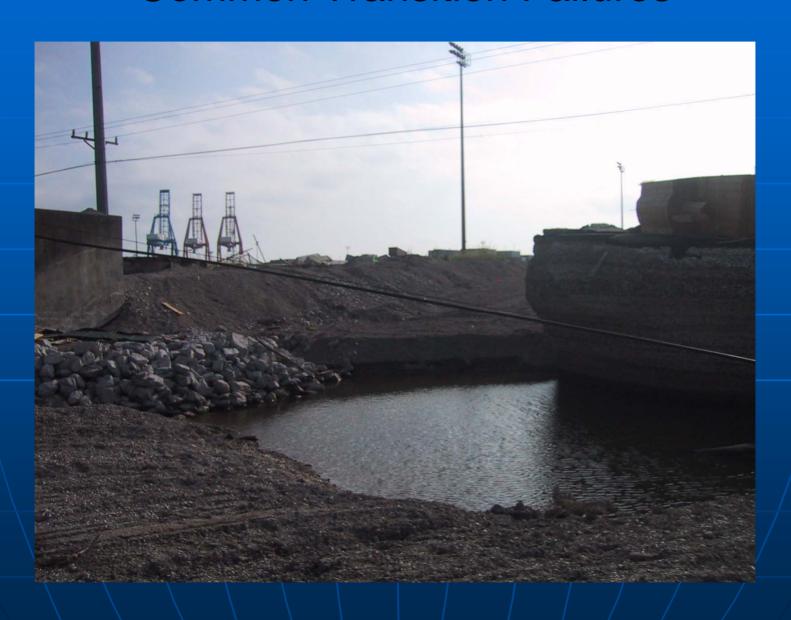
#### Common Transition Failures

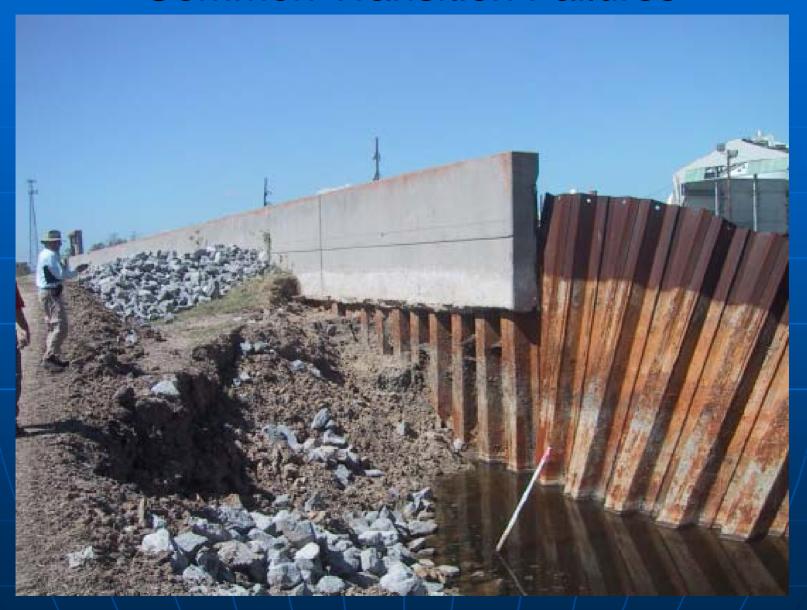
#### Common Transition Failures
