HOGR Request of March 19, 2008 - 6th Production

Background:

- In March 2007 KBR conducted technical inspections (TI) on 229 structures in order to accurately assess current conditions before assuming operations and maintenance. The 229 structures consisted of the following:

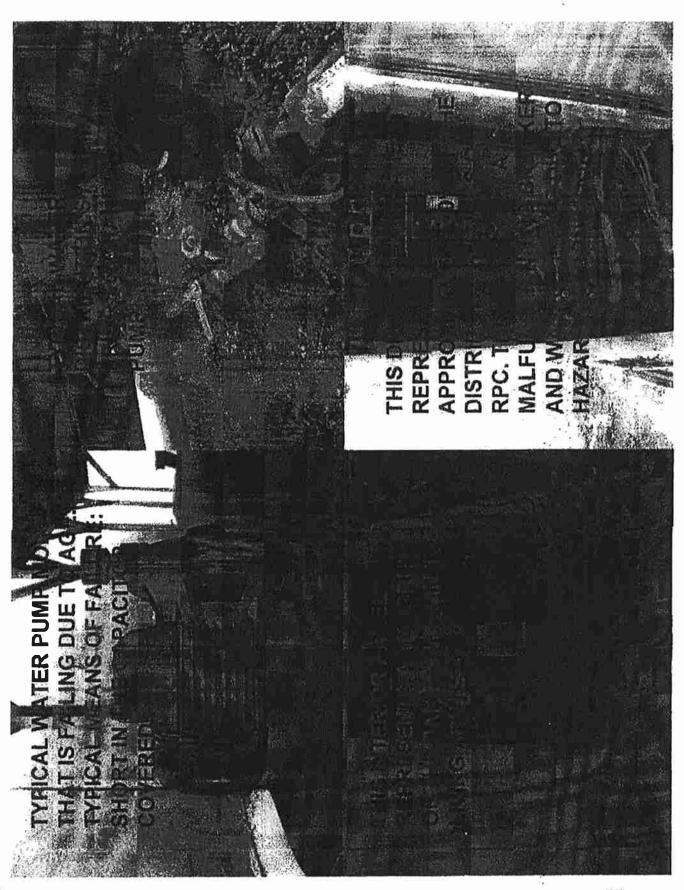
- Faulty or non existent electrical grounding systems
 - Faulty power distribution systems
 - Failing and faulty plumbing systems including Waste Water distribution systems and Potable water delivery systems (aging galvanized piping as well as rapid failure of aging and existing pumps that have been in place for at least 20+ years)

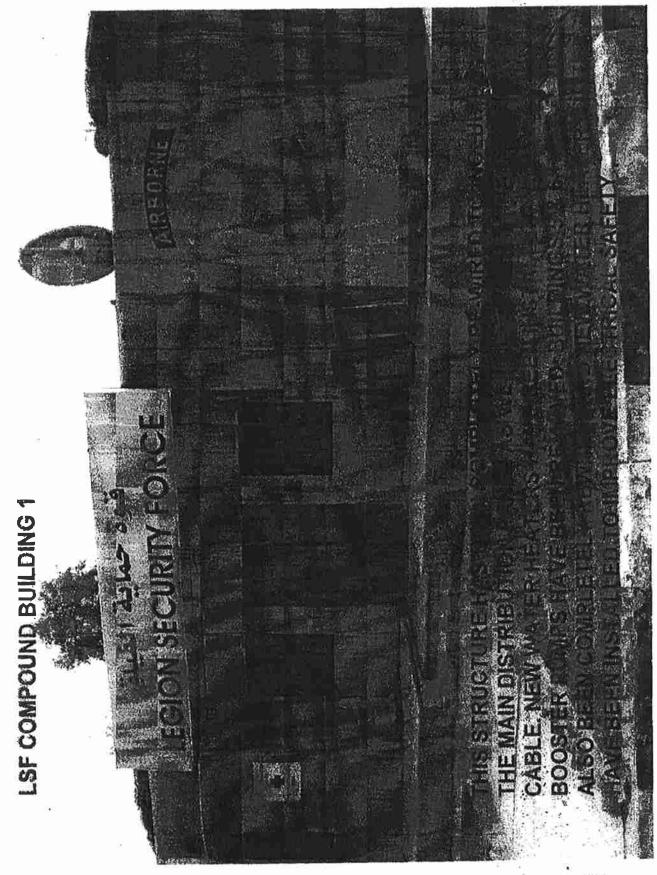
Two fires within the last 4 months due to faulty electrical systems At this time there has been no formal request from the customer to repair either facility. Loss of approximately 150 Bed Spaces
