DEFENSE CONTRACT MANAGEMENT AGENCY
DEFENSE CONTRACT MANAGEMENT AGENCY INTERNATIONAL
6359 Walker Lane, Suite 220
Alexandria, Virginia 22310-3259

CAR # HQ-08-LOGCAP-001 LIII

Deficient Quality System - Level III Corrective Action Request

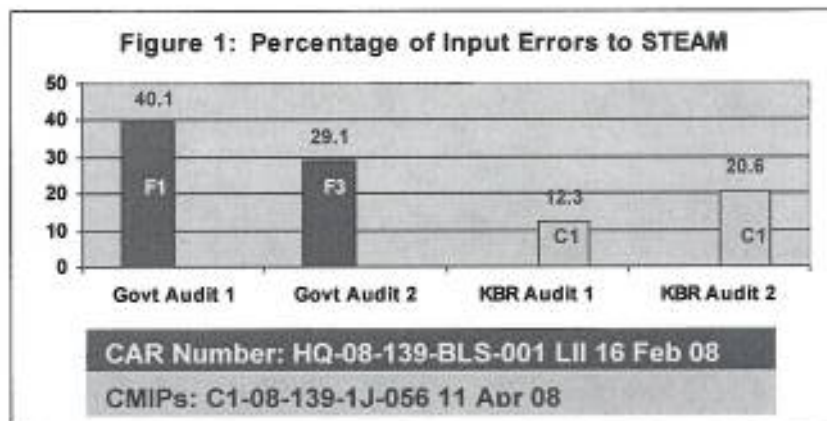
Figure 1 shows the percentage of erroneous data inputs into the STEAM system documented by Government and KBR Quality Assurance. Erroneous inputs include: Wrong work priority categorization, incorrect job start and stop times, incomplete work orders, etc

At site F1, an initial input error rate of 40.1% was recorded. A subsequent audit at F3 returned an error rate of 29.1%. With these results, the Government issued CAR HQ-08-139-BLS-001 LII. KBR Quality performed two audits at site C1 following implementation of KBR’s Corrective Action plan which showed 12.33% and 20.6% error rates after the issuance of the CAR.

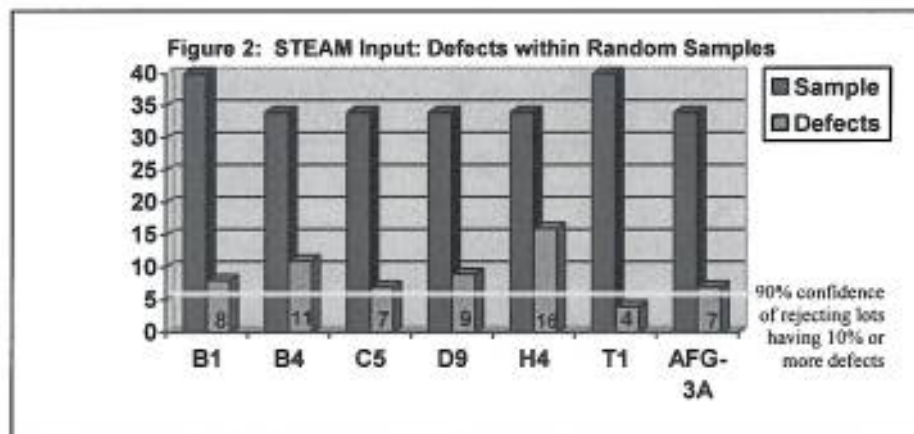
overall average error input rate for sites surveyed was 24.8% and mirrors previous findings by KBR at site F3 in Apr 2008.

Figure 2. Steam Input: Defects within Random Samples, the overall average error input rate for all sites surveyed was 24.8% and mirrors previous findings by KBR at site F3 in Apr 2008.

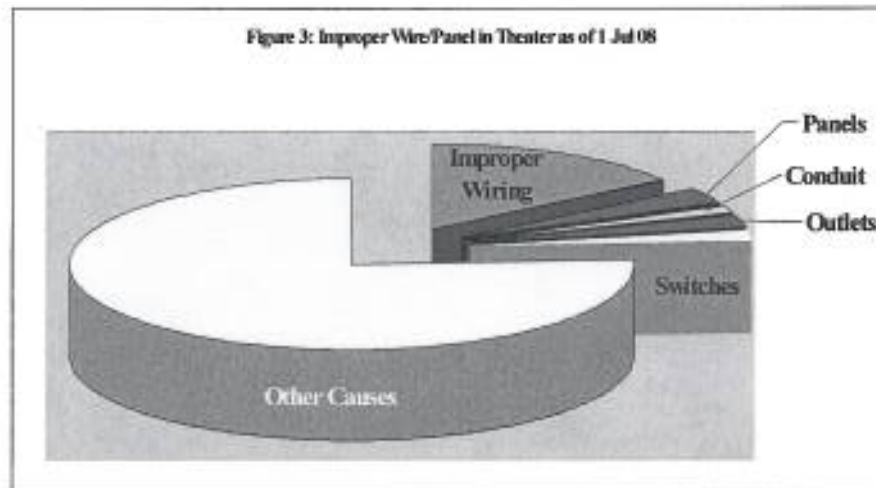
- A. At the Government's request, KBR trended and provided data for the March through May 2008 fire hazard inspections conducted IAW T.O. 139 paragraph 8.19. KBR provided a *Fire and Emergency Services Deficiency Report* on 01 Jul 08 (Attachment 33) in response to this request. The report revealed that a total of 26,205 incidents of improper wiring were discovered during the fire hazard inspections. In addition to improper wiring, another 5,225 cases of errors with fuses and panel boxes, 2,285 incidents of conduit and raceway hazards, 4,571 incidents of outlet box hazards, and 3,201 incidents of hazardous switches and fuses were noted for a combined total of 41,487 electrical facility fire hazards. Across the theater, a total of 171,538 hazards were recorded in the report. Improper wiring and panel/fuse boxes account for 18.3% of the total hazards as shown in Figure 3.

Figure 3. Data obtained from KBR's Emergency Services Deficiency Report, shows 18.3% of all incidents are related to faulty electrical wiring or electrical distribution panels. The pale grey segment of the pie is composed of 122 additional causal categories contained in the report.

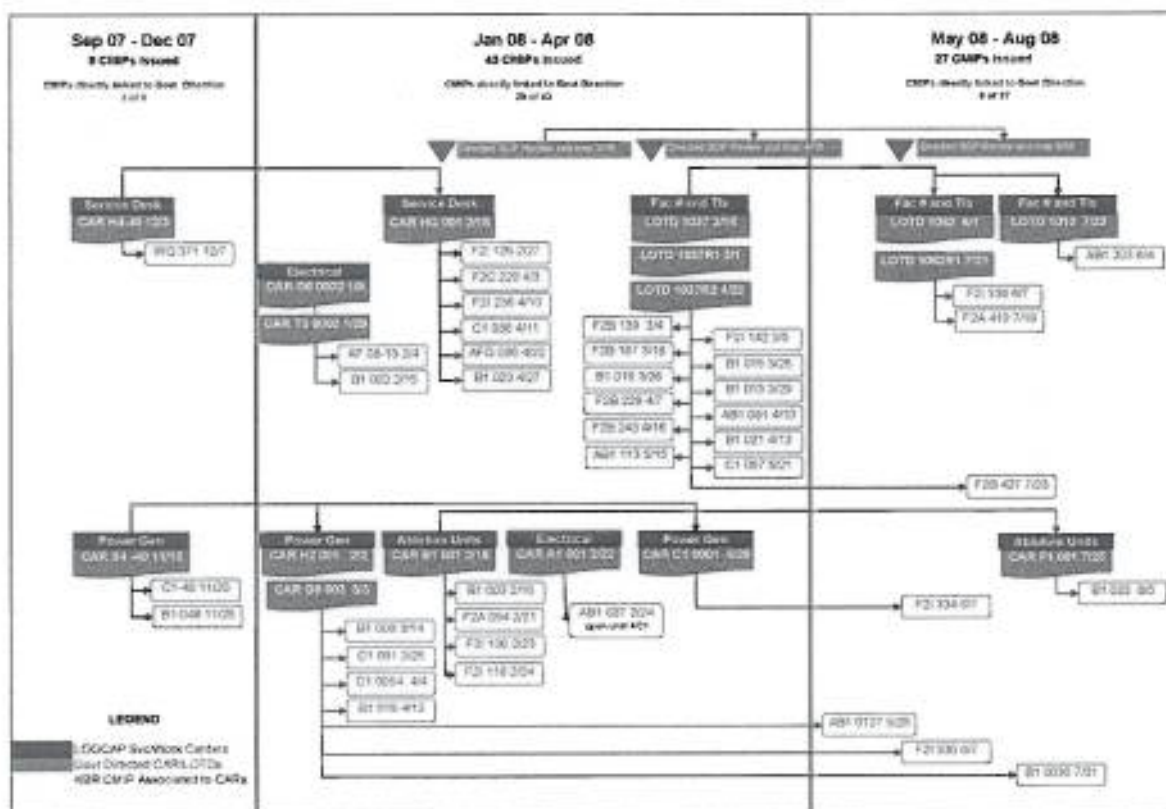
Figure 4: KBR failed to detect and correct systemic electrical issues that required Government direction. 41 of 79 CMIPs (52%) issued, were a result of Government directed actions. NOTE: The number of CMIPs provided is from ONLY four of 149 sites. (Attachment 43)

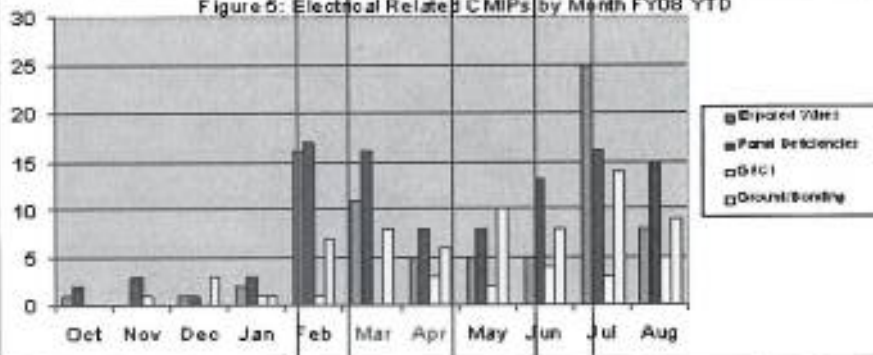
Figure 5: Electrical Related CMIPs by Month FY08 YTD

376 CMIPs Reviewed
 267 repeat (71% of 376)
 16.78% of all CMIPs (17% of 1591)

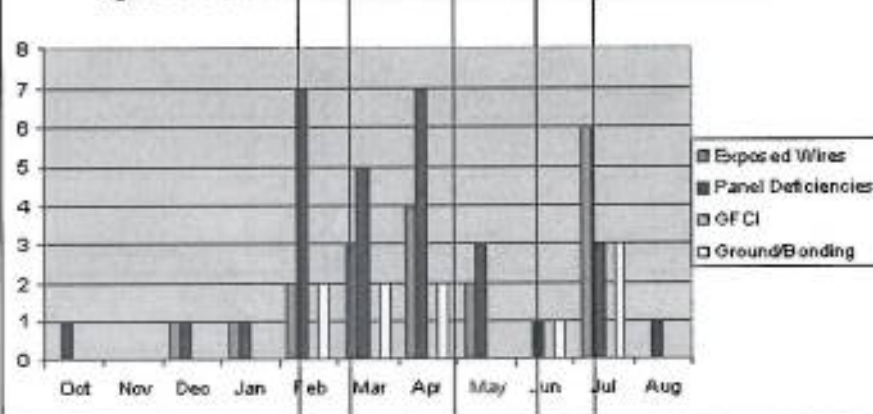
Figure 6: O&M Facilities Maintenance CMIPs by Month FY08 YTD

145 CMIPs Reviewed
 59 repeat (40.7% of 145)
 3.7% of all CMIPs (3.7% of 1591)

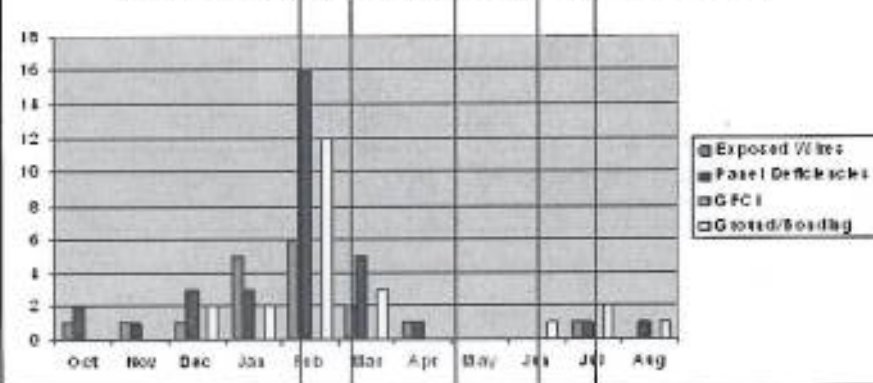
Figure 7: Safety (Electric Related) CMIPs by Month FY08 YTD

147 CMIPs Reviewed
 74 repeat (50.3% of 147)
 4.7% of all CMIPs (4.7% of 1591)

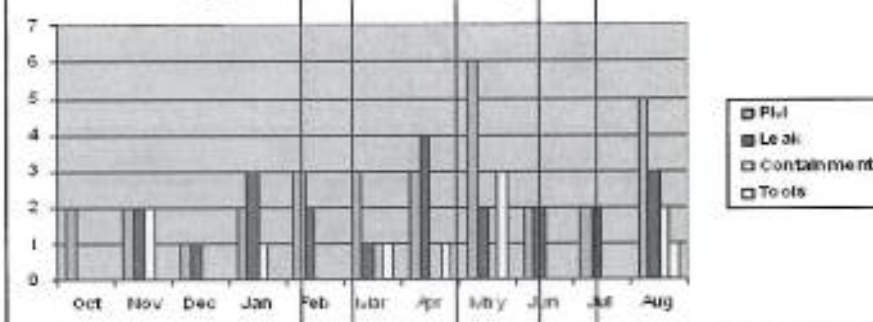
Figure 8: Power Gen CMIPs by Month FY08 YTD

- d. Power Generation (Figure 8):
 - i. 143 CMIPs reviewed.
 - ii. 64 repeat CMIPs discovered (45% of 143).
 - e. Total repeat CMIPs: 464 or 29% of the total CMIP population. This is consistent with the repeat CMIP findings in the first sample.

143 CMIPs Reviewed
 64 repeat (44.8% of 143)
 4.0% of all CMIPs (4.0% of 1591)

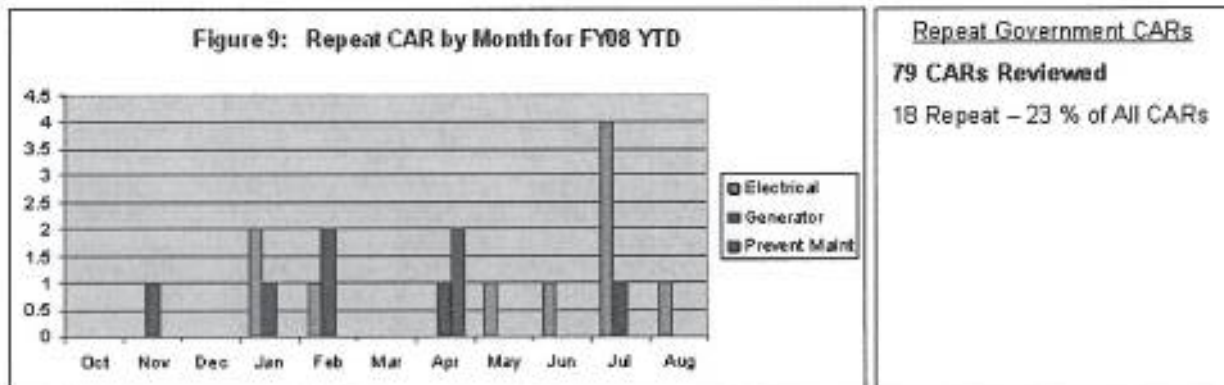
- iii. **Example # 2 CARs:** An analysis of CARs also demonstrates repeat findings and indicates that KBR does not consistently execute systemic corrective action to prevent recurrence across the LOGCAP Program. Of the 79 CARs DCMA issued this FY, 18 (23%) were repeat findings (Attachment 48). Of note, most are related to electrical services.
