DEPARTMENT OF THE ARMY

UNITED STATES ARMY COMBAT READINESS/SAFETY CENTER FORT RUCKER ALABAMA 36362-5363

SUBJECT: Assessment of Electrical Hazards in Operation Iraqi Freedom (OIF)

C - Figures Supporting CRM Assessment

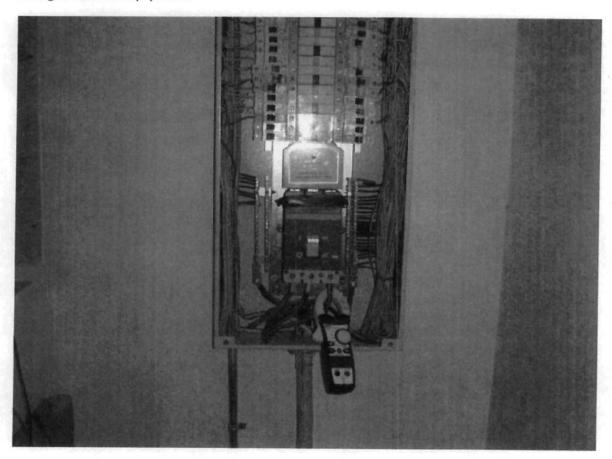
Panel 1-1 250a breaker. Wire sizing good. No ground electrode conductor. No GFI for water heater. The A/C equipment grounding conductor, which ran around the building daisy-chaining all units together, was 2.5mm. Inside building receptacle covers were missing and cracked. Outside circuits were not weather proof. There were splices outside not in an enclosure. Outdoor wiring was not secure.

Overall assessment is unsafe due to lack of effective ground fault path, unsafe wiring practices and damaged electrical equipment.

Figure 1 Mayors Cell Panel. Five wires coming in but no ground electrode conductor.

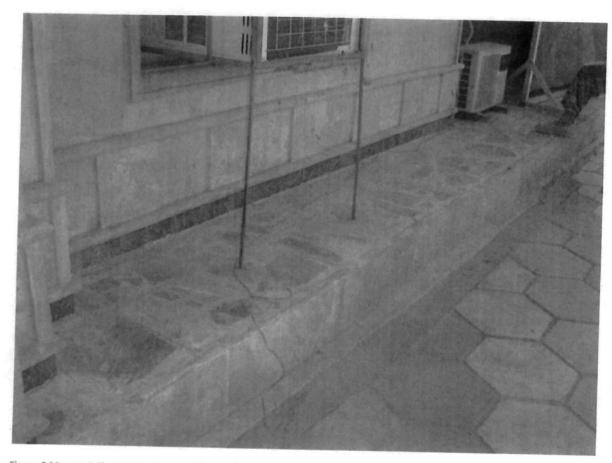
Figure 2 Mayors Cell. Equipment grounding conductor for A/C units daisy-chained and run on open ground.

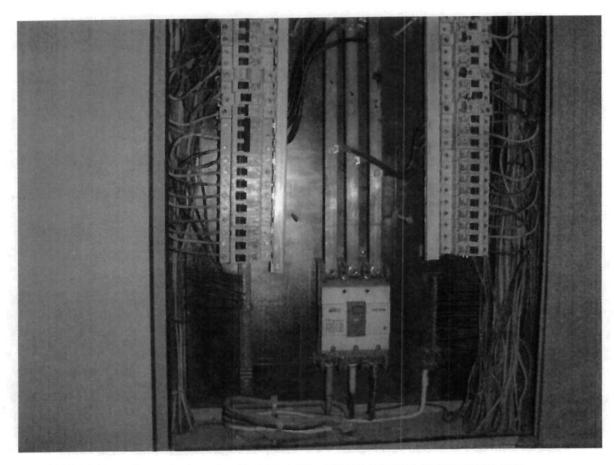
There was no grounding electrode conductor or equipment grounding conductor brought into the panel. The building piping and structural materials were not bonded to the ground system. There was no effective ground fault path.

Assessment: Not safe.

Figure 3 BLDG 11. Four wires coming in, no bonding of neutral to ground and no ground electrode conductor.

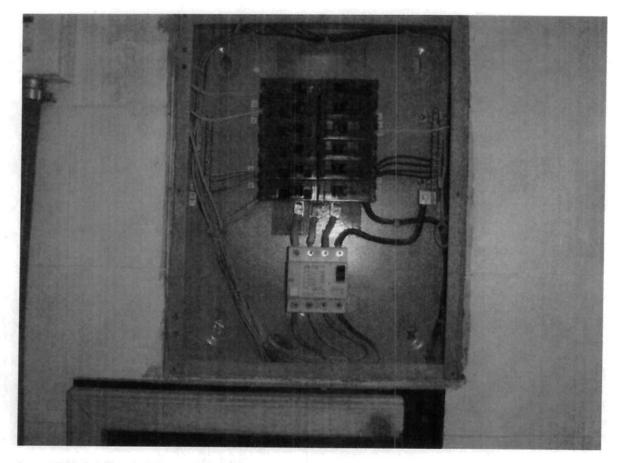
There was no equipment grounding conductor brought into the panel. The main breaker was GFCI. There was no effective ground fault path.

Assessment: Building has no effective ground fault current path.

Figure 4 BLDG 34A Male Showers. Four wires brought into an RCCB (residual current circuit breaker) with no equipment grounding conductor or ground electrode conductor.

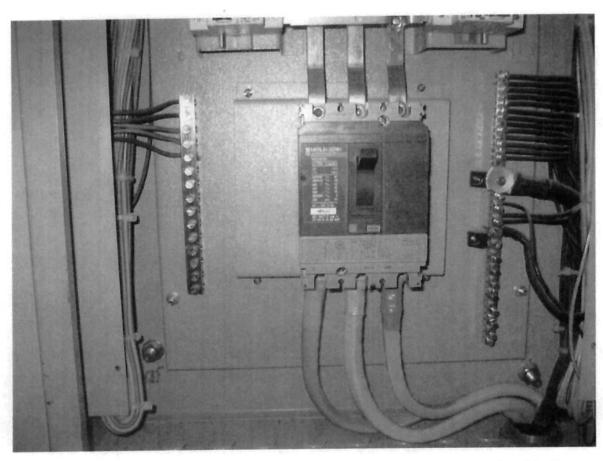
Three panels in the building were assessed. There was no equipment grounding conductor or ground electrode conductor brought into the panel. The panels were not grounded and there was no effective ground fault path. There was no bonding of the piping or structural conductive materials.

Assessment: Building panels were not properly grounded; therefore, none of the electrical equipment was grounded. There was no effective ground fault path.

Figure 5 Bldg 2. There is no equipment grounding conductor or grounding electrode conductor, typical of panels in this building

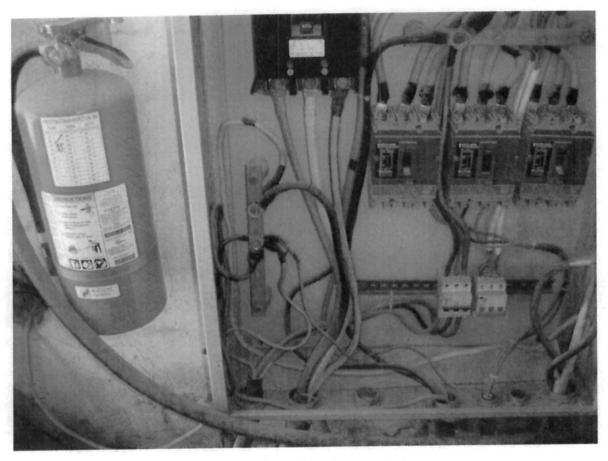
Assessed the main power panel and the pump control panel. There were four wires coming in to the power panel (three hots and a neutral) and no bond between the neutral and ground. There was no grounding electrode conductor or equipment grounding conductor brought into the panels from the source, the building had no effective ground fault path for a short to ground event. The control panel had numerous wires not terminated hanging loose in the cabinet.

Figure 6 Pool Distribution panel (note four incoming wires on left and no ground bus).

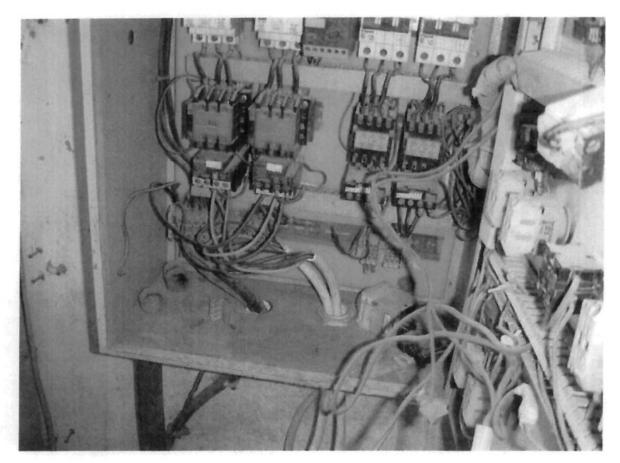
Figure 7 Pool pump control panel.

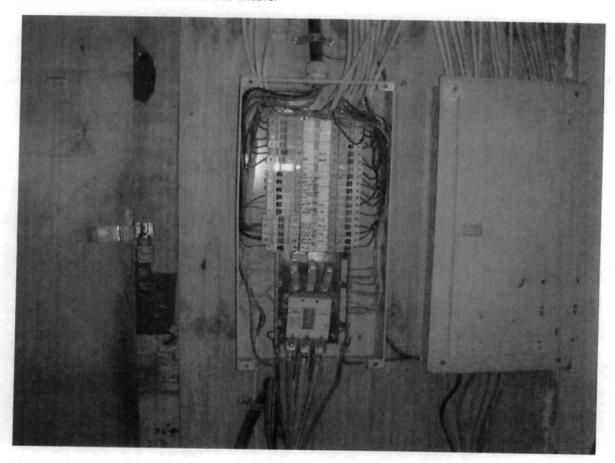
Found three subpanels in the building. No equipment grounding conductor was run from the main disconnect to the subpanels. A grounding electrode conductor was run to one panel then series connected to the other two panels. One panel had an undersized bonding jumper from the equipment grounding bus to the neutral bus (see photo). There was current on the grounding electrode conductors going to the second and third subpanels, but no current on the conductor to the ground electrode. Live wires were hanging loose in the panel (disconnected source to wires and secured them). The connection between the grounding electrode and grounding electrode conductor was poor. The

conductor was wrapped around the electrode and the connection was then covered with tape. Outside connections were not weather proof. Connections were scabbed into the feeders and taped over.

Assessment: Electrical installation was unsafe.

Figure 8 JSS Babel. No equipment grounding conductor and routing of ground electrode conductors carrying current.

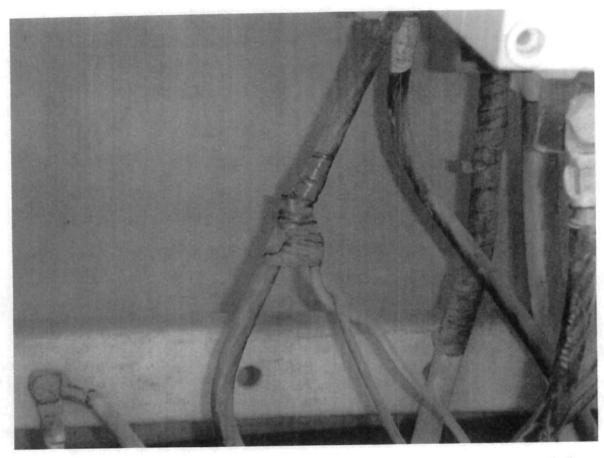
Figure 9 JSS Babel. Less than acceptable way to run power. Smaller conductors spliced (not even mechanically attached) to a feeder. There is no overload protection for this circuit.

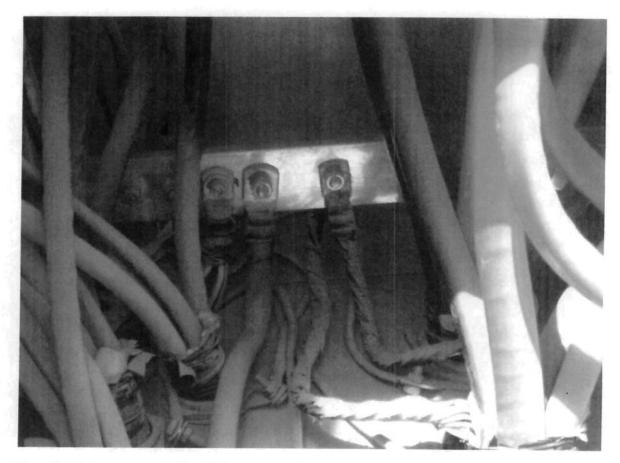
The main disconnect panel had five conductors coming in from the generator. Three hots, a neutral and the ground (cable shield twisted, taped and bolted to the ground bus). The system used to feed from the generators to the LSA trailers uses the bond at the generator as the effective ground fault current path. I am not confident in the way the shield was used as the equipment grounding conductor because of the bond to the cabinets and the size of the shield after it was trimmed and twisted together to be attached to the ground bus in the cabinets.

Figure 10 Main disconnect panel cable shields connected to the ground bus and used for equipment grounding conductor.

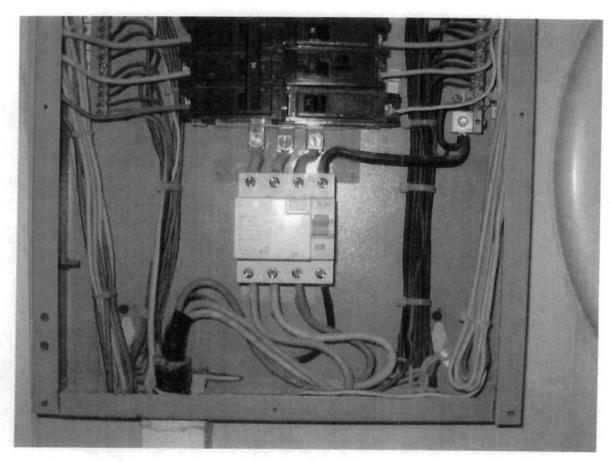
There were five wires running from the subpanel to the latrine/shower facilities. The equipment ground wire running into the building was pulled out of the cable jacket and spiced to the ground electrode conductor outside of the building in a junction box. The main panel was fed by a GFCI breaker, there was a ground bus and neutral bus in the panels. Overall appearance of the panels was satisfactory.

Figure 11 Typical shower trailer in the Audie Murphie LSA. Note only one ground conductor coming in (equipment ground conductor splice in small box on the outside of the trailer).

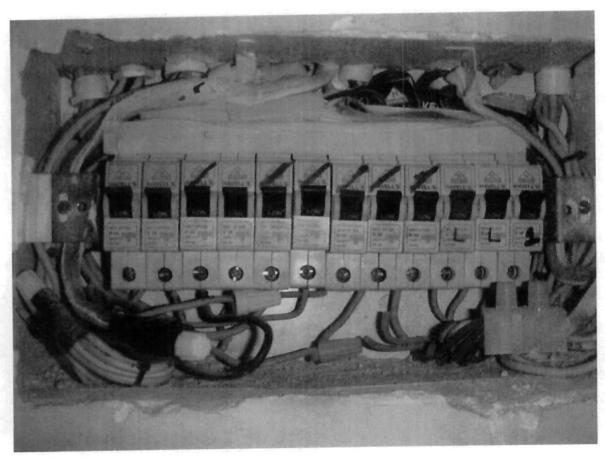
The band building was a pool converted into an office space and practice area. Found one breaker panel in the whole bldg. There must be another distribution panel feeding the multiple a/c units around the bldg. None of the breakers were marked (don't know which breaker feeds what). The hole in the wall the breakers were in was much too small for the breakers and wiring. There was card board and tape stuffed between the wires for insulation (assumption). The power feeding the breaker box was scabbed of the pool system main breaker (the system was not marked at all and this is my best guess). The pool power distribution system used only four incoming wires and did not appear to be bonded in the cabinet.

Figure 12 Band BLDG breaker box (with cardboard between wires).

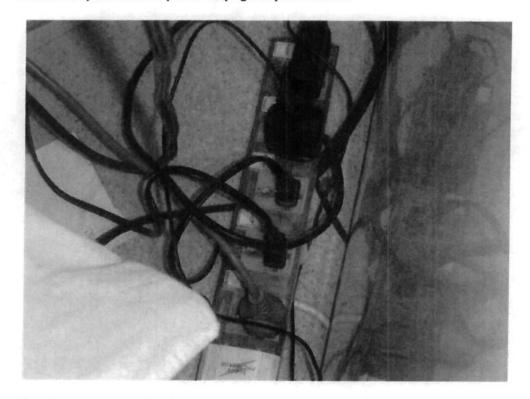
Found many instances of power strips grossly overloaded.

Figure 13 Power strip in Soldier's living area, overloaded and in close proximity to combustible material.

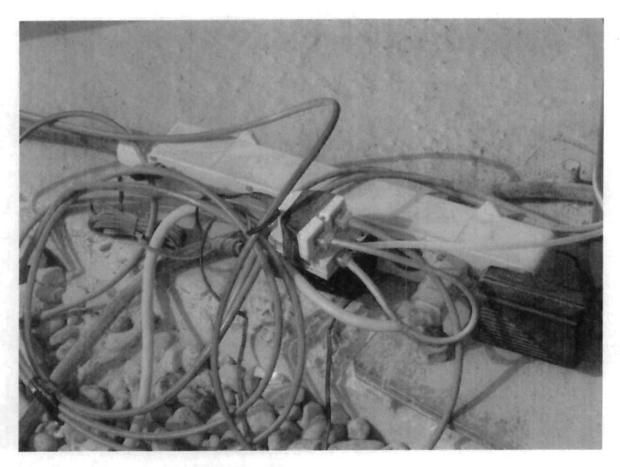
Figure 14 Overloaded power strip located outside, subject to extreme weather conditions.

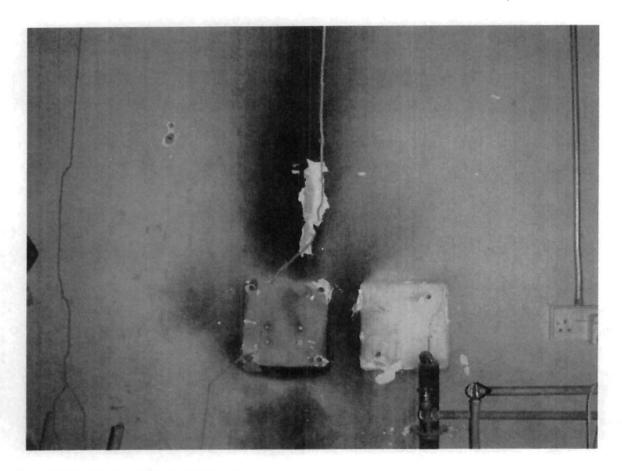
Figure 15 Recent fire caused by makeshift repair

This evidence of burned electrical device was found in the laundry room in the senior officer and NCO billets, FOB Loyalty

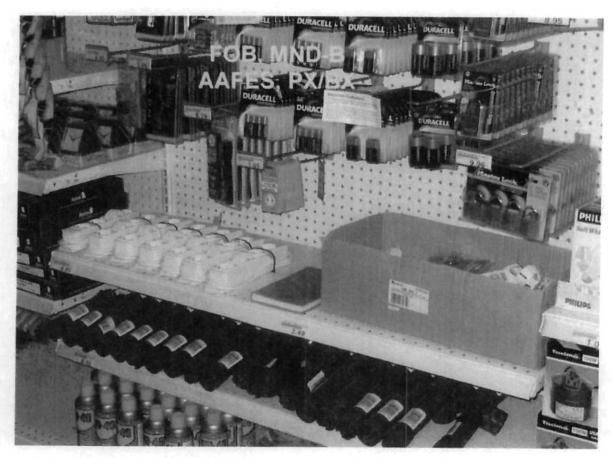
Figure 16 Power strips and adapters sold in the PX

The power strips and adapters found in the PX at FOB Loyalty were European standard. They would be useless for many of the applications used by the Soldiers. Soldiers would purchase their adapters and power strips in the bazaar. Most of which are uncertified or counterfeit.

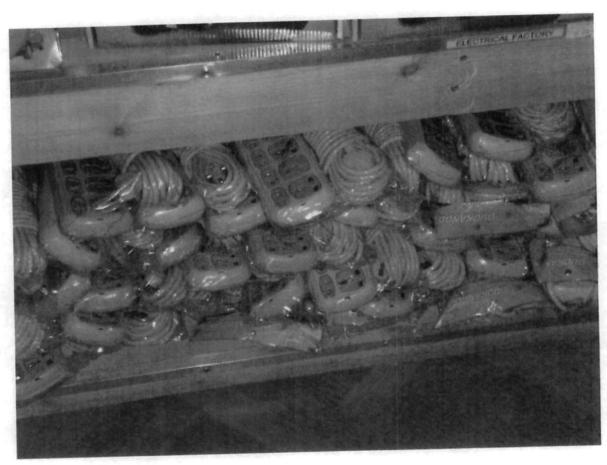
Figure 17 Uncertified power strips found in the bazaar.

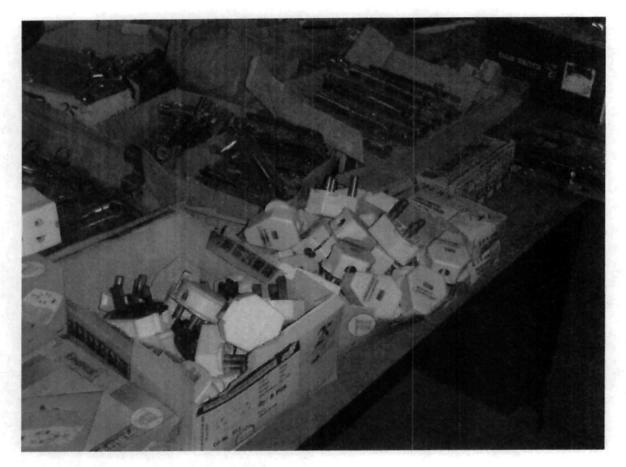
Figure 18 Uncertified, and possibly counterfeit adapters found in the bazaar.

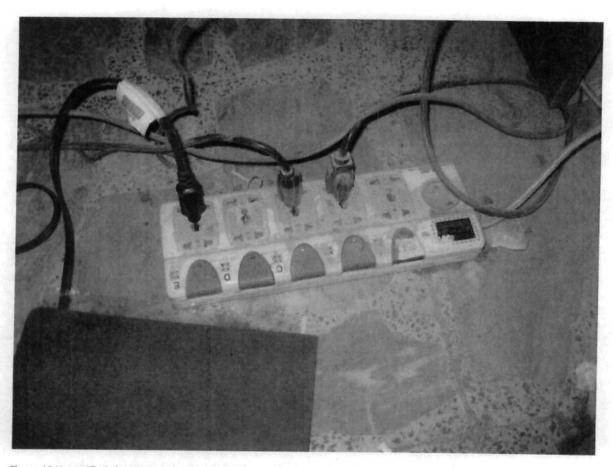
Figure 19 Uncertified electrical power strip found in an office area at FOB Loyalty

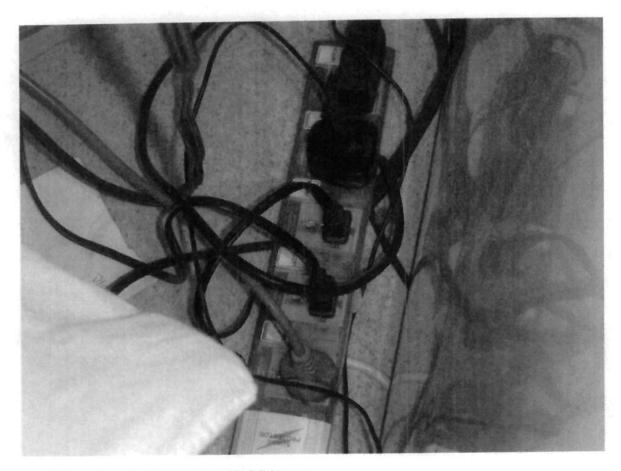
Figure 20 Uncertified power strip found in Soldier's living area.

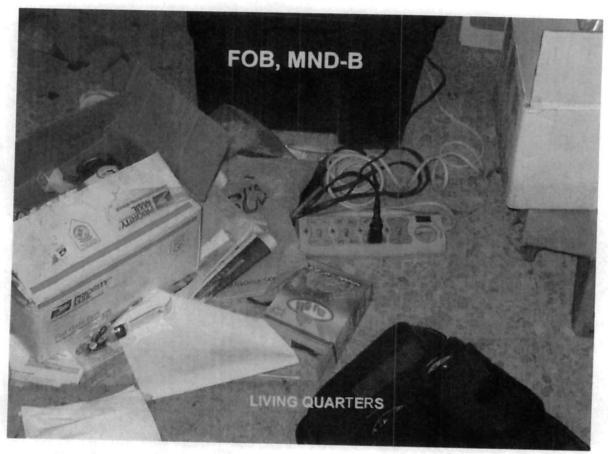
Figure 21 Soldier living quarters at FOB Loyalty.

An example of clutter and combustible material in close proximity to an uncertified power strip.

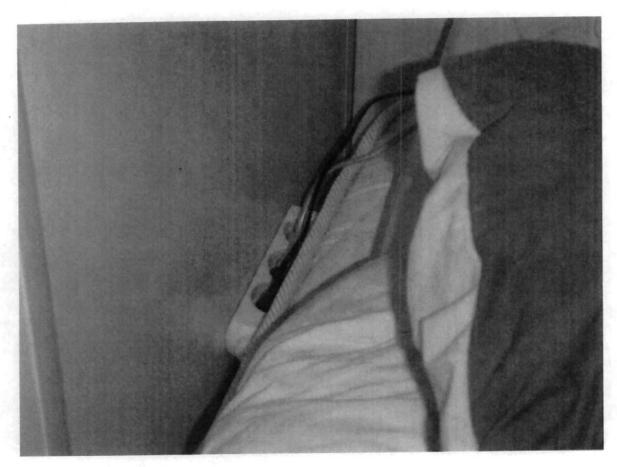
Figure 22 Power strip wedged against the wall and bedding.

An overloaded circuit would heat up and cause a fire of the Soldier's bedding and death within minutes.

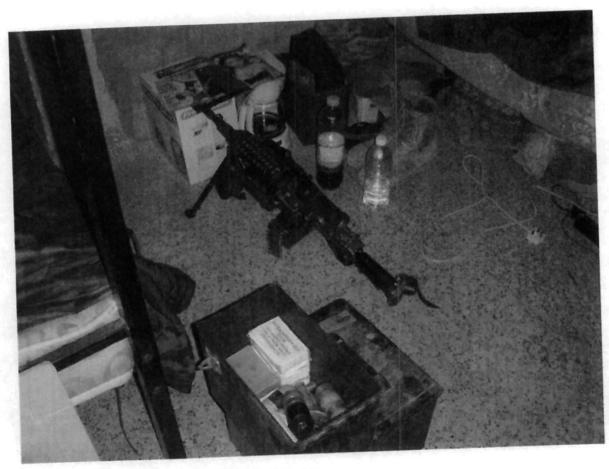
Figure 23 Ammunition and loaded weapons stored in living areas

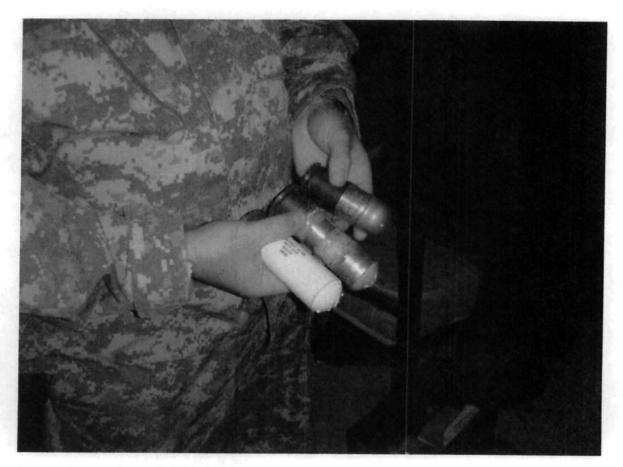
Figure 24 40mm rounds stored in Soldier living areas

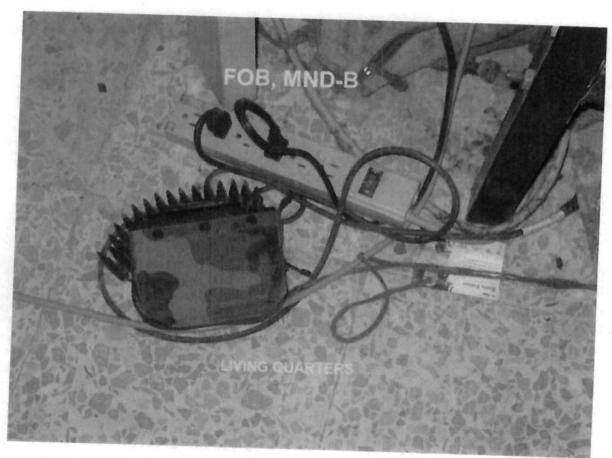
Figure 25 Ammunition laying in close proximity to a likely fire source.

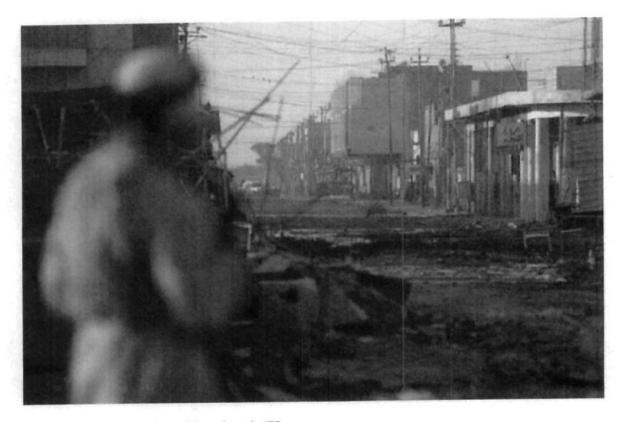
Figure 26 Low hanging wires located throughout the ITO

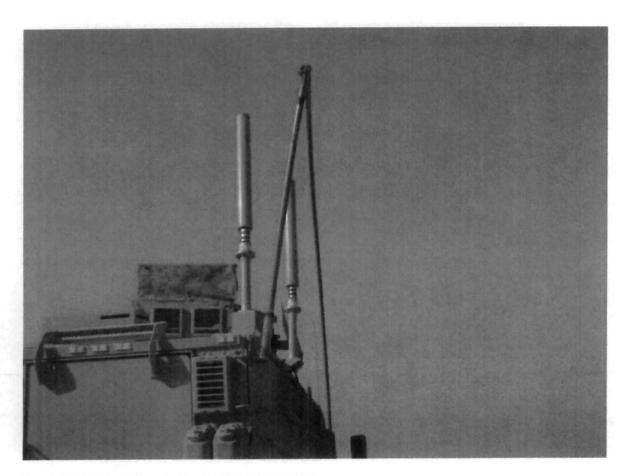
Figure 27 MRAP wire strike protection for IMG Navistar variant.

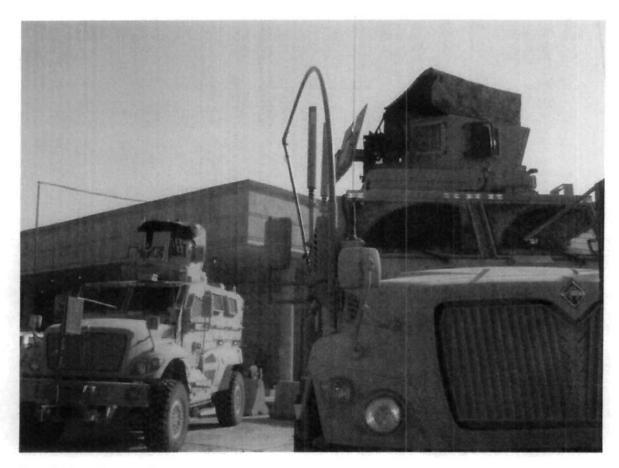
Figure 28 Wire strike protection.

Soldier installed make-shift protection to deflect wires. The system is made from two pieces of PVC piping, duct taped together at the aft connection.

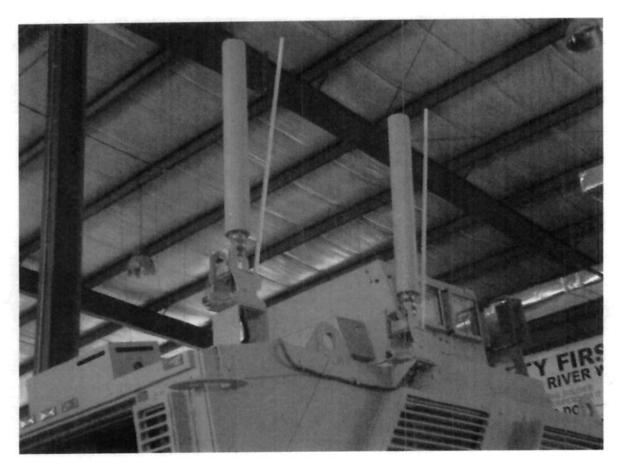
Figure 29 MRAP wire strike protection for the IED jammer antennae.
