Washington Briefing
Deepwater Horizon Interim Incident Investigation

24th May 2010

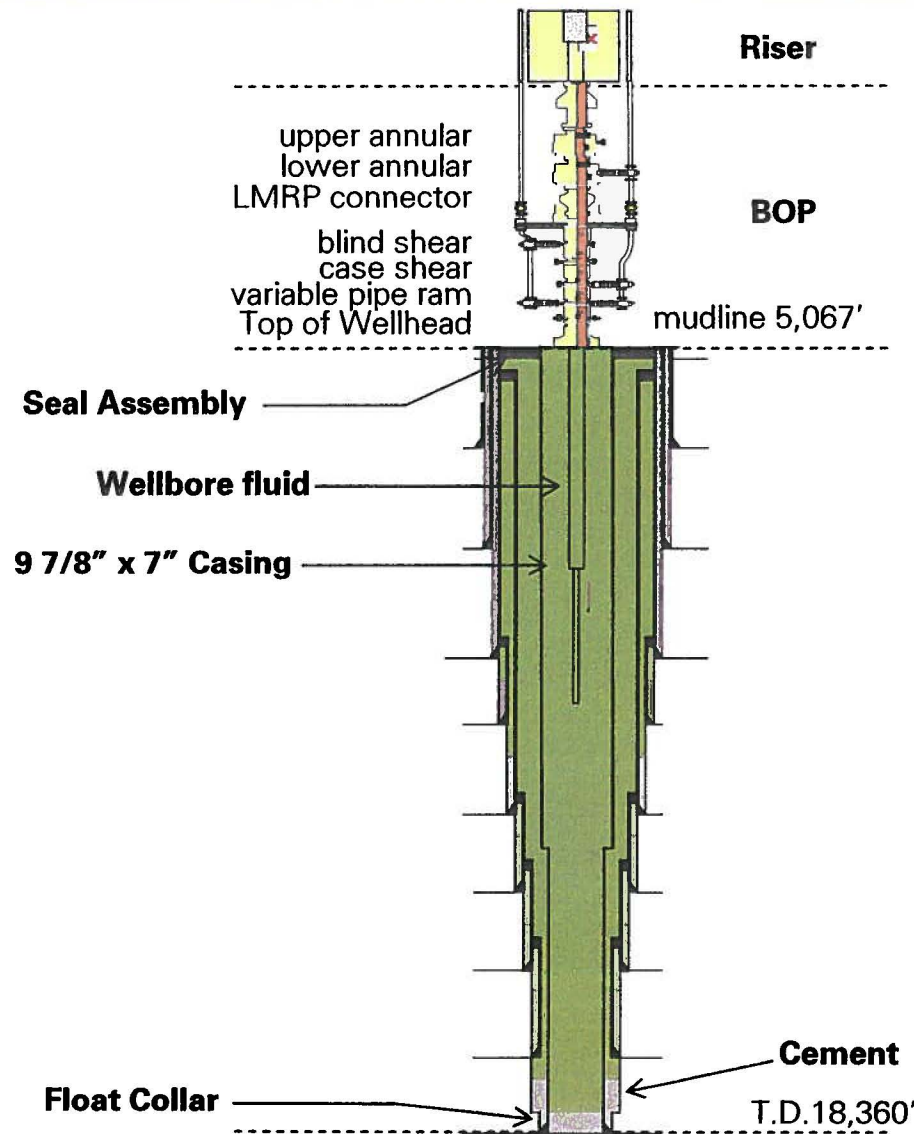
Macondo Well Diagram – Key Components & Critical Factors

1. Loss of Integrity of the 9 7/8" x 7" casing created a path for hydrocarbon (HC) influx
2. Unrecognized well conditions
 - Influx unrecognized - Integrity test failed to identify communication with the reservoir
 - Operations allowed HC influx to enter and move up the well bore – *well became capable of flowing*
 - Response failed to control the well
3. BOP & Emergency Systems failed to isolate the HC source
4. Gas plume ignited

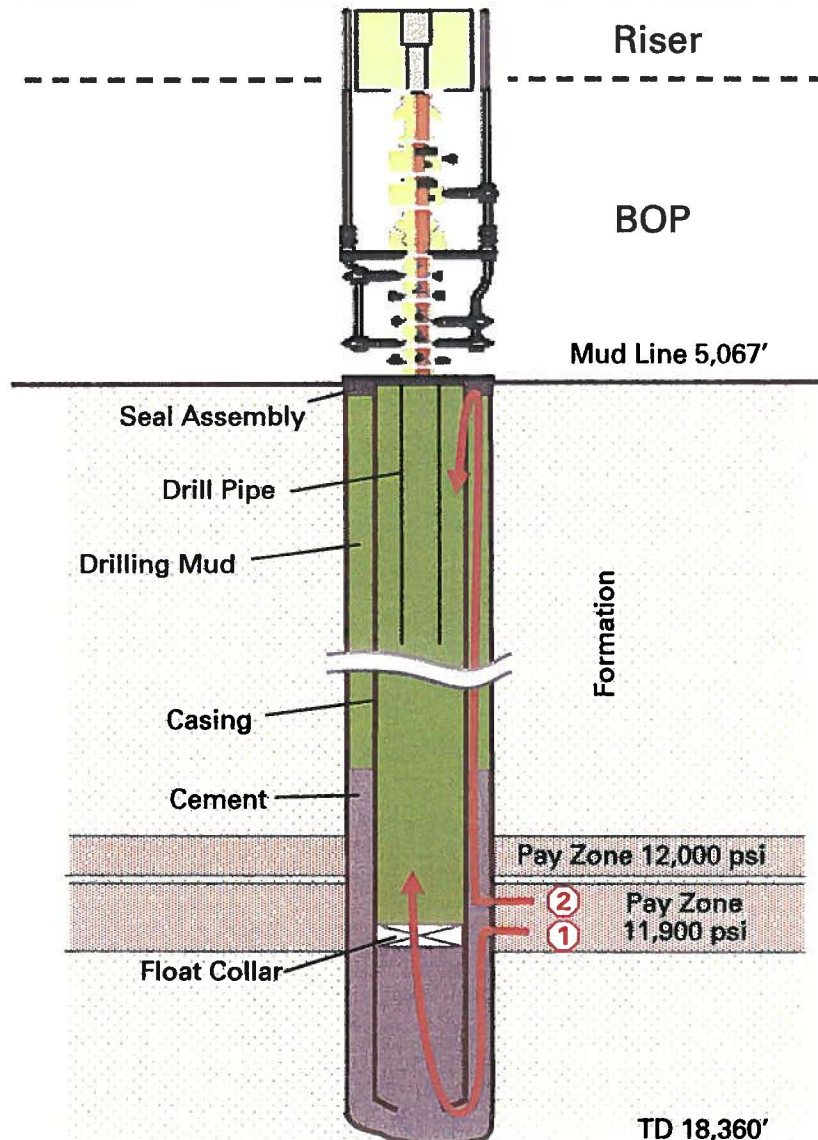
Critical Factor 1 – Loss of Integrity of Casing

- Cement failed to isolate the reservoir
- The float collar (1) or the seal assembly (2) leaked

- Review design and execution of the cement job
- Review design and installation of casing shoe track and seal assembly
- Laboratory testing of float collar
- Detailed well dynamic modeling to assess likely influx point

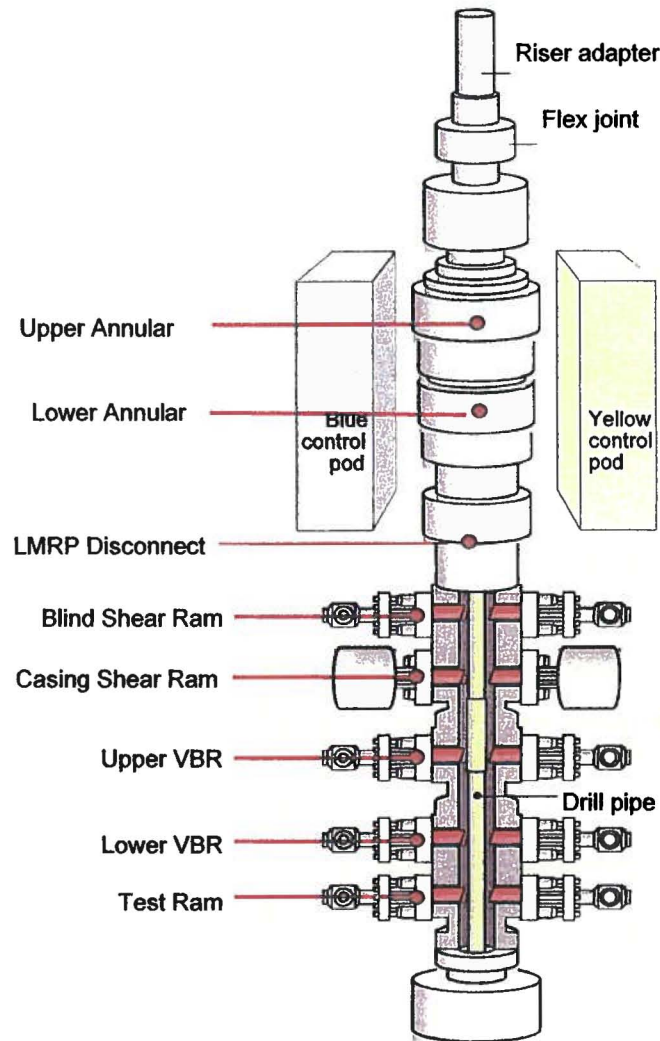
Critical Factor 3 – BOP Failed to Isolate Source

- Action to activate the BOP once well condition was recognized failed to isolate the source
- EDS failed to secure the well (when activated from bridge after explosion)
- AMF/Dead-man failed to secure well
- Subsequent ROV interventions failed to secure the well

- Understand BOP testing history and performance of emergency systems, EDS, Auto shear, AMF (Deadman), ROV hot stab
- Understanding of BOP modifications – could they have affected its functionality?
- Assess leaks identified during ROV intervention and determine significance – could they have affected its functionality?
- Evaluation of BOP maintenance history regards system completeness, OEM parts and 3rd party services
- Inspect & test BOP once retrieved from sea floor

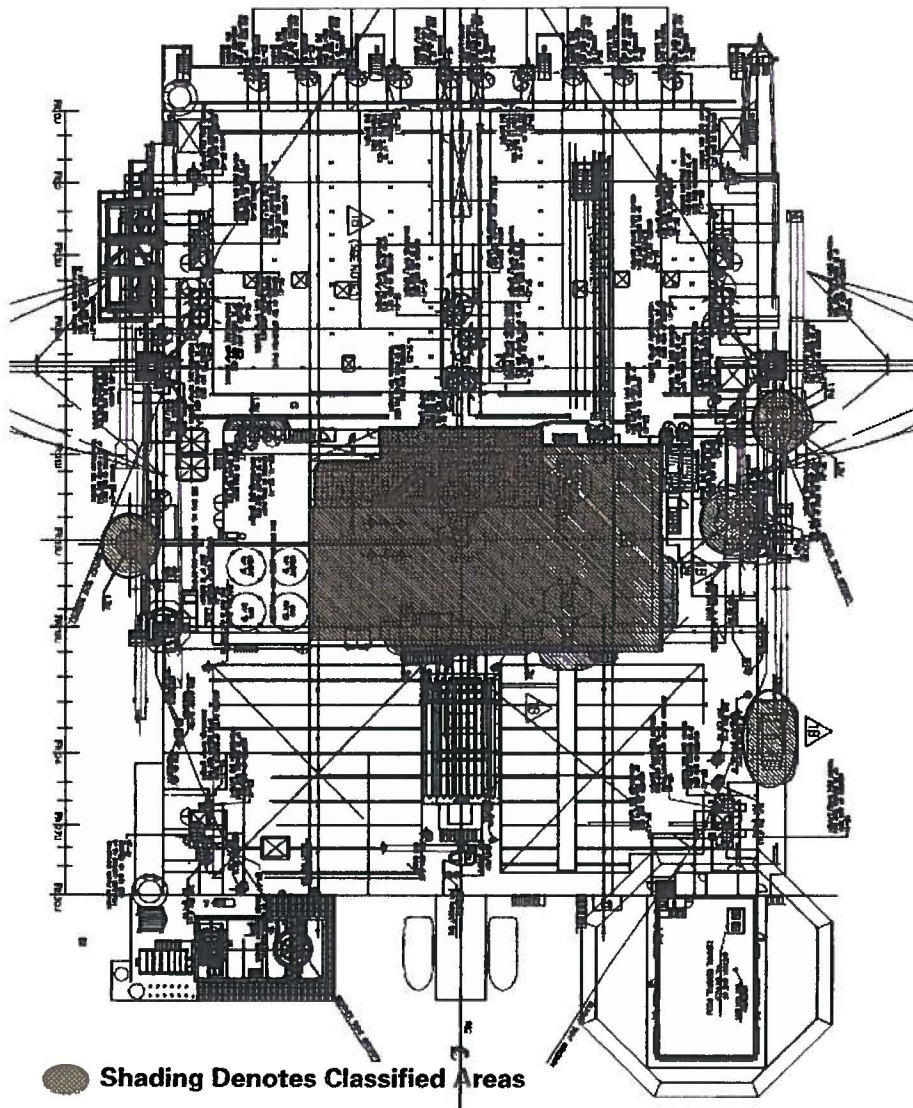
Hazardous Area Classification - Main Deck

- Hydrocarbon gas detected by several gas detectors prior to explosion (two witness statements from bridge).
- Several potential scenarios of hydrocarbon release to atmosphere have been identified.
- Dynamic modeling estimates suggests that flammable gas mixtures could have reached non-electrically classified areas.

- Fluid dynamic modeling being further developed in-line with most probable release scenarios.
 - Access to pit room / mud pumps
 - Access to derrick via degasser
 - Access to engine room
- Review of electrical area classification, fire and gas design and ventilation system design.

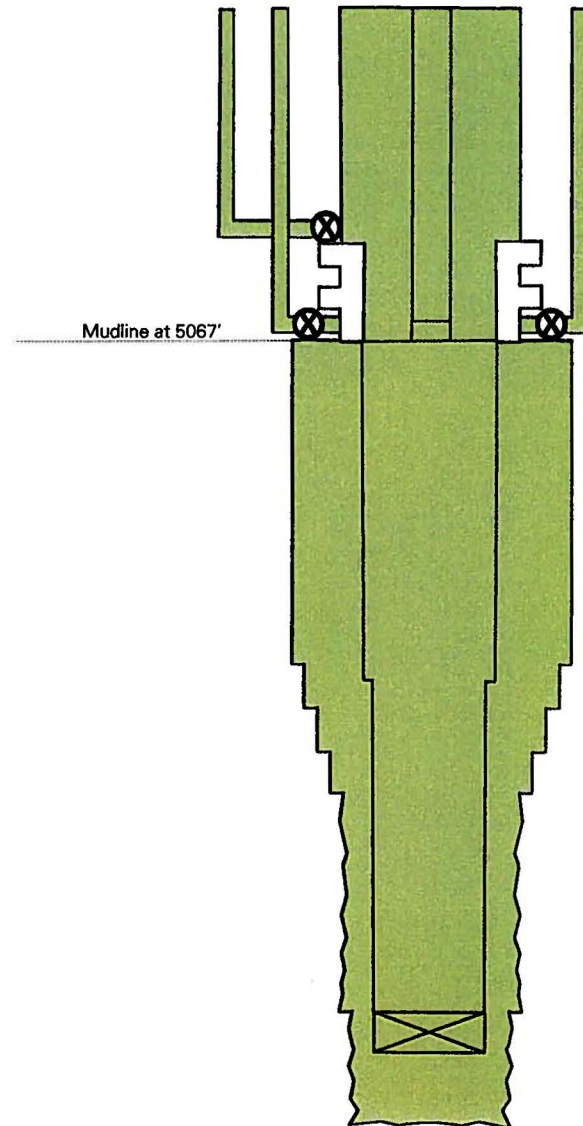
Run Casing – Convert Float Equipment

Data
<ul style="list-style-type: none">• Run 7" x 9-7/8' production casing<ul style="list-style-type: none">– Crossover at 12487'– Float Collar at 18114'– Shoe at 18304'– 56' of rat hole• Laid out three joints of 7" due to damaged threads• Saw 10k weight bobble at 18218 (only time string took weight during run)• 9 attempts to convert float equipment<ul style="list-style-type: none">– Sheared at 3142 psi vs 500-700 psi design

Interpretation
<ul style="list-style-type: none">• Circulating pressure below normal after shearing float collar

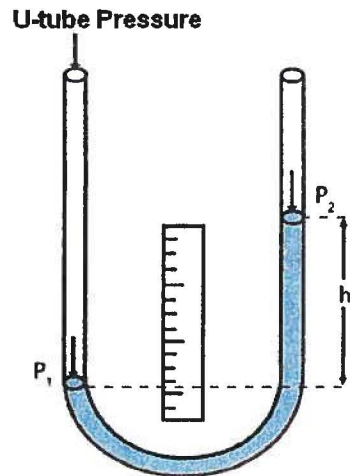
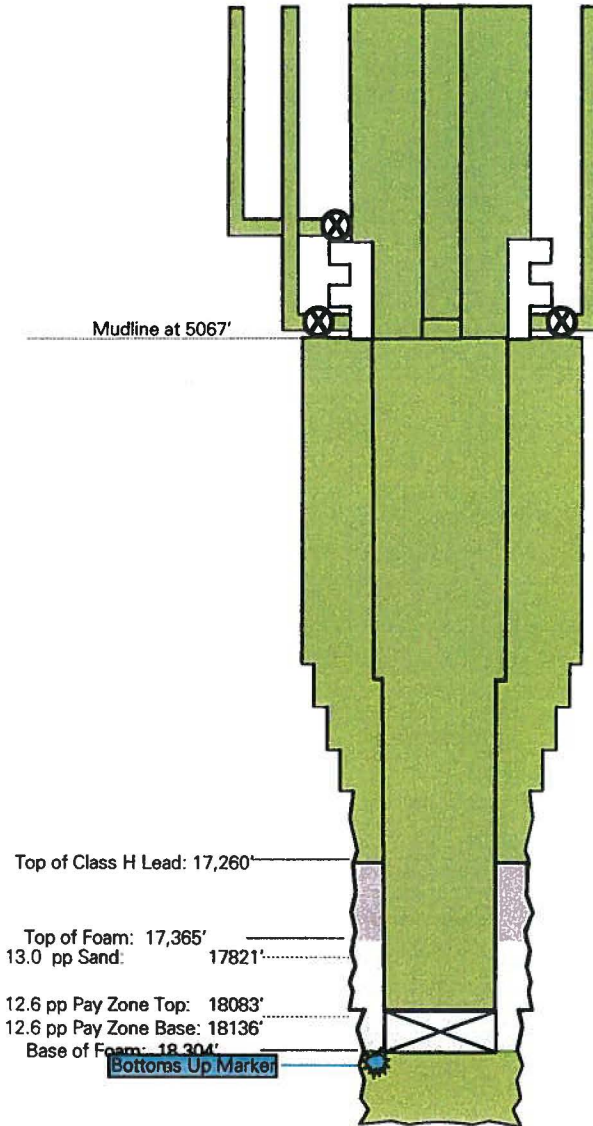
Cement Job

- Circulate 342 bbl before cement job
- Pump nitrified foam cement
 - Pumped 60 bbl cement
- Estimated TOC at 17260'
- Bumped plug with 1150 psi
 - Cement in place at 00:35
 - Bled back 5 bbls to 0 psi
 - Minimal calculated U-tube pressure after job (nearly balanced)
- 14.0 ppg mud in rathole with 16.7 ppg cement in shoe track

- Job pumped per plan – no cement losses observed
- Minimal U-tube may have prevented definitive float test
- Potential for contamination of cement in shoe track due to density difference between cement and mud

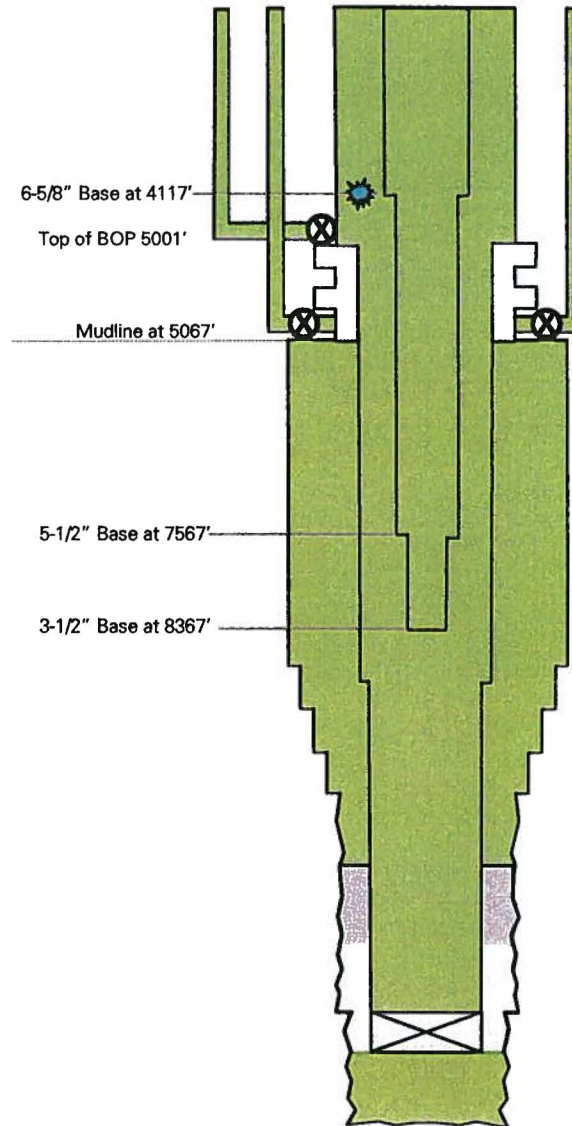
Finish Trip in Hole

<u>Interpretation</u>
<ul style="list-style-type: none">• The approach to transferring mud may have impaired pit monitoring over next 4 hours

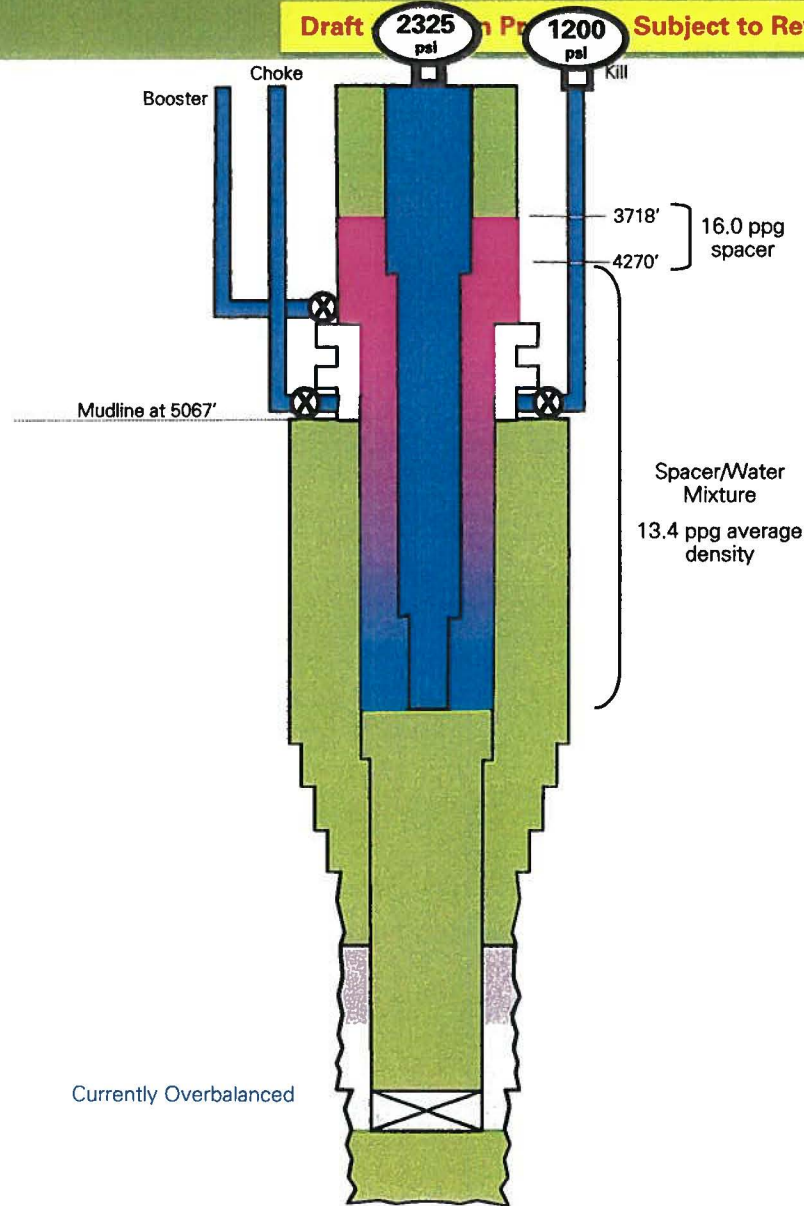
Pump Seawater

Data
<ul style="list-style-type: none"> Pump 352bbbls seawater <ul style="list-style-type: none"> Not enough to get spacer above BOP 2325 psi static pressure after pumping <ul style="list-style-type: none"> Calculated U-tube is 1628 psi

Interpretation
<ul style="list-style-type: none"> Higher than expected static pressure may indicate large spacer-to-water interface Significant solids settling expected once pumps stop High gel strength with 100% spacer

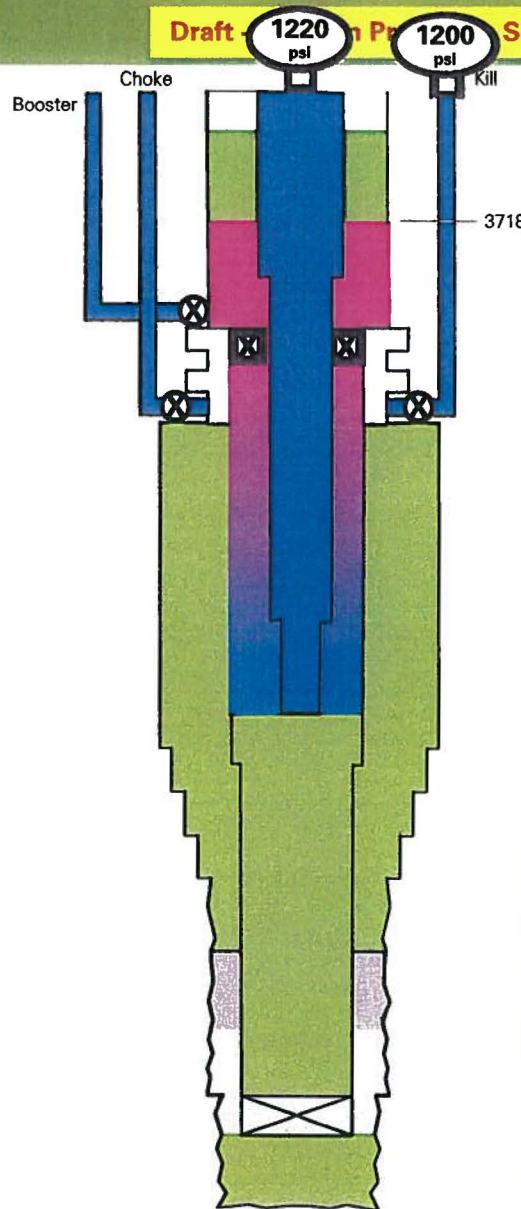
Bleed to 273 psi

- ### Data
- Open kill line
 - Pressure equalizes
 - Drillpipe pressure goes to 1400 psi
 - Kill line pressure drops to 645 psi
 - Bleed pressure to 273 psi on drillpipe as kill line pressure drops to zero
 - DP pressure never gets to zero
 - First time well is under balance
 - Observed that fluid level in the riser had dropped

- ### Interpretation
- U-tube between drill pipe and kill line due to heavy fluid in the annulus
 - Suspect the annular is leaking

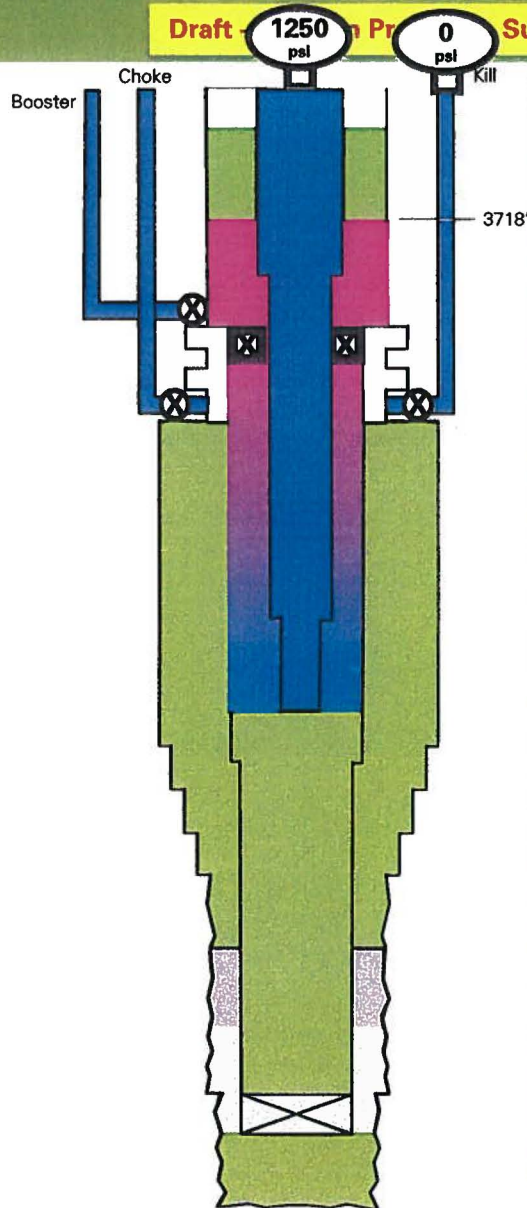
Drillpipe Pressure Builds / Fill Riser

Data
<ul style="list-style-type: none">• Shut in drillpipe• Pressure builds to 1250 psi in 6 minutes• Filled the riser with 50bbls from trip tank• Mud offload to Bankston ends at 17:17<ul style="list-style-type: none">• Mudloggers not informed that offloading had ceased

Interpretation
<ul style="list-style-type: none">• If the annular was leaking it is now sealed• Discussion on rig floor about pressure on drillpipe<ul style="list-style-type: none">– Decision made to conduct negative test on kill line

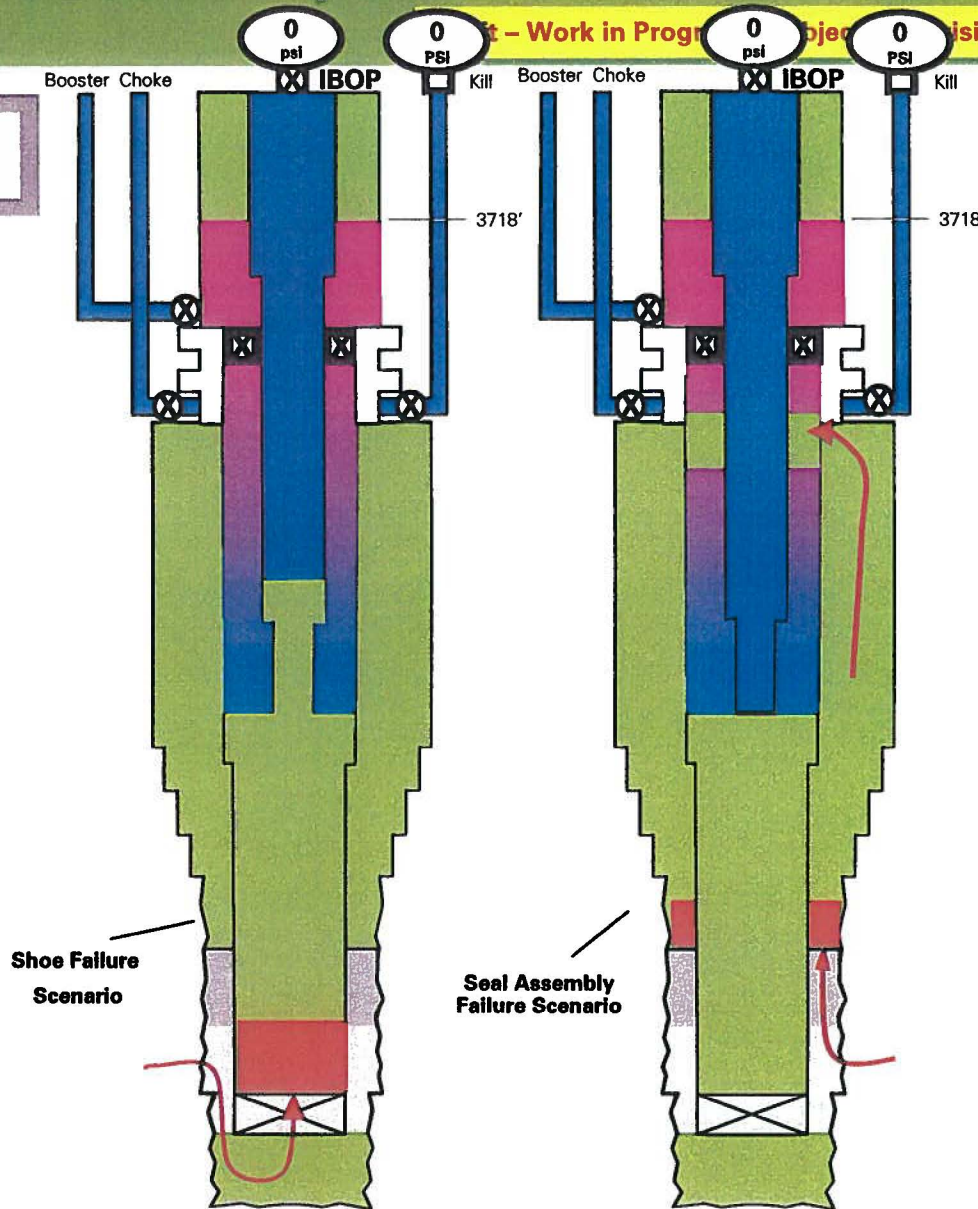
Bleed from 1202 to 0 psi

- Bleed drillpipe from 1202 to 0 psi
- IBOP is then closed

- Witness statements indicate 15 bbls taken at this bleed
 - Normal compressibility would be approximately 5 bbls
 - Influx from the well is suspected

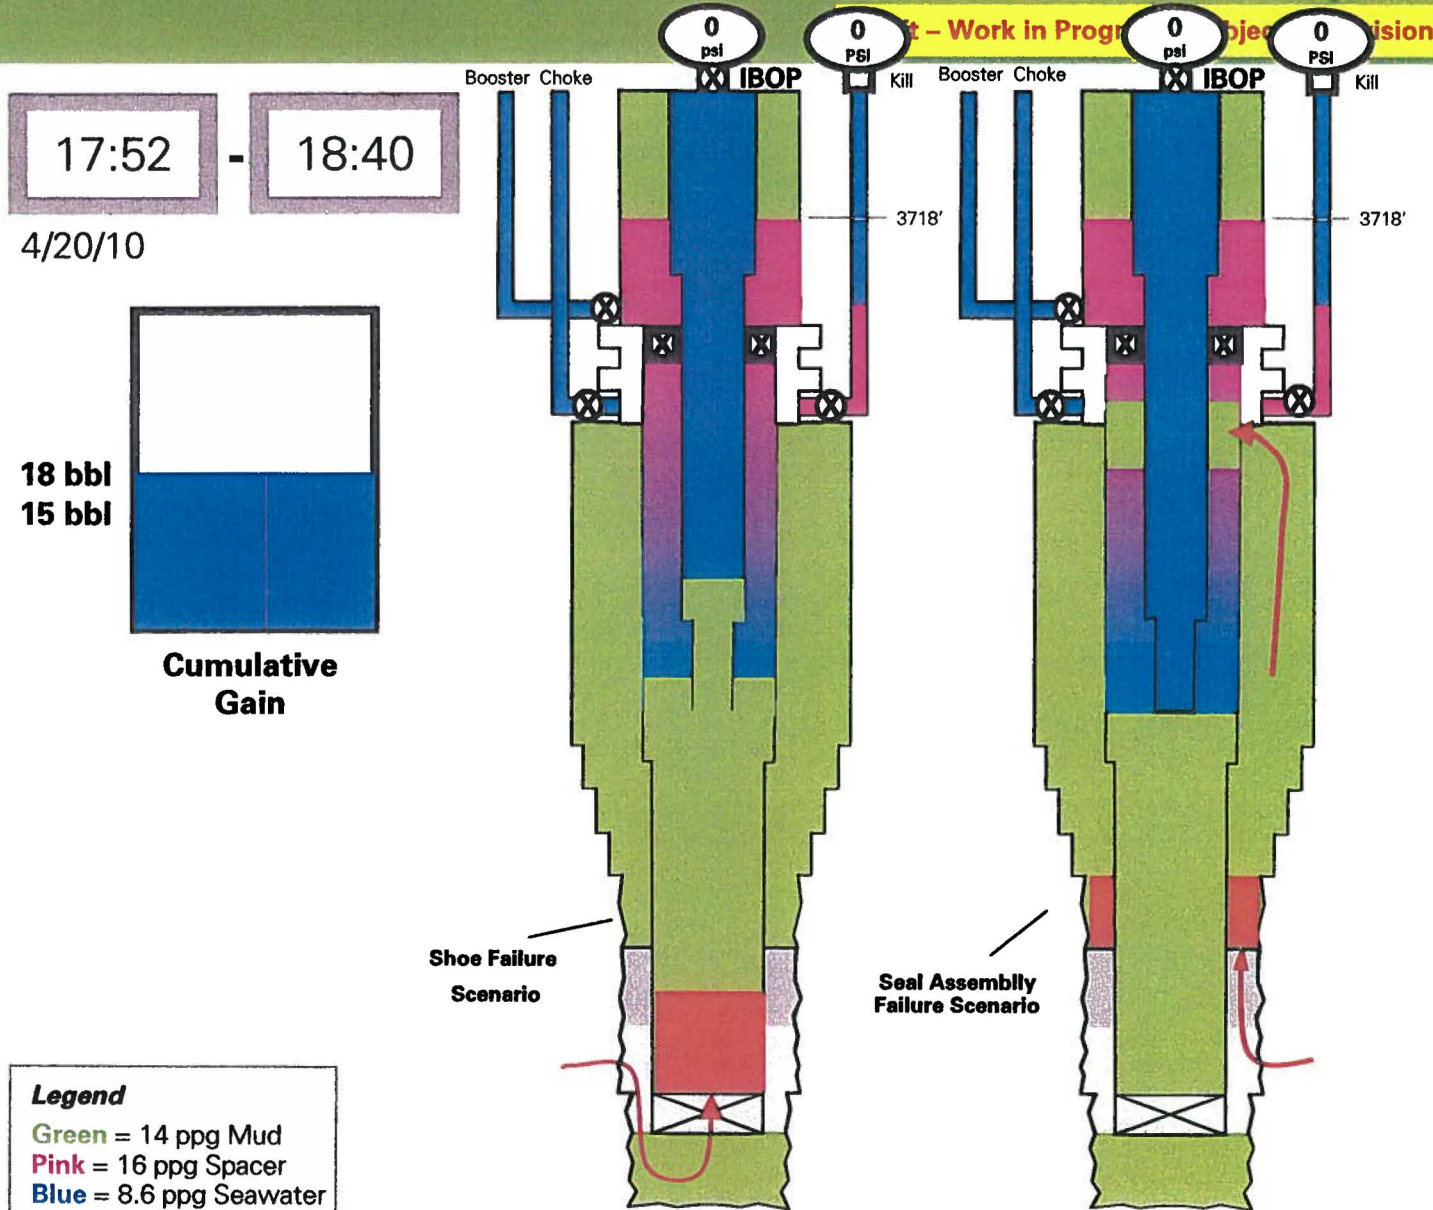
Bleed Kill Line / Pressure Builds Gradually

- Pressure monitored through cement unit quickly rises to 790 psi and falls
- Pressure slowly builds from 0 to 1400 psi over 31 minutes

- Start monitoring drillpipe pressure at cement unit
- Bleed 3-15 bbls from kill line to cement unit
- Cementer witness statement that well continued to flow and spurted
- Shut kill line and see pressure build

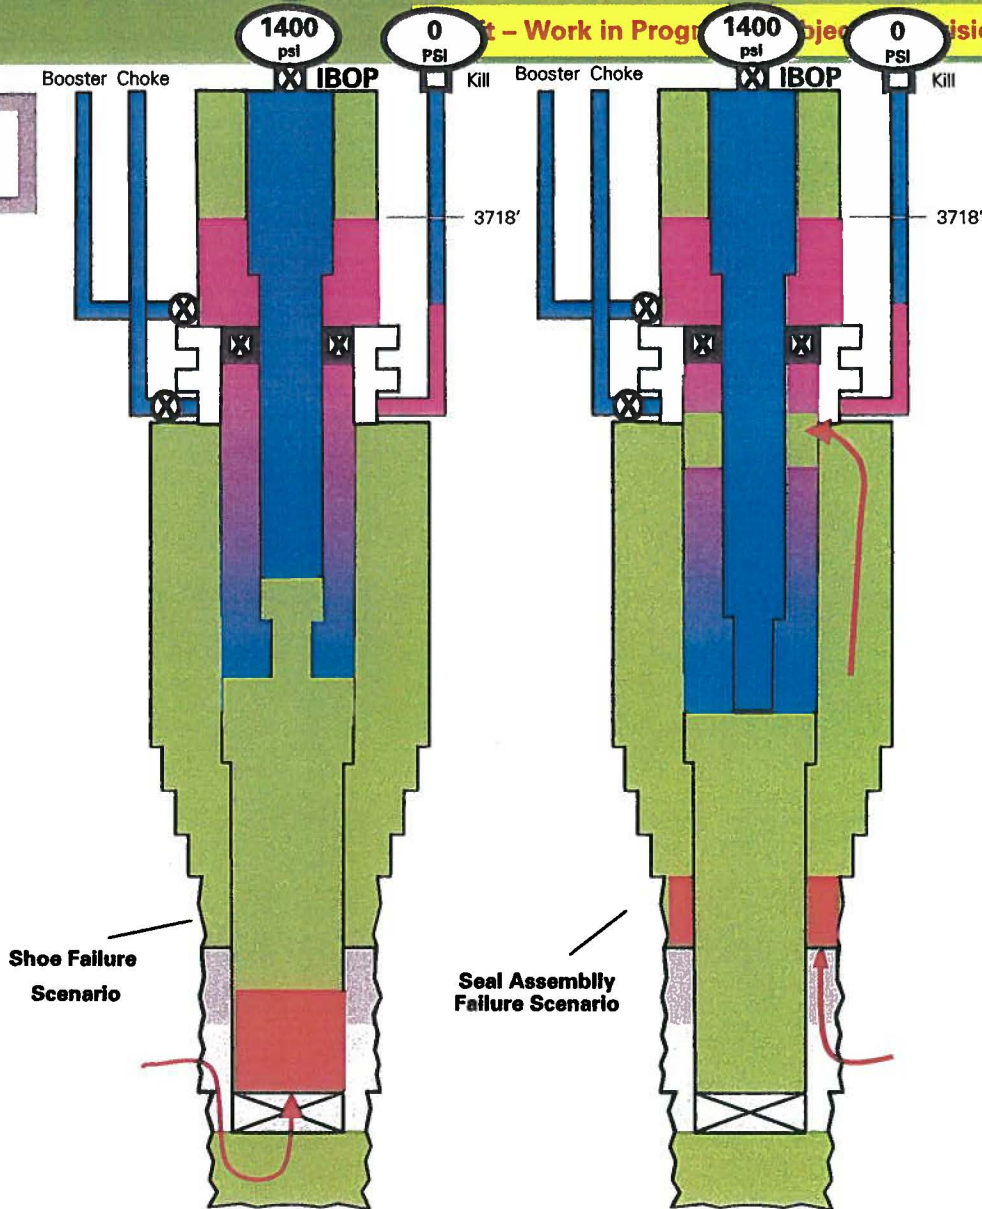
Pressure Holds – Negative Test

Data
<ul style="list-style-type: none"> • Drillpipe pressure (monitored at Halliburton) stays steady at 1400 psi • Pumped on kill line to ensure full • Bled off 0.2 bbls to trip tank • Monitored kill line for 30 minutes • Prepare to displace with seawater

Interpretation
<ul style="list-style-type: none"> • Discussion about pressure on the drillpipe • No flow observed on kill line • Rig team satisfied that test successful

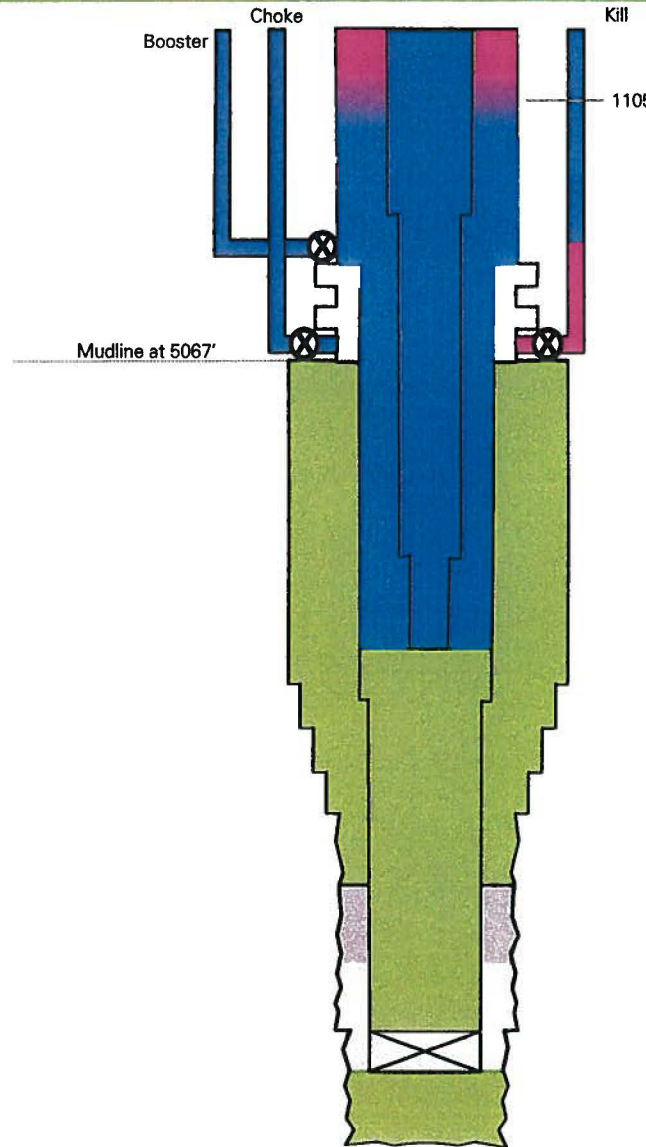
Displace to Seawater

- Pumped 1304 bbl seawater
 - Using rig pumps and booster
- Shut down for sheen test – spacer back
 - 1017 psi on DP when shut down
- Sheen test passes
- Crew instructed to divert returns overboard

- Flow out greater than flow in commencing at 20:58 while slowing pumps for spacer return
- Second indication of flow at 21:08 when pumps shutdown for sheen test
 - Pressure builds to 1263 over 5.5 minute period
 - Flow meter indicates well flowing

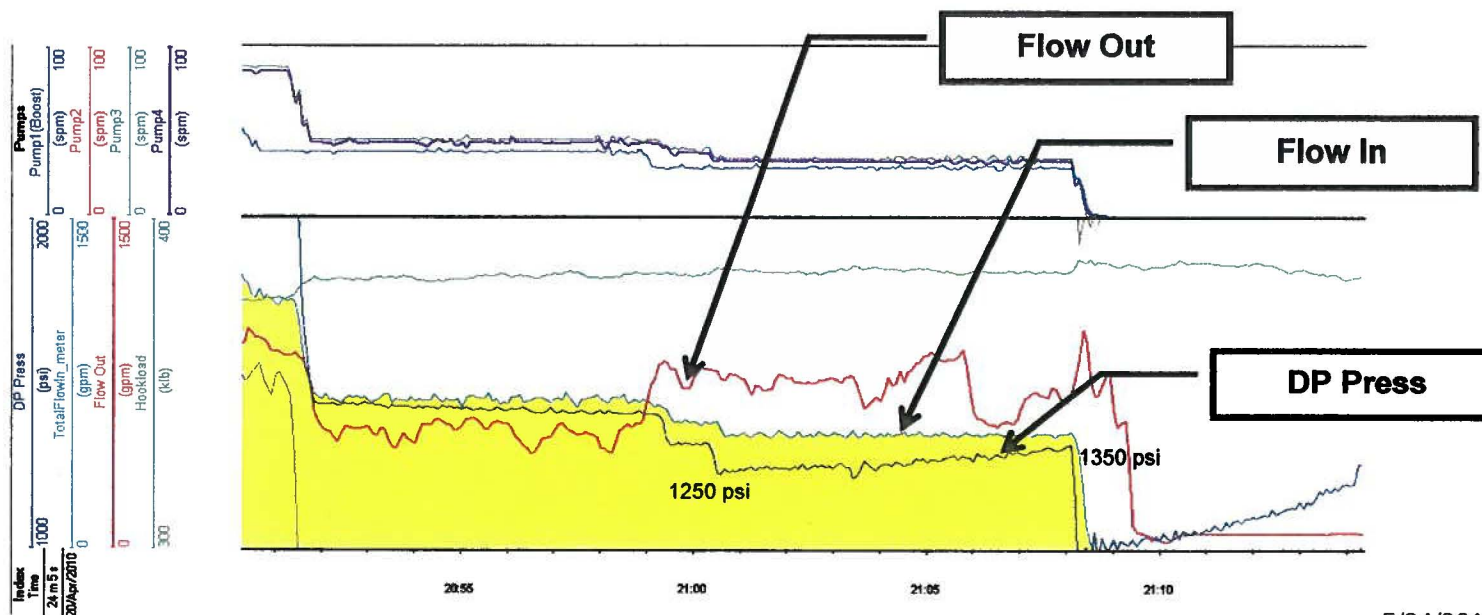
Critical Factor 2: Flow Indication #1 51 minutes before explosion

- Following final integrity test of wellbore, BOP annular was opened and well displacement of mud to seawater began:
 - Flow-out volume of mud and drillpipe pressure showed expected correlation until about 20:58
 - At 20:58, pumps were slowed and the following abnormal results:
 - Drillpipe pressure increased from 1250 psi to 1350 psi
 - Flow-out volume increased instead of slowing
 - Flow-out vs flow-in shows gain of approx 57 bbls over 12 minute period
 - First indication of flow ~51 minutes before the explosion

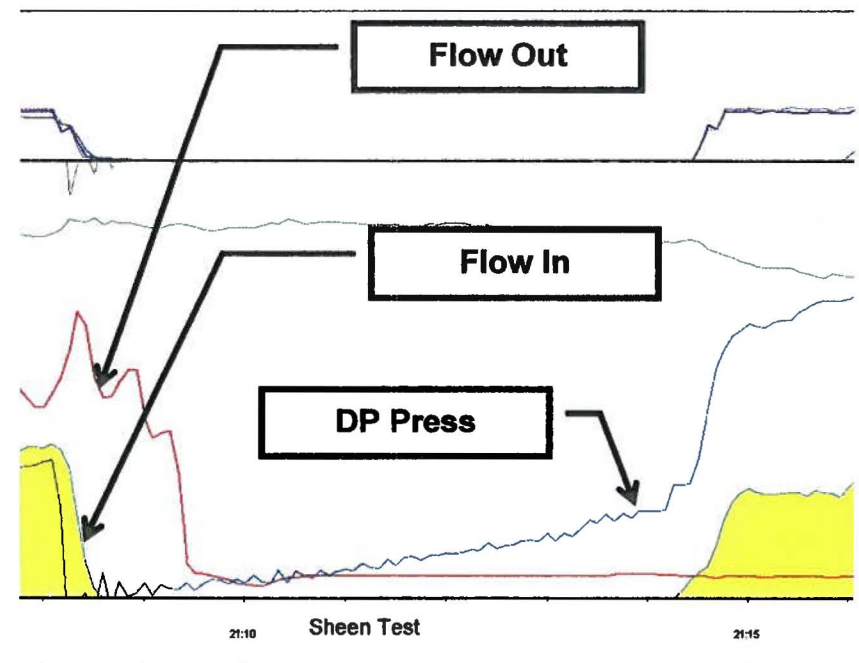
Flow Back @ 21:08

- At 21:08 – pump shutdown as spacer observed at surface. Sheen test required.
 - Flow-out should be zero, but real-time data indicates well flowing after pump shut off
 - Drillpipe pressure increased from 1017 psi to 1263 psi over 5.5 minute period of sheen test

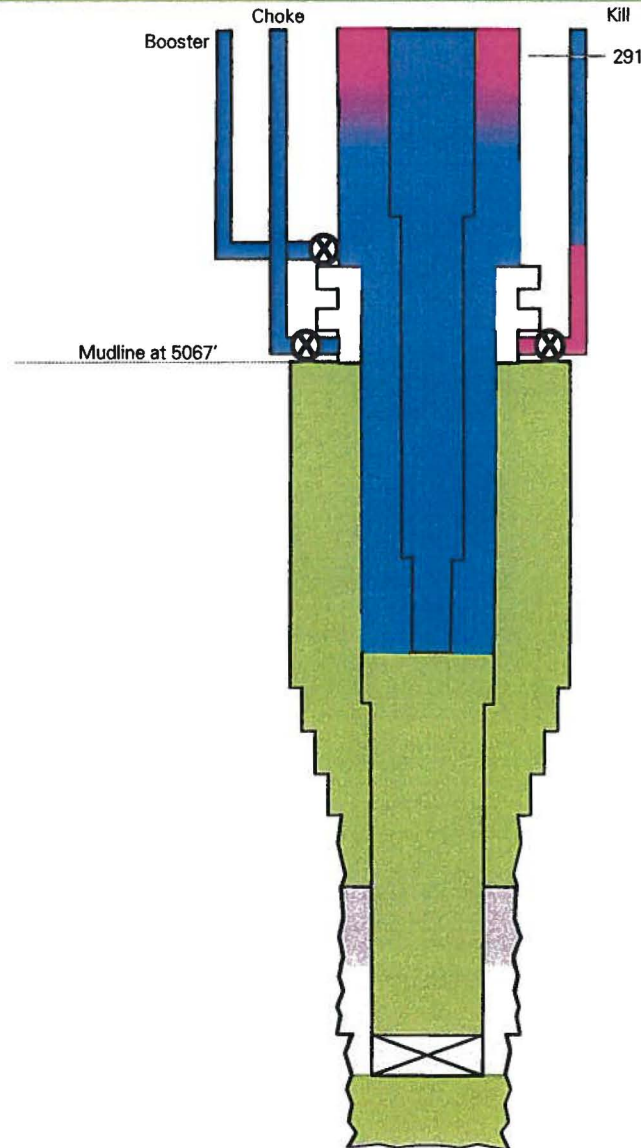
Resume Displacement

- **Resume displacement**
 - Pump another 265 bbls
 - Returns going overboard
 - Flow meter bypassed – unable to monitor flow out
- **Pumps stop at 21:31**
- **Significant pressure buildup starting at 21:47**
- **Data lost at 21:49**
 - Last pressure reading 5700 psi

- **Pumps stop at 21:31 – suspect problem identified with well**
- **4 calls made from rig floor and Chief Mate discusses well with Toolpusher on rig floor**
- **Suspect explosion at 21:49**
- **EDS at 21:56 by Captain**

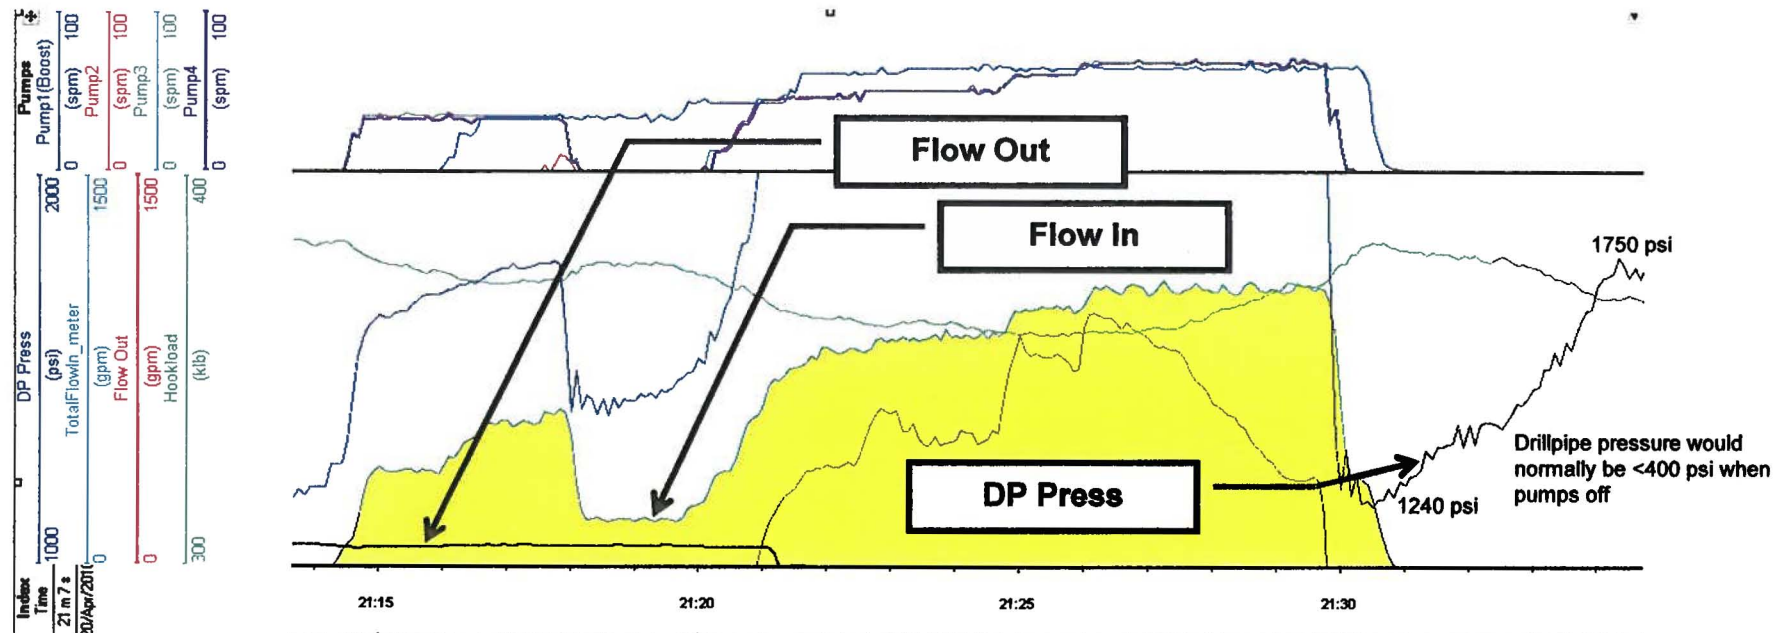
Critical Factor 2: Flow Indication #3 18 minutes before explosion

- Sheen test passed and approval granted to discharge overboard
- At 21:14, pumping resumed to continue displacement to seawater
- At 21:31, problem observed (e.g. mud returns, abnormal pressures)
 - Pump abruptly shutdown
 - Drillpipe pressure at time of shutdown was 1240 psi. Increased to 1750 psi over next 6 minutes.
 - Flow-out data not available due to fluids being discharged directly overboard (bypasses flowmeter)

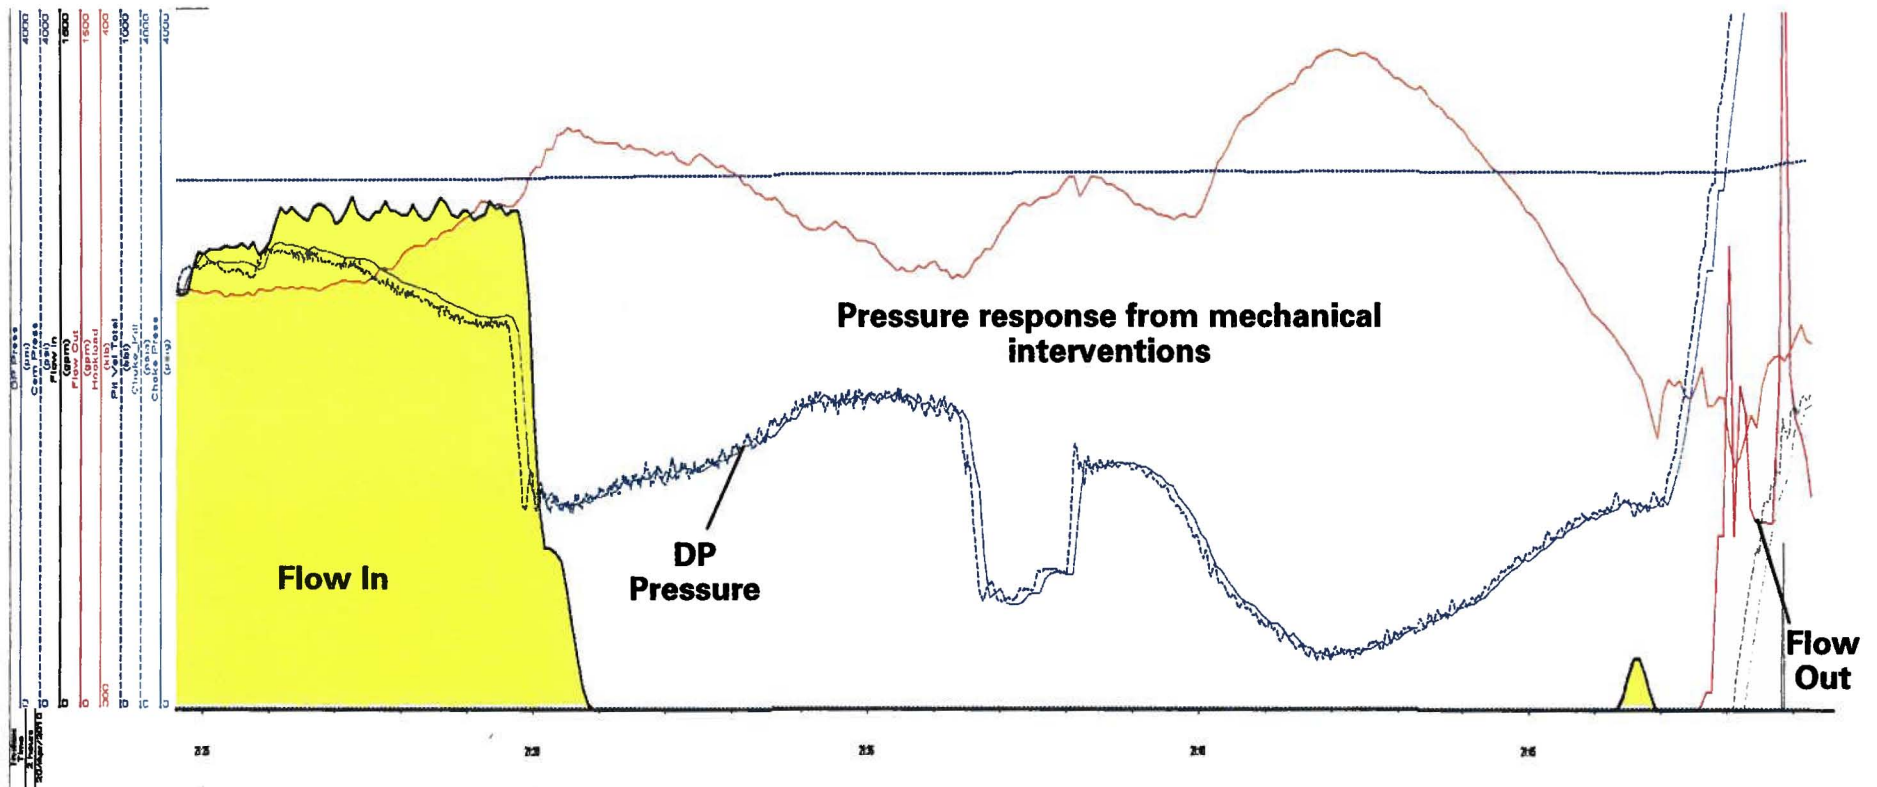
Final 18 Minutes

Data lost, suspect explosion
