4 September 2004

INFORMATION PAPER

SUBJECT: Visual Inspection of Karshi-Khanabad (K2) Airbase, Karshi, Uzbekistan

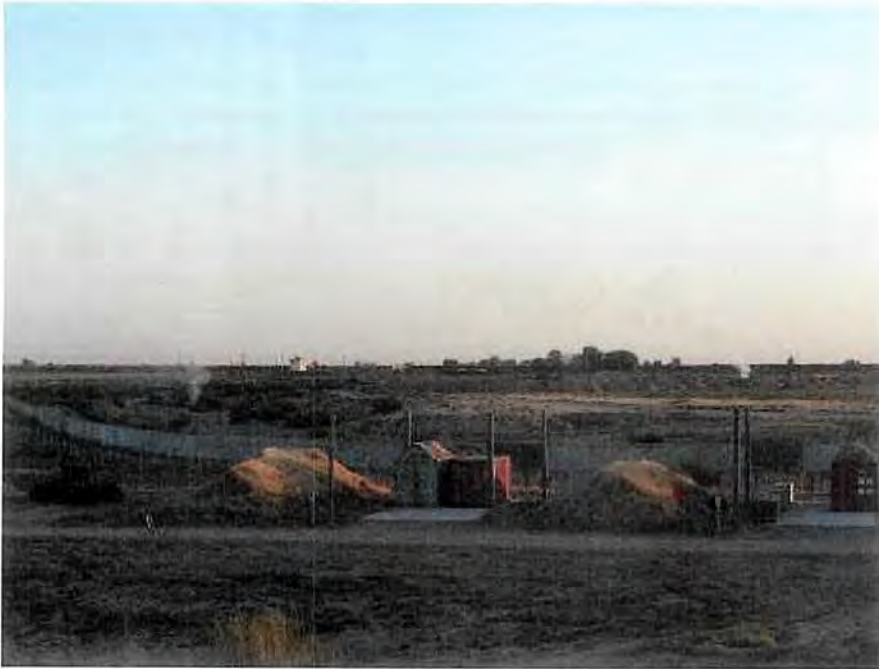
(1) (U) (~~S~~) There is currently open pit burning on the South side of the fence near the ASP (vic 41S QD 52346 01273). On 1 September 2004, there was one large fire actively burning during the VSI, and on 2 September 2004 there were two smaller fires burning in the same area (see Appendix B, Figures 1 and 2). The smell of burning plastic was evident, and ash was noted blowing from the fire site over the ASP. An ambient air monitoring station measuring total suspended particulate, respirable particulate, polynuclear aromatic hydrocarbons, and volatile organic compounds has been located within the ASP. Results will be available before 1 December 2004.

Figure 1. Two open pit trash fires burning South of K2 Airbase Ammunition Supply Point (ASP) (021900DSEP04)

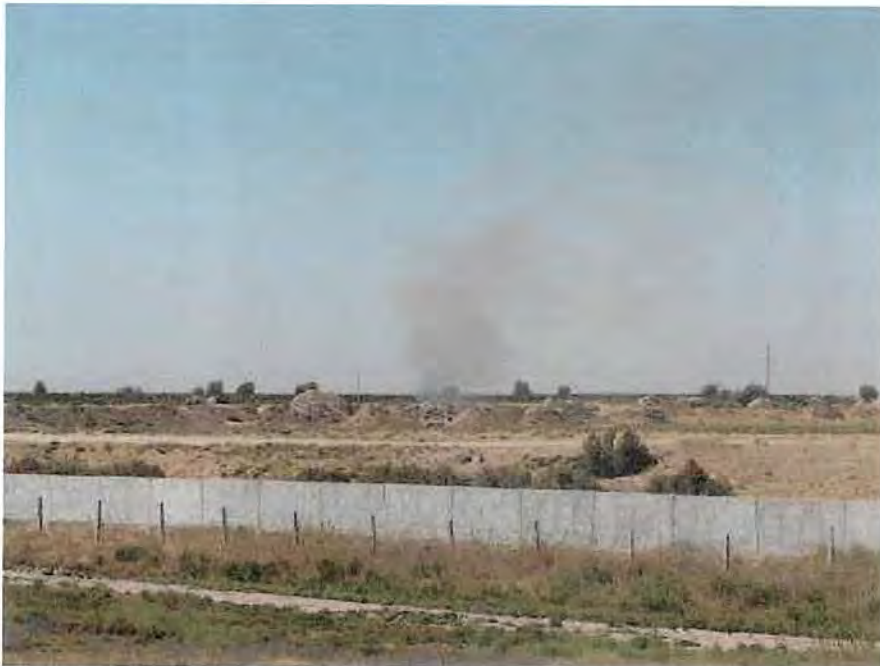
Figure 2. Open pit trash fire burning South of K2 Airbase ASP (021000DSEP04)

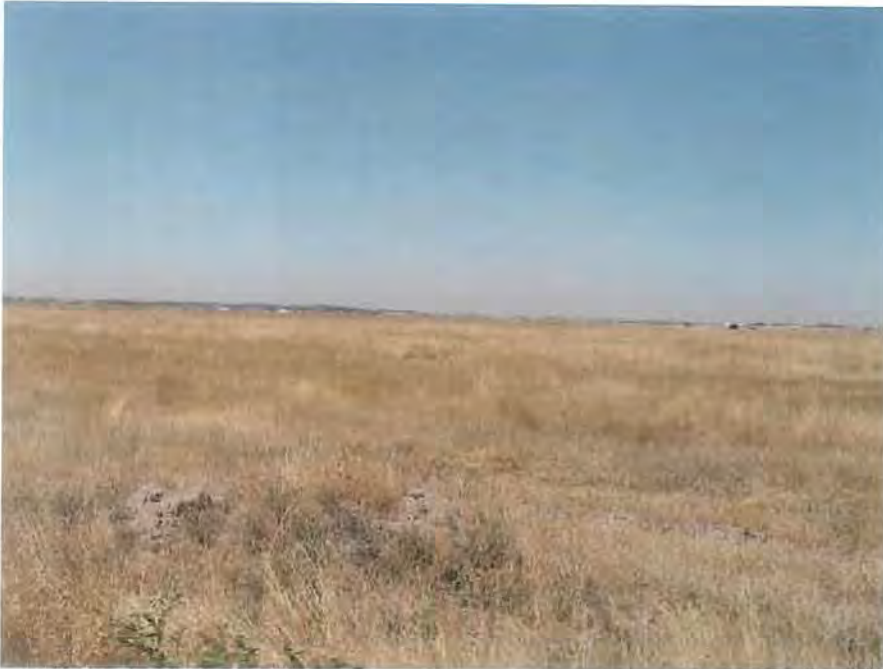
Uzbekistan government (vic 41S QD 53842 01637). The area along the South fence is generally rolling terrain with washes or shallow ravines running from North to South. One area along the road appeared to be an open dump (vic 41S QD 53068 00435) (see Appendix B, Figures 3 and 4). There did not appear to be any hazardous material disposed at the site, and direct reading measurements collected with a MultiRAE Plus Toxic Gas Monitor (containing a photoionization detector with a 10.6 eV lamp) did not indicate ionizable gas concentrations above the detection limit. There did not appear to be any other obvious disposal or industrial areas along the South road; however, several small clusters of Uzbeki military buildings (e.g., guard towers) were noted in the area near the road. Previous use of the area is not known.

Figure 3. View from South Road facing North

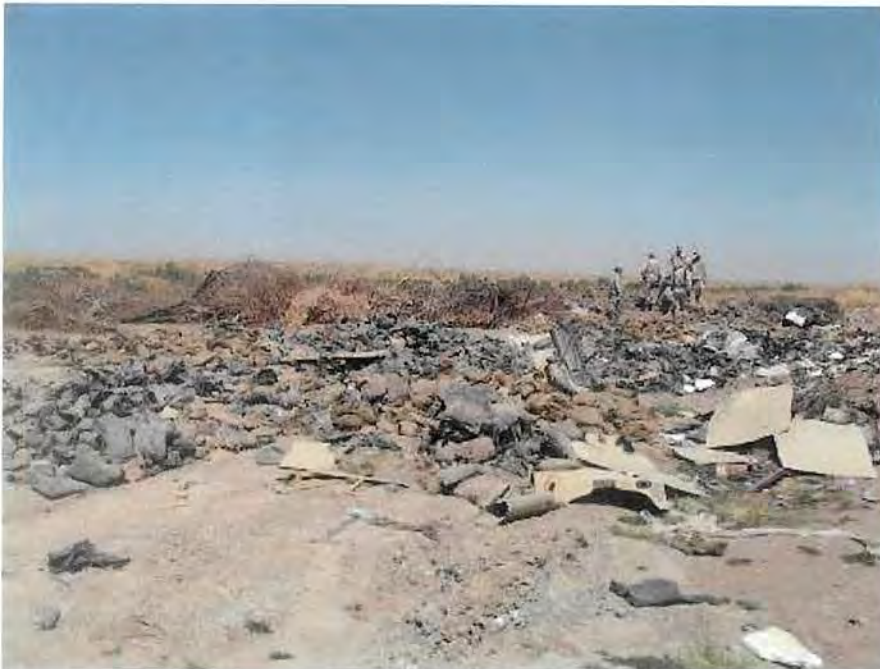
Figure 4. Open dump located along South Road (trash, sandbags, construction debris, and HMMWV parts)

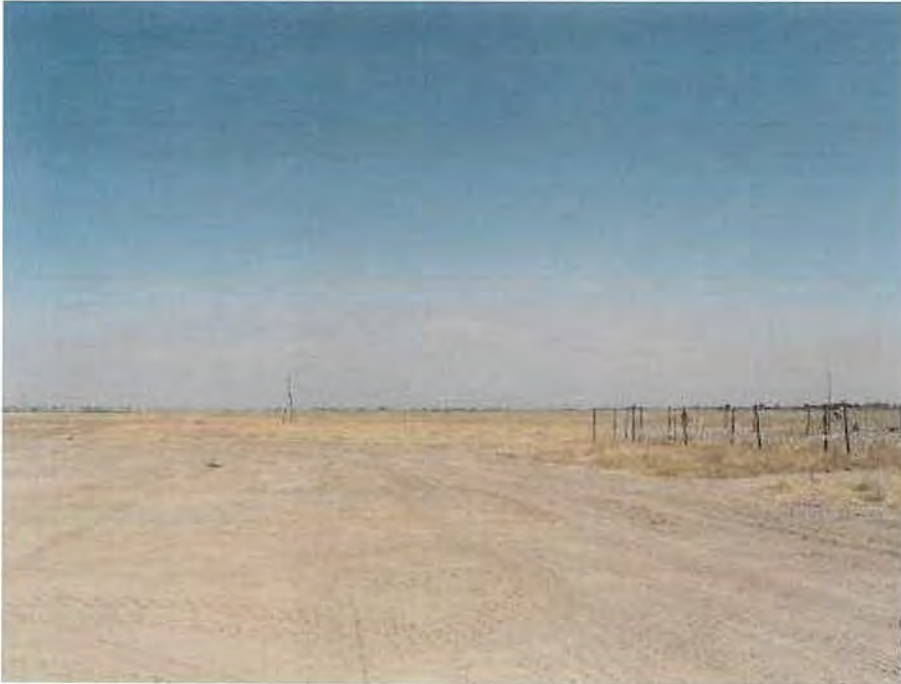
(4) (U) (~~S~~) On 1 September 2004, the DOEHS team toured the area just South of the emergency runway in the area shown in the figure. The area was generally flat and covered with vegetation, and no buildings were noted in this area other than a US military communication facility (see Appendix B, Figures 5 and 6). There did not appear to be any obvious industrial or disposal sites in the area. Previous use of the area is not known; however, cotton may have been cultivated in the area. Three composite soil samples were collected in the areas shown in the figure and will be analyzed for heavy metals, semi-volatile organic compounds, pesticides, herbicides, and polychlorinated biphenyls (PCBs).

Figure 5. View East of the US Military Communication Site (located South of runway)

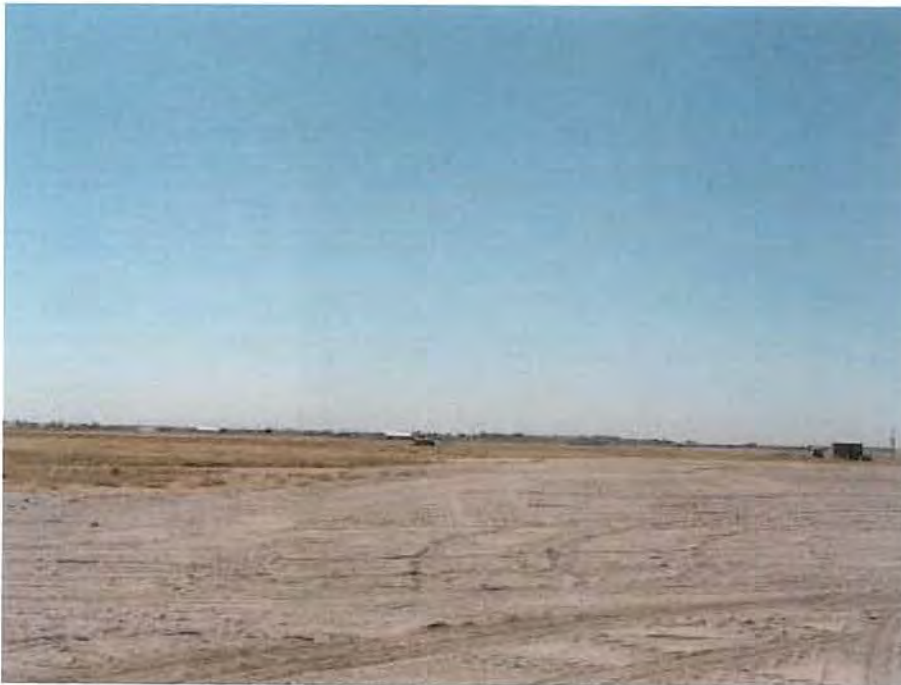
Figure 6. View West of the US Military Communication Site (located South of runway)

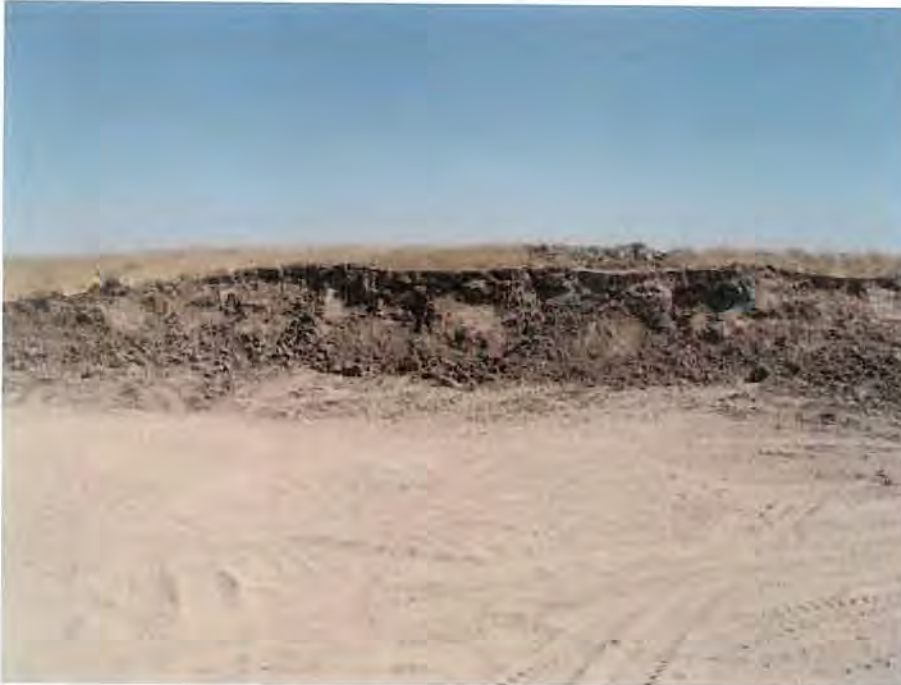
(5) (U) (~~S~~) The installation engineers conducting construction operations in the ASP identified a cut site (vic 41S QD 52735 02811) located South of the runway (see Appendix B, Figures 7 through 9). On 1 September 2004, the DOEHS team monitored soil at the cut site, as well as soil placed into newly constructed berms at the ASP, with the MultiRAE Plus Toxic Gas Monitor, and no concentrations of ionizable gas were noted above the detection limit.

Figure 7. Engineer cut site located along South Road

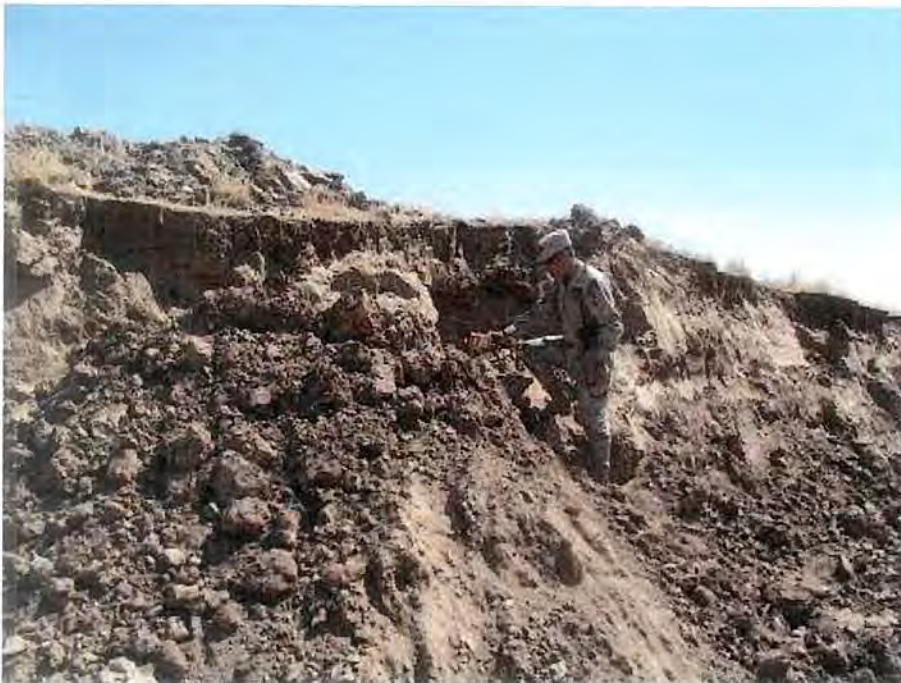
Figure 8. Air monitoring using MultiRAE Plus Toxic Gas Monitor at engineer cut site

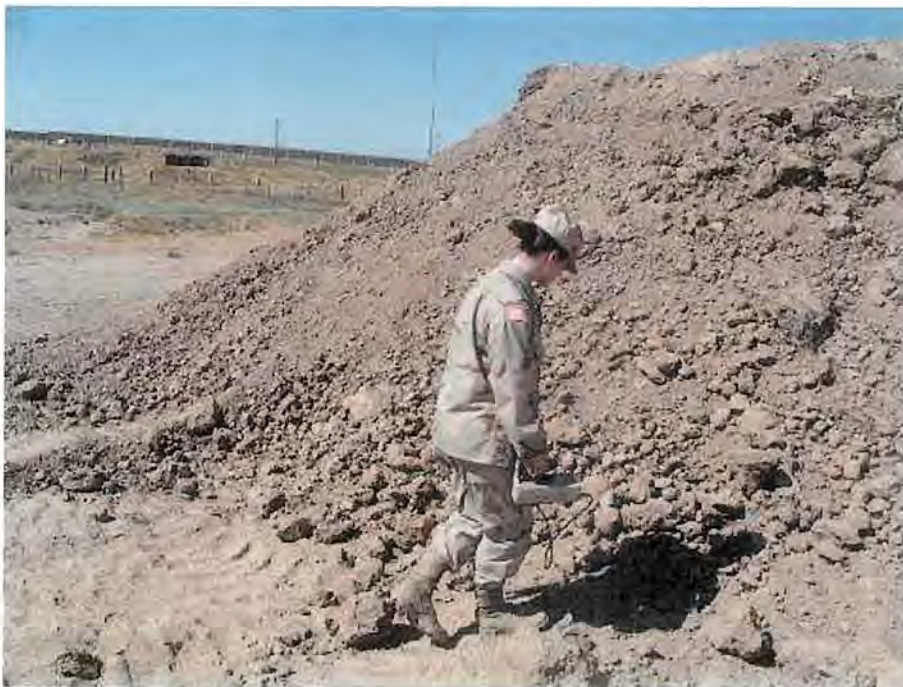
(7) (U) (~~S~~) Direct reading ionizing radiation measurements collected with an Eberline E600 Radiac Set equipped with an SPA-9 beta/gamma probe at the ASP, the open dump, the HM/HW storage area, the cut site, and the new DFAC site were all consistent with normal background radiation levels.

Figure 9. Radiation monitoring on newly constructed berms at K2 Airbase ASP
