Federal Register

[Docket No. FAA-2004-18744; Directorate Identifier 2004-CE-24-AD]

Airworthiness Directives; Great Lakes Aircraft Company, LLC, Models 2T-1A-1 and 2T-1A-2 Airplanes

ACTION: Notice of proposed rulemaking (NPRM).

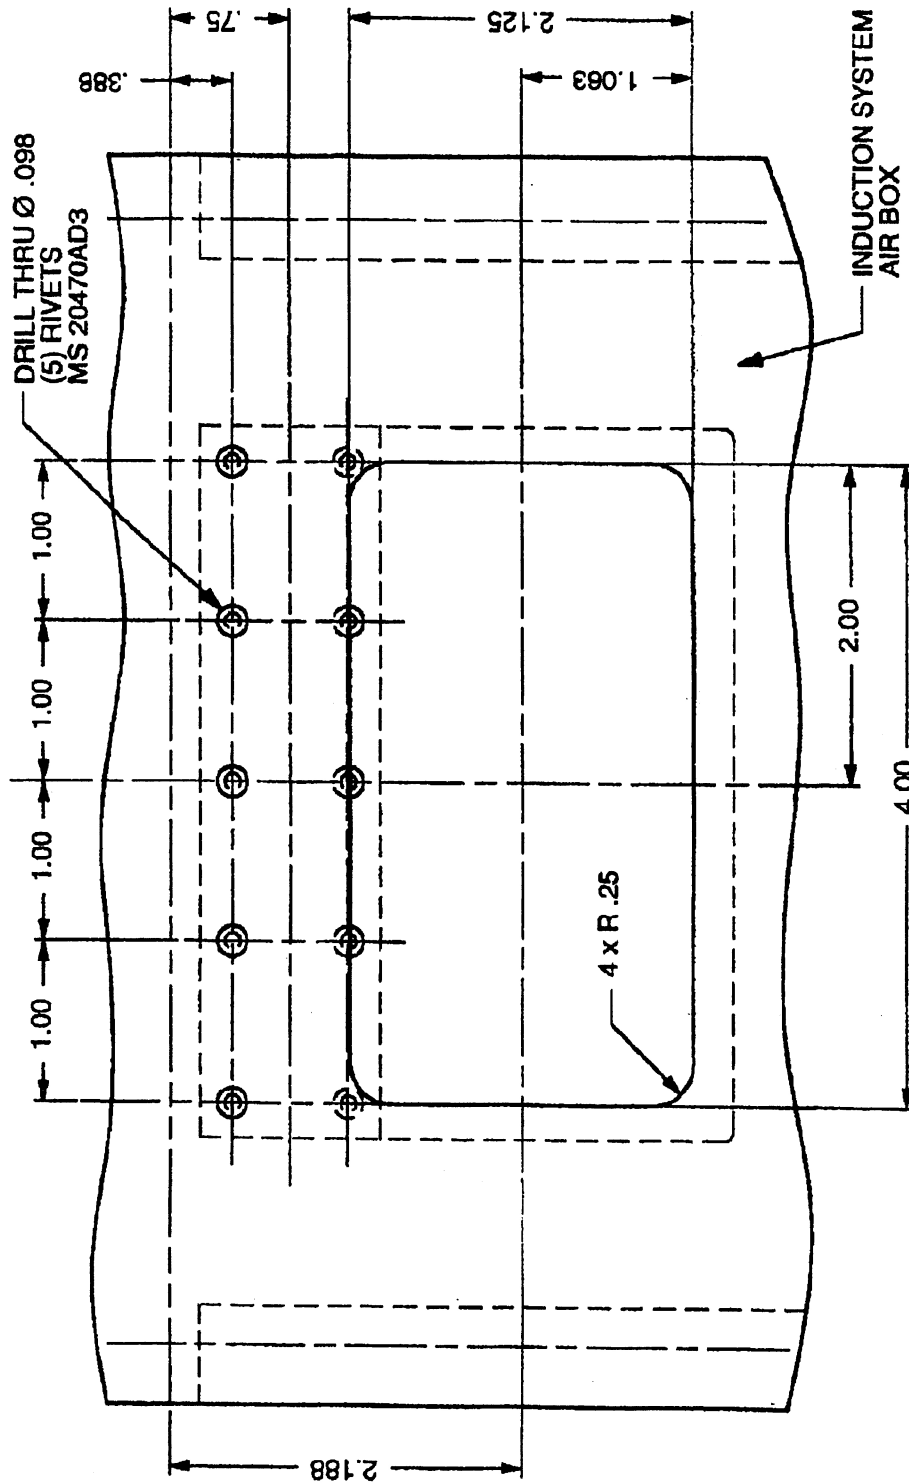
Fig. 1

GREAT LAKES AIRCRAFT, TYPES 2T-1A-1 AND 2T-1A-2
ENGINE INDUCTION SYSTEM AD 79-20-08
ALTERNATE AIR DOOR INSTALLATION
FULL SCALE

Actions	Compliance	Procedures
(2) Visually inspect the alternate air door for distortion, heat damage, and cracks. If any damage is found, repair or fabricate a new door following Figure 1, Figure 2, and Figure 3 in this AD.	<i>For airplanes previously affected by Ad 79-20-08:</i> Initially inspect at the next scheduled inspection required by Ad 79-20-08 or within the next 25 hours TIS after the effective date of this AD, whichever occurs later. Repetitively inspect thereafter at intervals not to exceed 100 hours TIS. <i>For airplanes not previously affected by AD 79-20-08:</i> Inspect within the next 25 hours TIS after the effective date of this AD. Repetitively inspect thereafter at intervals not to exceed 100 hours TIS. <i>For all affected airplanes:</i> If damage is found during any inspection, before further flight, repair or replace the damaged alternate air door.	Not applicable.

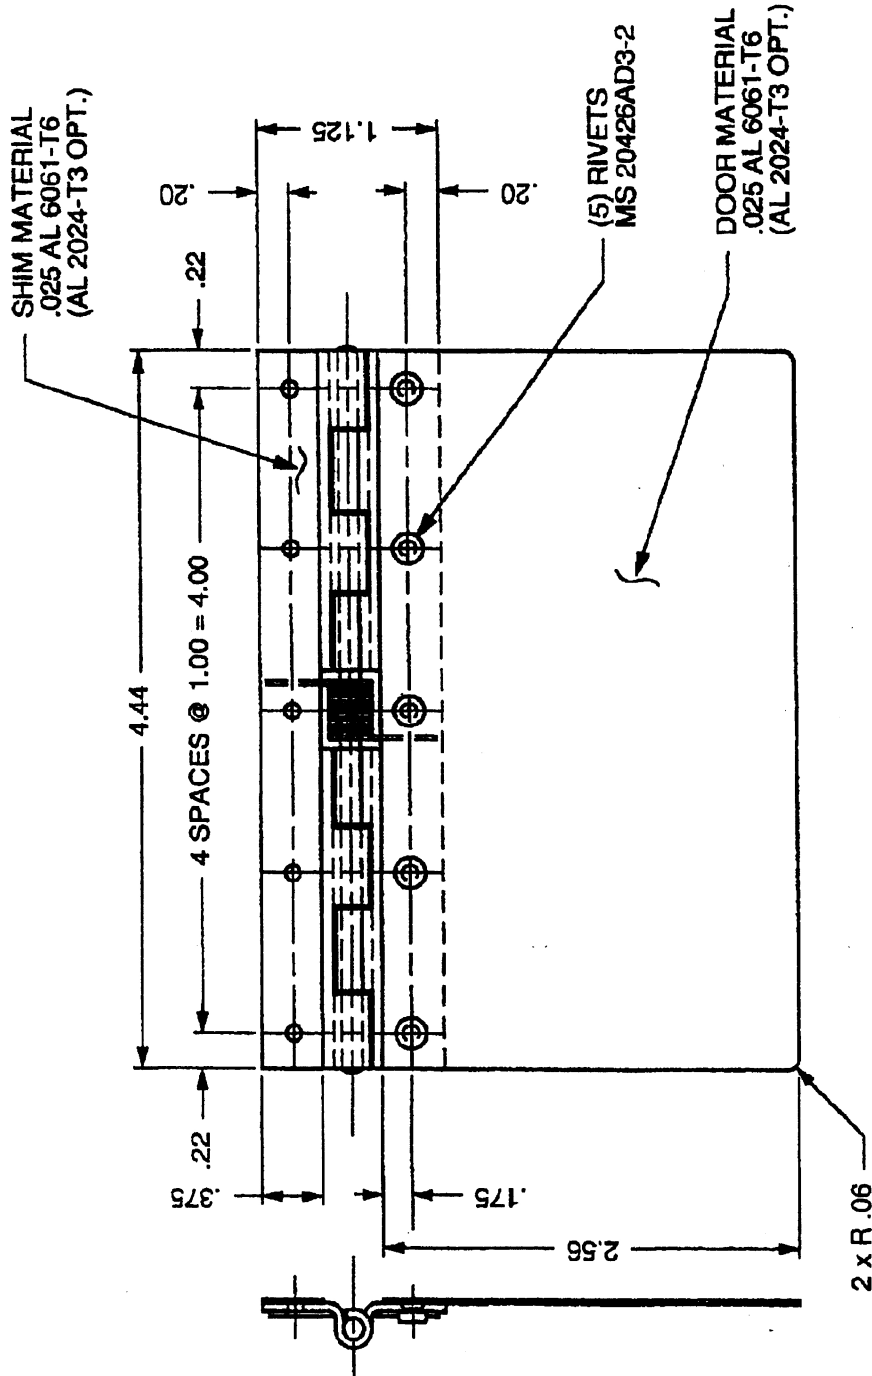
Fig. 2

GREAT LAKES AIRCRAFT, TYPES 2T-1A-1 AND 2T-1A-2
ENGINE INDUCTION SYSTEM AD 79-20-08
ALTERNATE AIR DOOR FABRICATION DETAIL
FULL SCALE

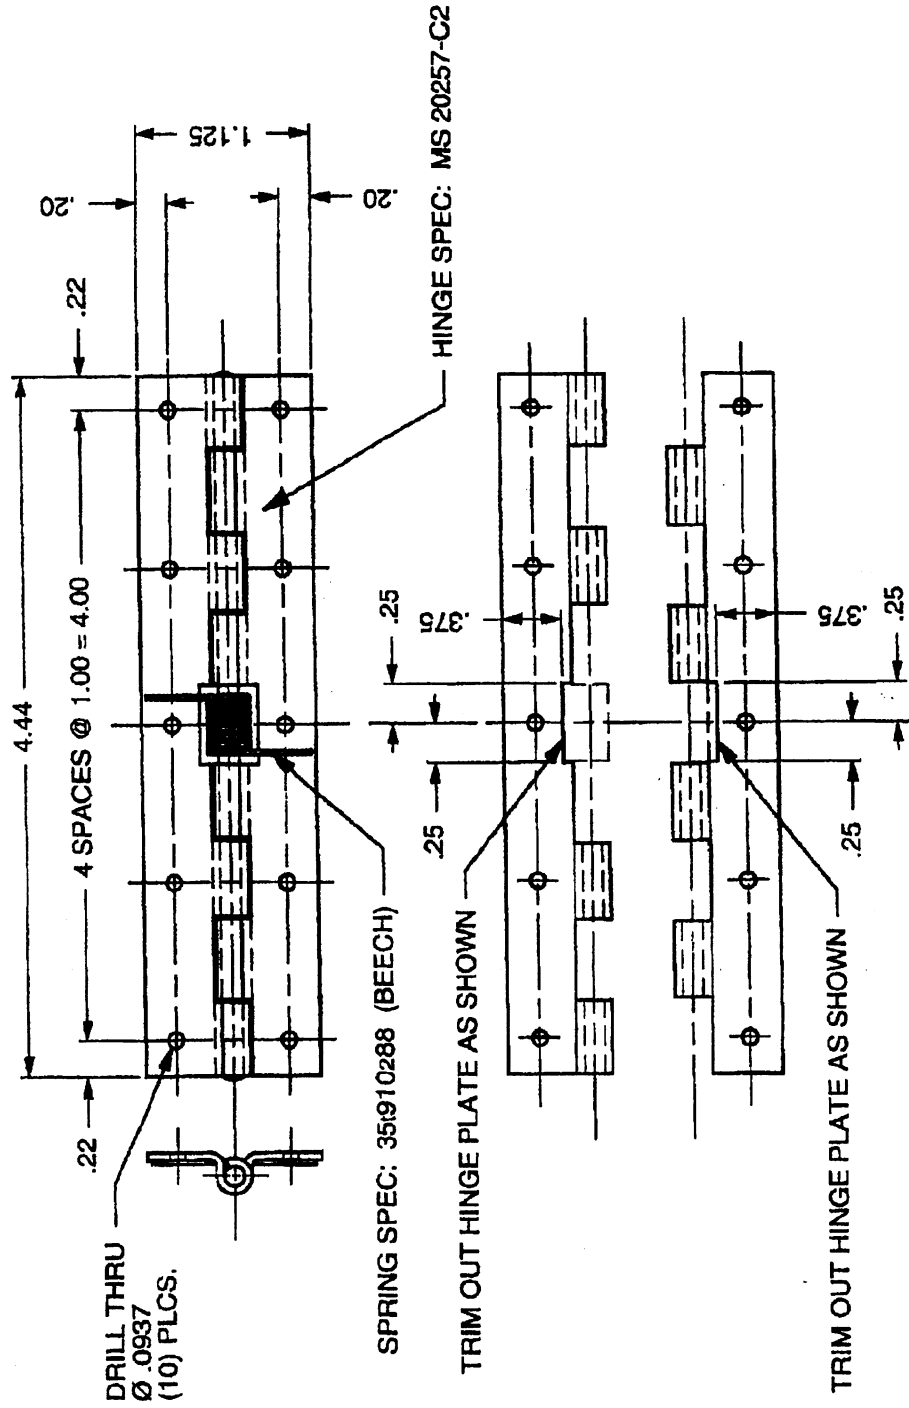
Fig. 3

GREAT LAKES AIRCRAFT, TYPES 2T-1A-1 AND 2T-1A-2
 ENGINE INDUCTION SYSTEM AD 79-20-08
 ALTERNATE AIR DOOR HINGE DETAIL
 FULL SCALE
