Preliminary Data – Hurricane Katrina Canal Breachings, 17<sup>th</sup> Street, London Avenue and Industrial Canal

Dr. Ivor van Heerden Director Center for the Study of Public Health Impacts of Hurricanes, Deputy Director LSU Hurricane Center Louisiana State University

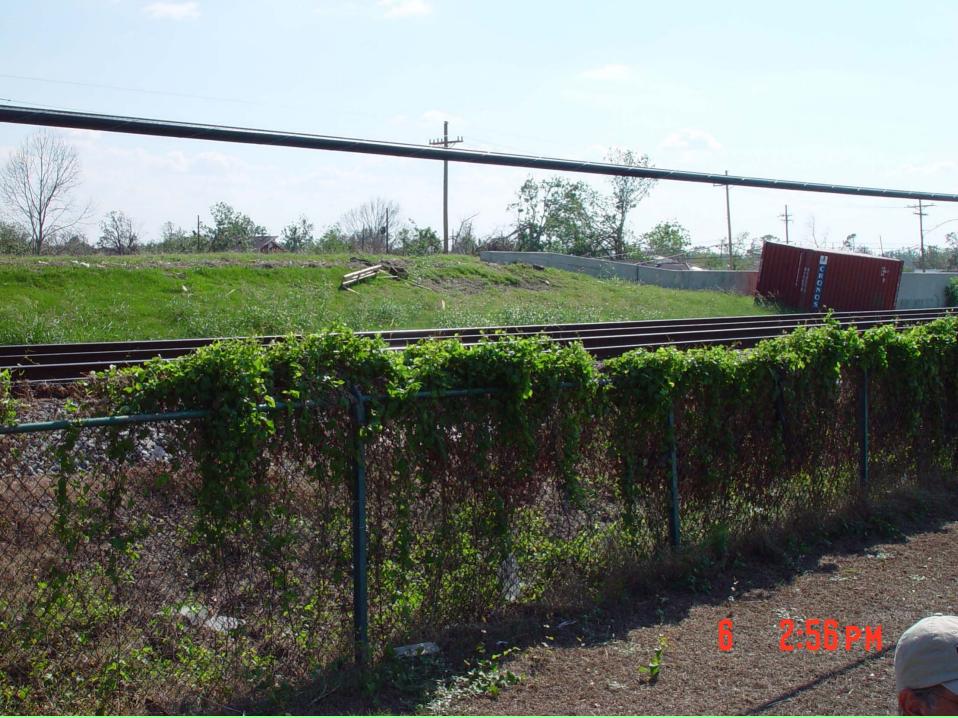
10 M SPOT Satellite Image: 2 Sept 2005 With Water depth overlays – Orleans East

Levee Overtopping

Industrial Canal Overwash

Levee Degradation

Flood elevation: +1ft NAVD 88 2 Sept 2005

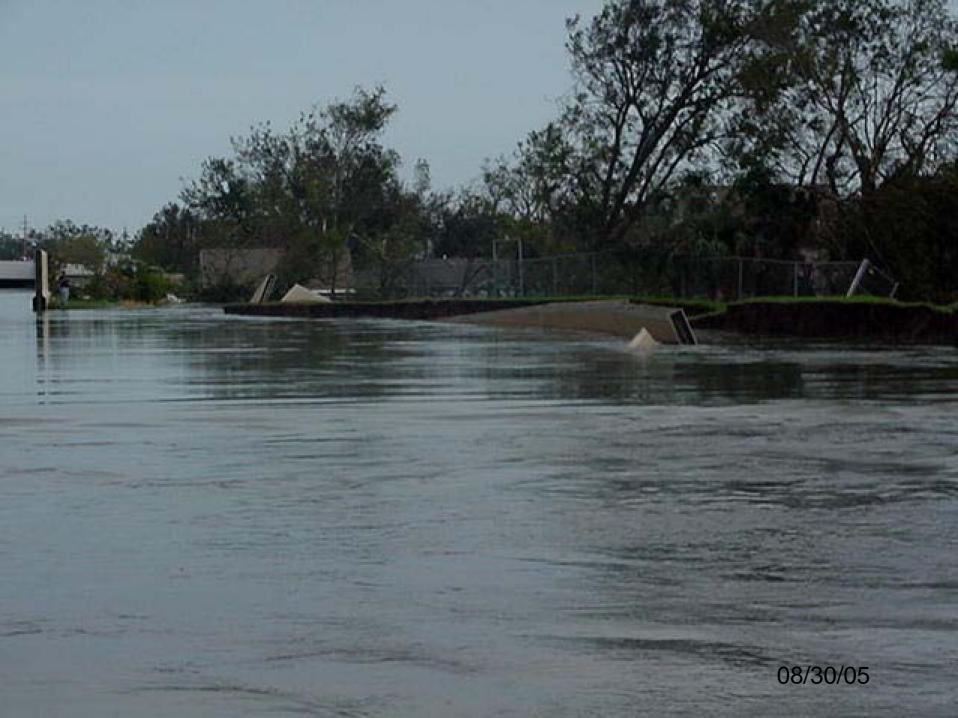
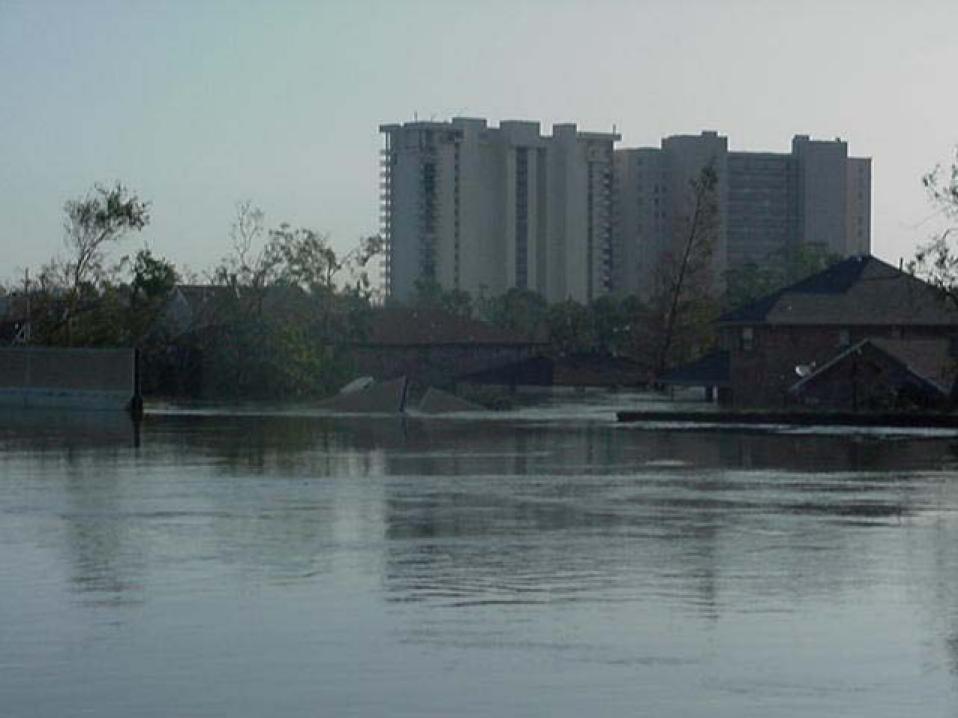
17<sup>th</sup> Street Canal – Note displaced levee section in middle of the breach, which moved 35 feet

Earth berm and fence moved 35 feet laterally (heave) by water pressure

17th Street Canal -'Heaved' yard behind levee wall that moved 35 feet laterally

Old swamp cyprus stumps exposed by scour

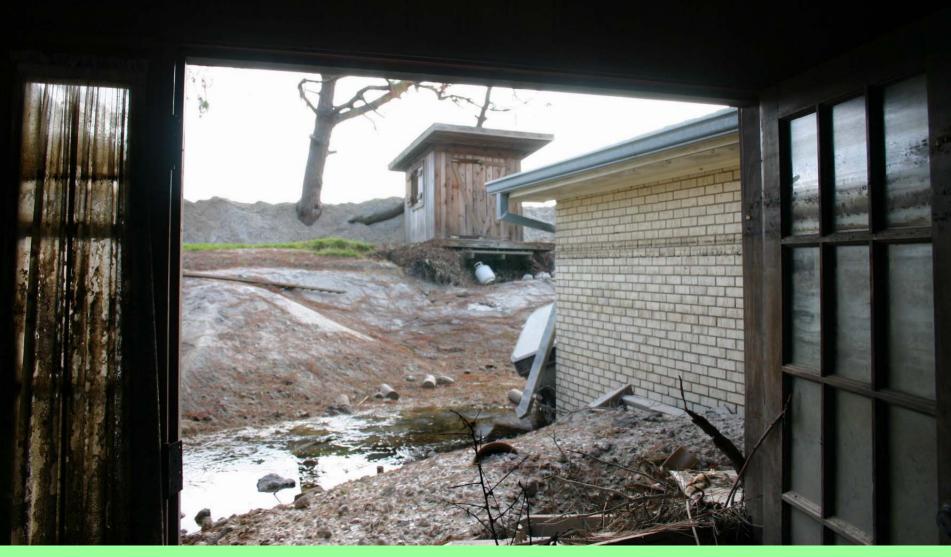
Clubhouse (as built) at base of levee soil embankment - London Ave Canal west breach. Note pine tree location on left.

#### Club house and pine tree after heave – London Ave Canal west breach, rose 6-8 feet!

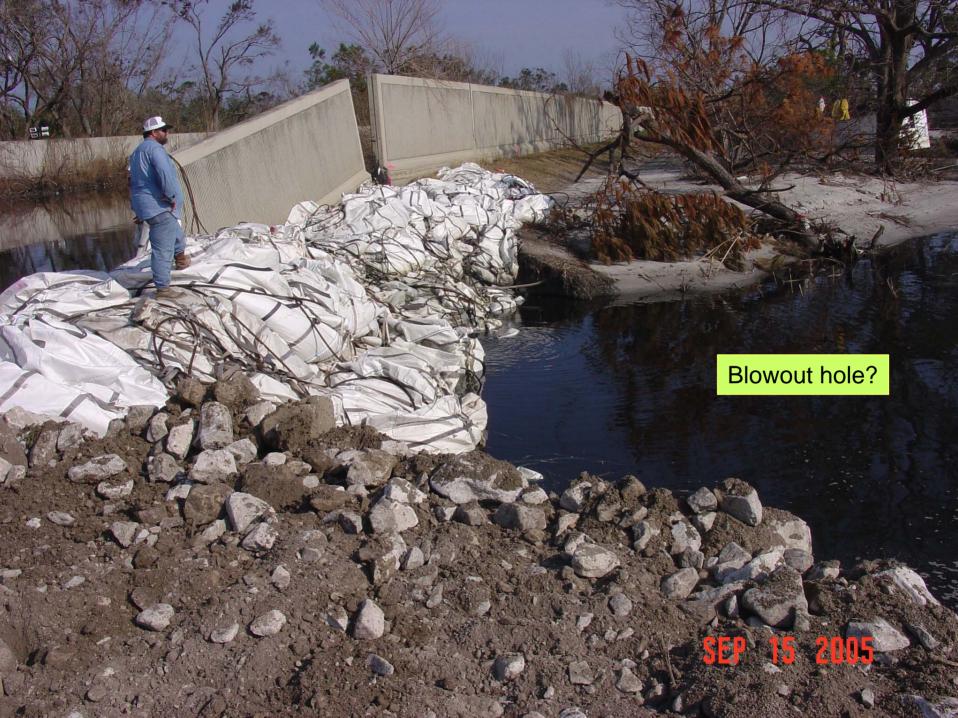
#### Mirabeau Breach – Blowout Preliminary Data

-4 FEET

-10+

MARSH

PEAT

SAND

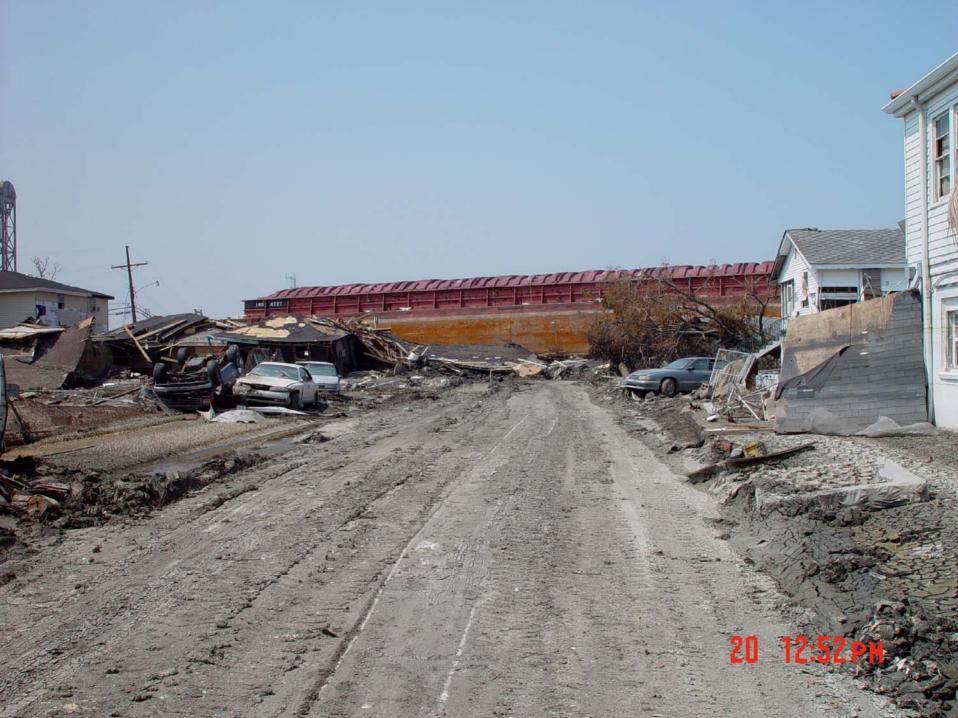
Note: 'R' bars bent horizontal while wall at 45 degree angle – barge bottom move across after wall collapsed?

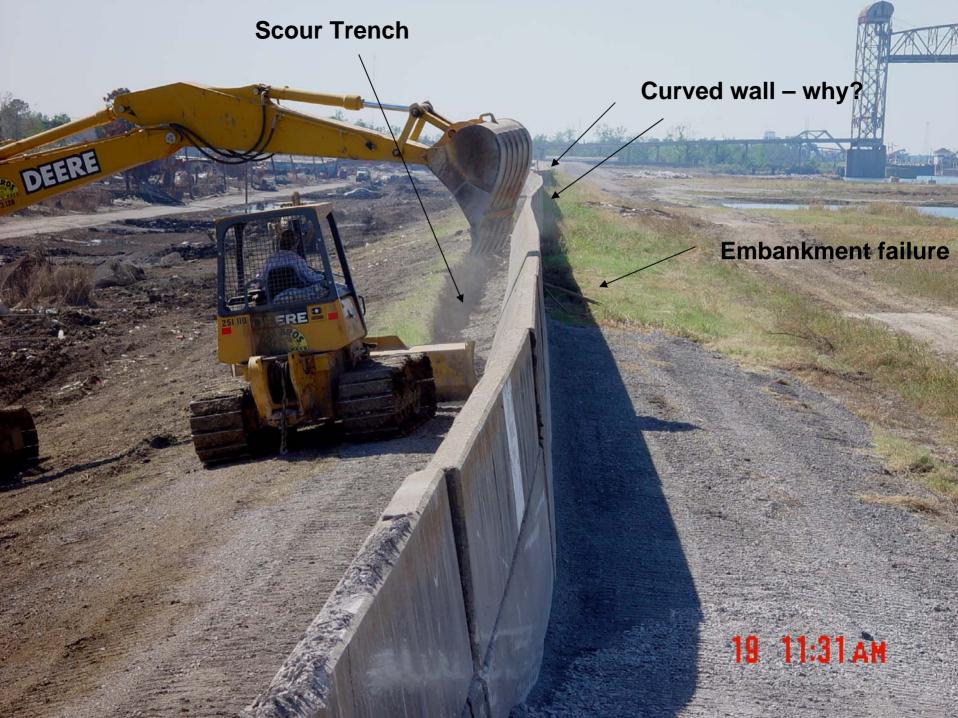
Levee wall tilted back. Cracks and soil failure in front of wall and development of downward percolation holes Cyprus tree stump from Old swamp floor
