<b>TEAM RIO</b>	<b>Trip Date:</b> 7 & 9 August 2003	<b>Issue Date:</b> Revision 0
-----------------	--	----------------------------------

**Trip Description/Location:** Qarmat Ali Water Treatment Plant

**Purpose of Trip:** Limited Environmental Assessment of Soils Potentially Contaminated with Sodium Dichromate at the Qarmat Ali Water Treatment Plant

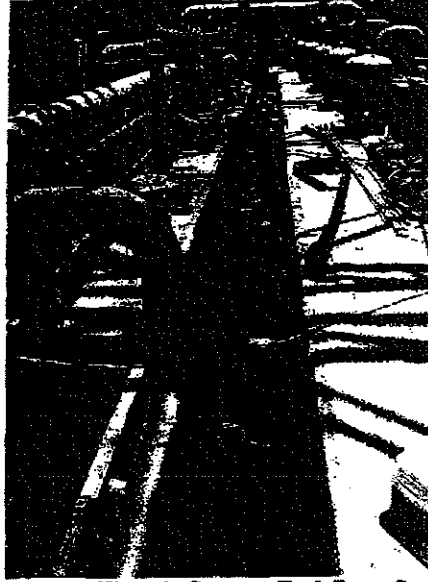
The sump in the concrete tank room in the area adjacent to the mixing room contains approximately one foot of yellow sludge. The rest of the sump contains orange colored water. The drainage ditch leading from the chemical injection building to the containment pond contains yellow sediment. Yellow stained soils extended into the containment pond.

Orange Water in Concrete Tank Room Sump

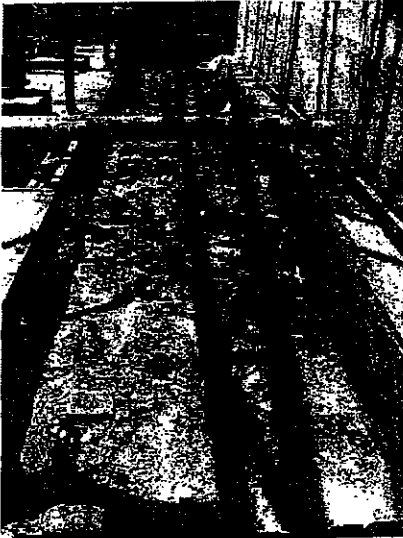
Yellow Sediment in Sump in Concrete Tank Room
