TEST AND BALANCE REPORT CONTRACT N62470-86-B-9517 CAMP LEJEUNE, NORTH CAROLINA

RENOVATE BUILDING 2615

MARINE CORPS BASE, CAMP LEJEUNE, NORTH CAROLINA

TEST AND BALANCE REPORT CONTRACT N62470-86-B-9517 SPEC. NO. 05-86-9517

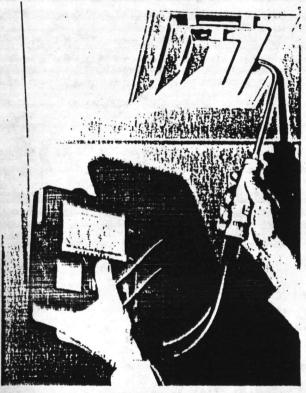
FIGURE 5-3 A Typical Air Diffuser Velocity Measurement

- 4) Working from the branch with the highest measured capacity to the branch with the lowest measured capacity, make adjustments in each branch. Beginning with the outlet most distant from the branch connection and proceeding toward the branch connection, make volume adjustments at each terminal as necessary. It is important that the balancer uses the proper "k" factor prescribed by the air terminal manufacturer for use in conjunction with a particular instrument. In addition, it is necessary that the readings at grilles, registers and diffusers be
