EWR D&I ANNOTATION

FAN-000001L064001DP88-1444

Description : THE DRIVER OF THE SUBJECT VEHICLE WAS TRAVELING NORTHBOUND ON A LOCAL ROAD WHEN, FOR UNKNOWN REASONS, THE VEHICLE VEERED OFF THE ROAD INTO A DITCH, WHERE THE VEHICLE STRUCK A TREE. THE DRIVER SUFFERED SEVERE INJURIES, HOWEVER, TWO PASSENGERS SUFFERED FATAL INJURIES. NO DEFECT ALLEGATIONS WERE INCLUDED IN THE RESPONSE. THE POLICE REPORT INDICATES THAT THE DRIVER FAILED TO CONTROL THE VEHICLE. THE REPORT ALSO INDICATES THAT ALL THREE VEHICLE OCCUPANTS FAILED TO WEAR THWIE SAFETY RESTRAINTS. THE OWNER OF THE VEHICLE TOLD POLICE THAT THE VEHICLE HAD PREVIOUSLY RECEIVED RECALL RELATED WORK ON THE AIRBAGS AND WINDSHIELD WIPER SWITCH. THE SUBJECT VEHICLE MANUFACTURER HAS MADE NO ASSESSMENT OF THIS CRASH EVENT. THERE ARE NO APPARENT SAFETY RECALLS THAT RELATE TO THE ISSUES IN REGARDS TO THIS CRASH EVENT.

INFORMATION UTILIZED FOR COMPLETION OF REPORT	3
SYNOPSIS	4
OBJECTIVE	4
COLLISION SCENE.....	4
COLLISION SEQUENCE.....	5
SERVICE BULLETIN	6
VEHICLE INSPECTION	6
FORENSIC SCENE MAPPING	7
SENSING AND DIAGNOSTIC MODULE.....	7
EXEMPLAR VEHICLE MEASUREMENTS.....	8
SPEED ANALYSIS	9
VEHICLE FACTORS.....	9
HUMAN FACTORS.....	10
ENVIRONM

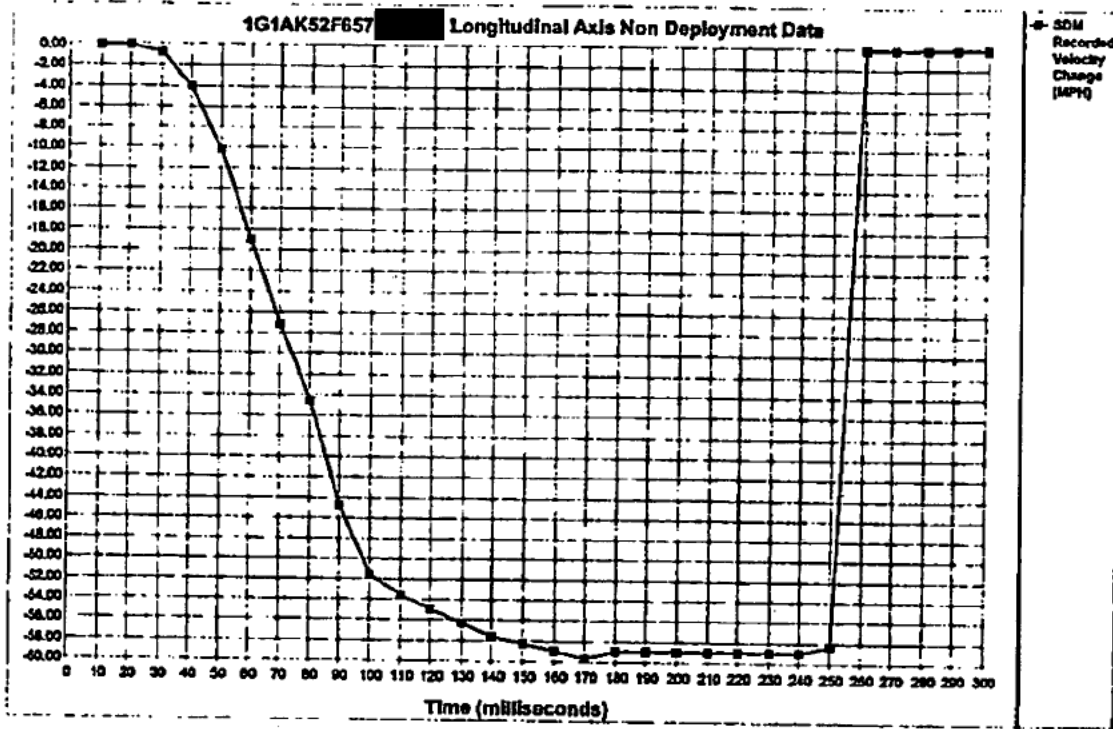
Time (milliseconds)	10	20	30	40	50	60	70	80	90	100	110	120	130	140	150
Longitudinal Axis Recorded Velocity	0.00	0.00	-0.68	-4.07	-10.17	-18.98	-27.11	-34.57	-44.74	-51.52	-53.55	-54.90	-56.28	-57.82	-58.29
Time (milliseconds)	160	170	180	190	200	210	220	230	240	250	260	270	280	290	300
Longitudinal Axis Recorded Velocity	-58.97	-58.65	-58.97	-58.97	-58.97	-58.97	-58.97	-58.97	-58.97	-58.29	0.00	0.00	0.00	0.00	0.00
