US Army Corps
of Engineers®
Engineer Research and
Development Center

DeBary Bayou Watershed Assessment Study City of DeBary, Volusia County, Florida

Final Report

Prepared for Florida Department of Transportation
DeLand, FL 32720

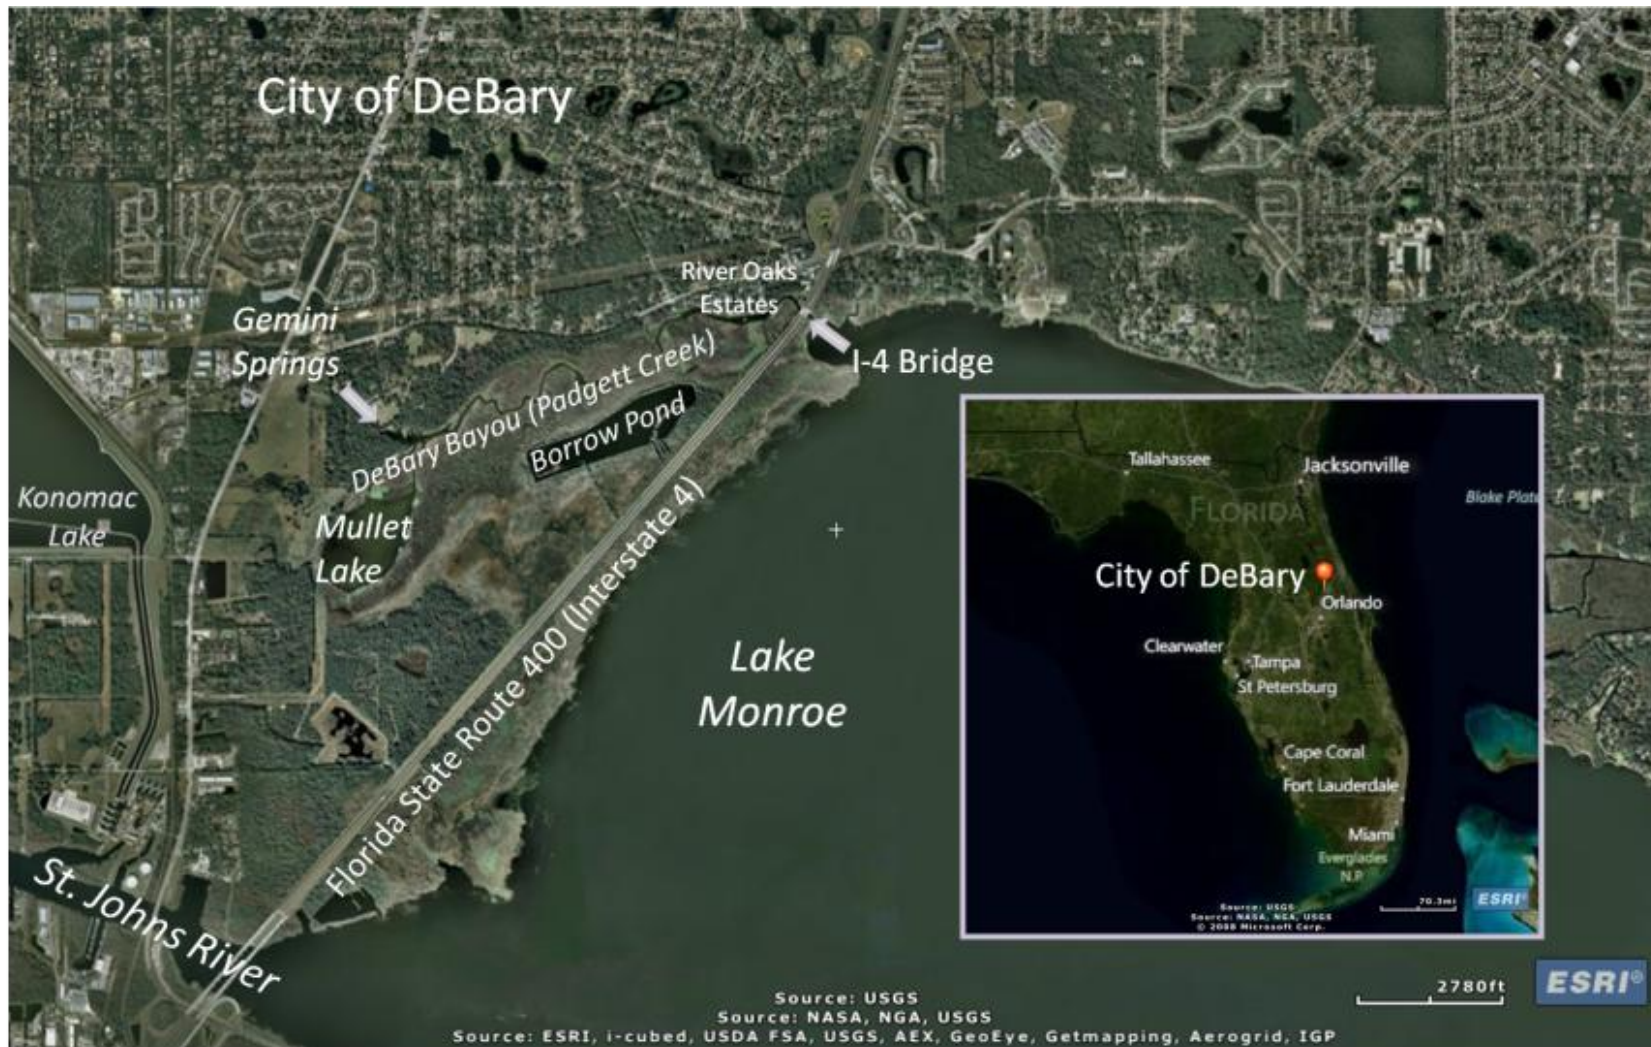
Figure 1. Location map showing DeBary Bayou (Padgett Creek), associated hydrologic features and selected infrastructure. Map images produced using ArcGIS Explorer.

A unique combination of natural and human-made components comprises the DeBary Bayou system (see Figure 1). These elements together create the complex ecological condition in DeBary Bayou. This section includes summary descriptions of physical, chemical, biological and anthropogenic attributes of DeBary Bayou and its regional context as documented in published literature, scientific studies, agency reports, and online resources. This characterization centers on those attributes of most interest to answering previously identified research study questions targeted at determining current and former ecological state, defining the magnitude and direction of any alterations or changes in functions or processes, and explaining causal factors where discernible. In particular, this study is focused on hydrology and sediment processes and any factors that influence reported increases in sedimentation rates and concomitant ecological impacts within DeBary Bayou.

Lake Monroe on St. Johns River is an inline or “river run” lake roughly 6 mi long, 4 mi wide and seven feet deep on average (SJRWMD 2002a). The Middle Basin Planning Unit 4D consists of a floodplain watershed area of 139 mi² (360 km²); the study area is on the north-west shore of Lake Monroe, immediately to the north of St. Johns River (see Figure 1).

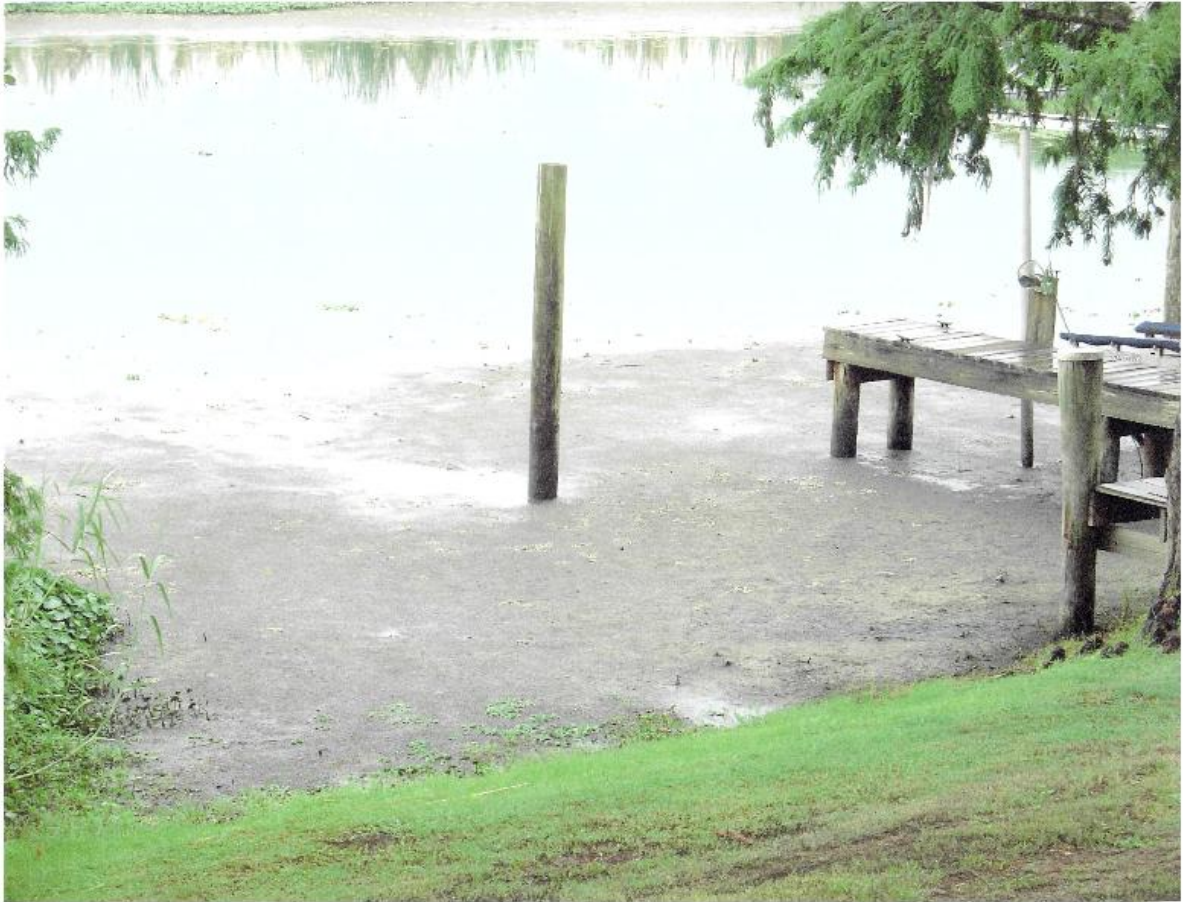
Figure 2. Fine Sediment and Organic Debris at Gray's dock, 2008 after the water receded from Tropical Storm Fay (content and characteristics of the material are unknown, though this was a widespread and persistent condition throughout the Middle Basin of the St. Johns River). Photo courtesy of Saundra Gray.

Within the last 40-50 years, residents have reported witnessing declines in environmental quality and accessibility within DeBary Bayou. Most notably, residents report that accumulation of fine sediment and organic material has affected boating access and general recreation opportunities, as well as declines in bass spawning, duck feeding, and access or use by other wildlife. By 2004 the creek has been described by some as all but impassable excepting air boats, alligators and small fish, particularly following tropical storm Fay in 2008, which brought in additional fine sediment and organic debris and resulted in persistent widespread turbid conditions throughout the Middle Basin (Figure 2). This storm produced the highest water levels in the St. Johns River and Lake Monroe in the period of time the Grays have lived in DeBary Bayou (for a point of reference, United States Geological Survey (USGS) gaging station on the St. Johns River at Lake Monroe reached a maximum stage of 7.9 ft during that storm, compared to 7.5 ft maximum stage in 2004 during hurricane Ivan, which was the first peak stage over 7.0 ft since 1964). These very extreme events may produce unusual amounts of sediment or organic debris.

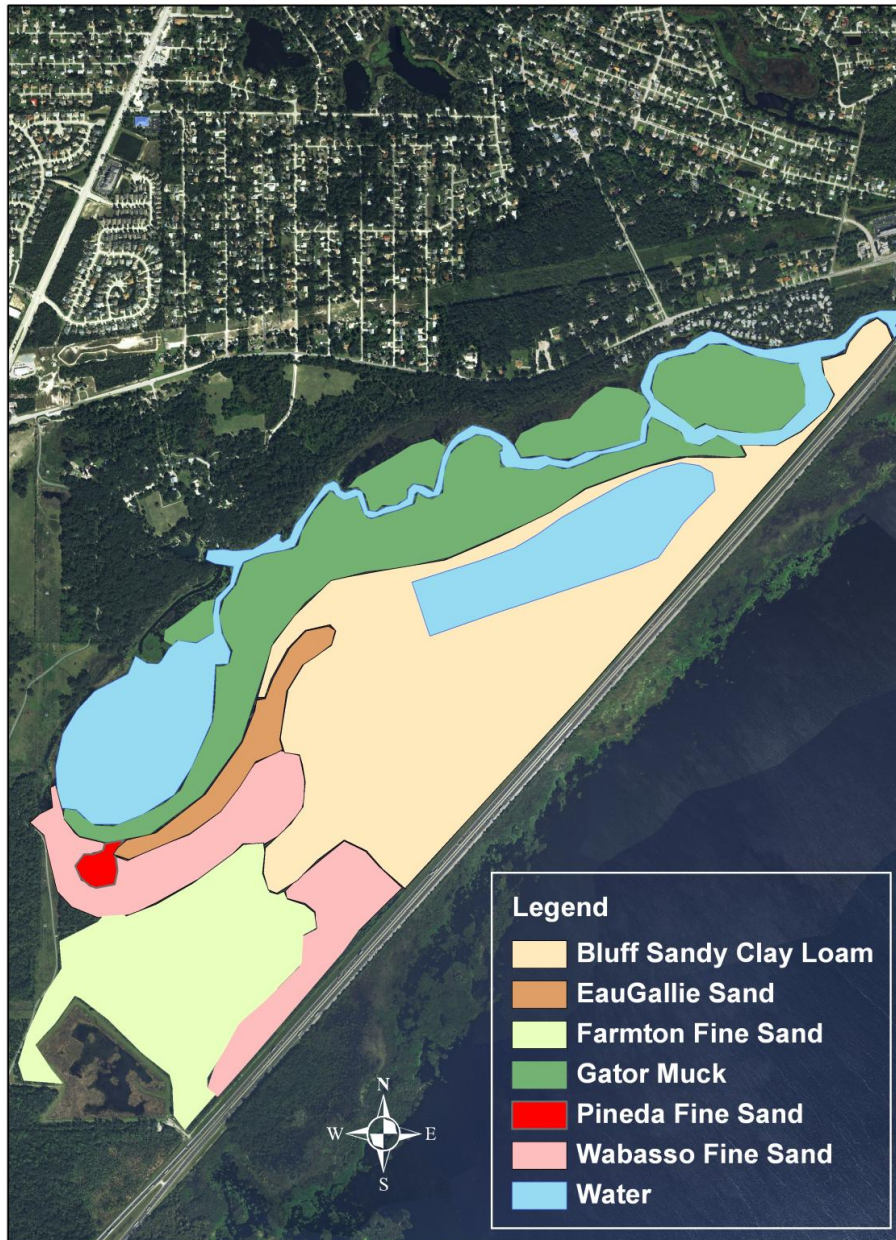
Soil Map

Figure 6. Soil types in DeBary Bayou, source information SJRWMD 2006. Image not to scale.

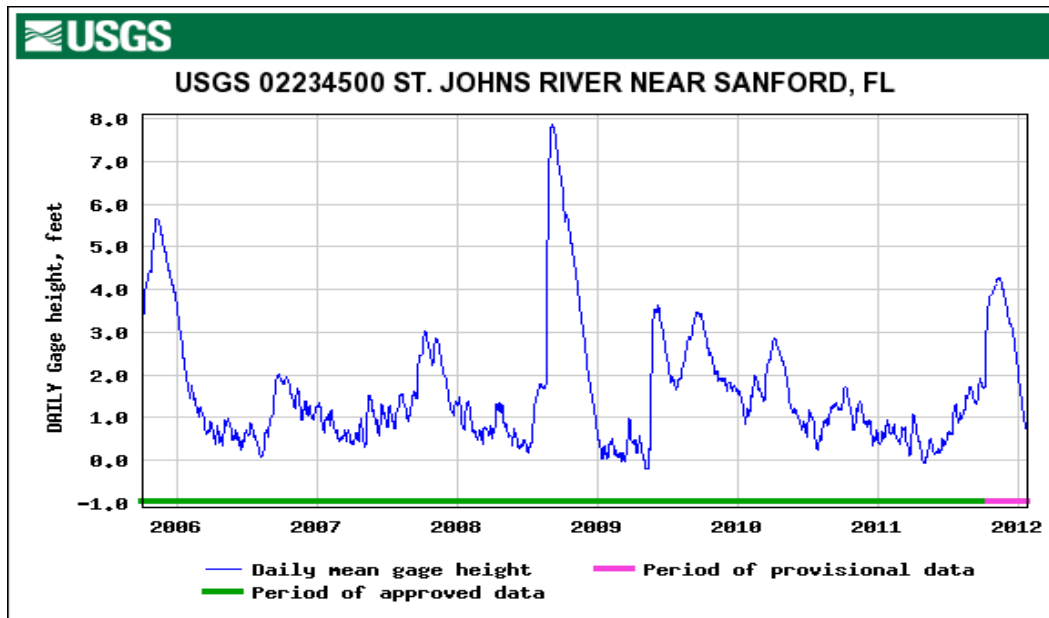
Figure 9. Gage Height for the period shown 1 October 2005 through 26 January 2012 (entire period of record for the gage from 1987). Stage exceeded 6.0 once during the period shown.

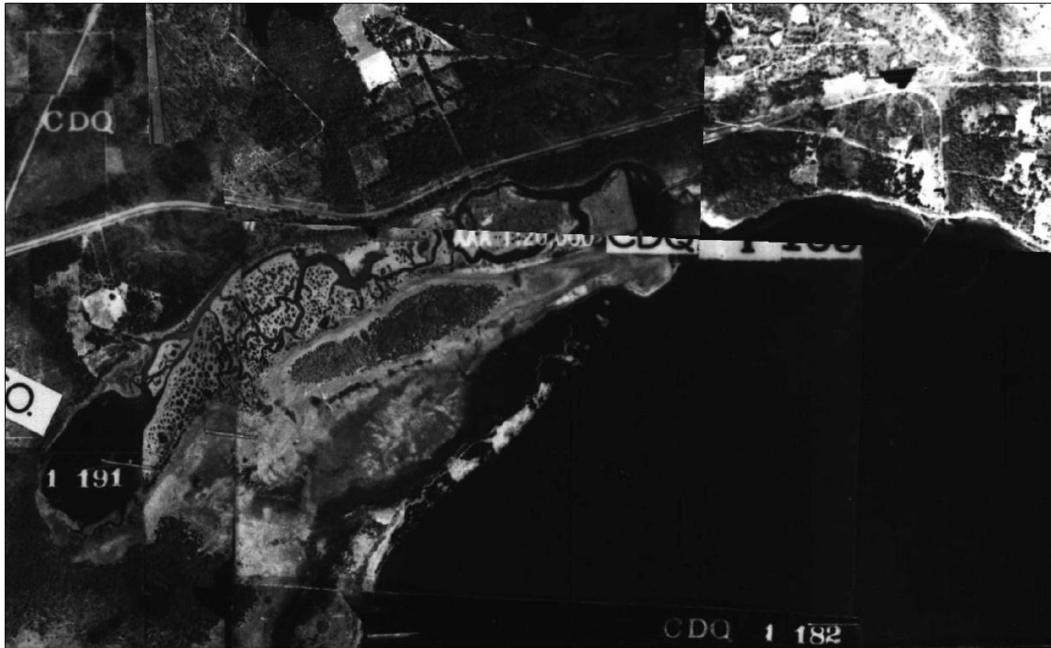
Figure 10. Aerial photograph, 1940, DeBary Bayou and Lake Monroe. Image prior to I-4 construction. Image not to scale in this reproduction.

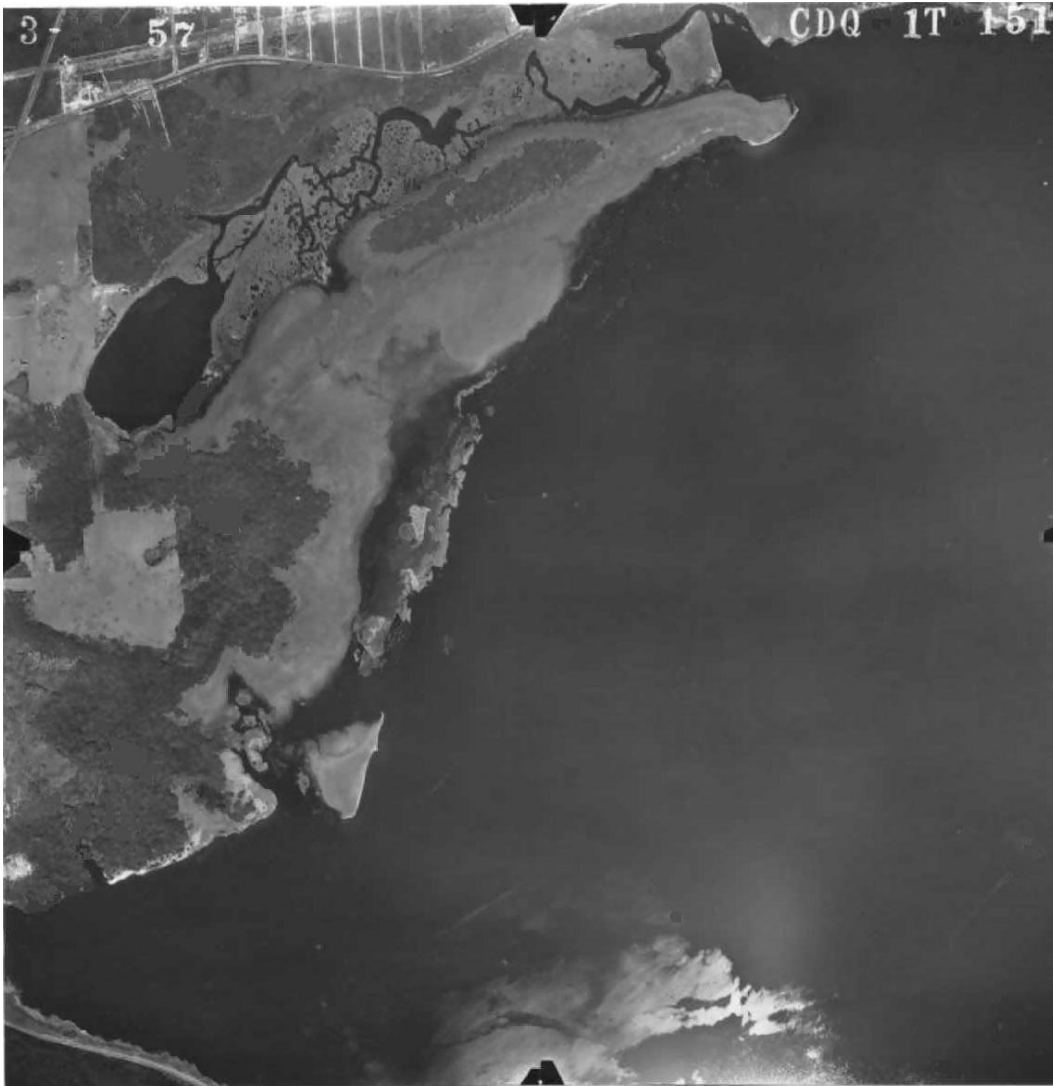
Figure 11. Aerial photograph,1957, DeBary Bayou and Lake Monroe, stage 0.84 ft. Image prior to I-4 construction. Image not to scale in this reproduction.

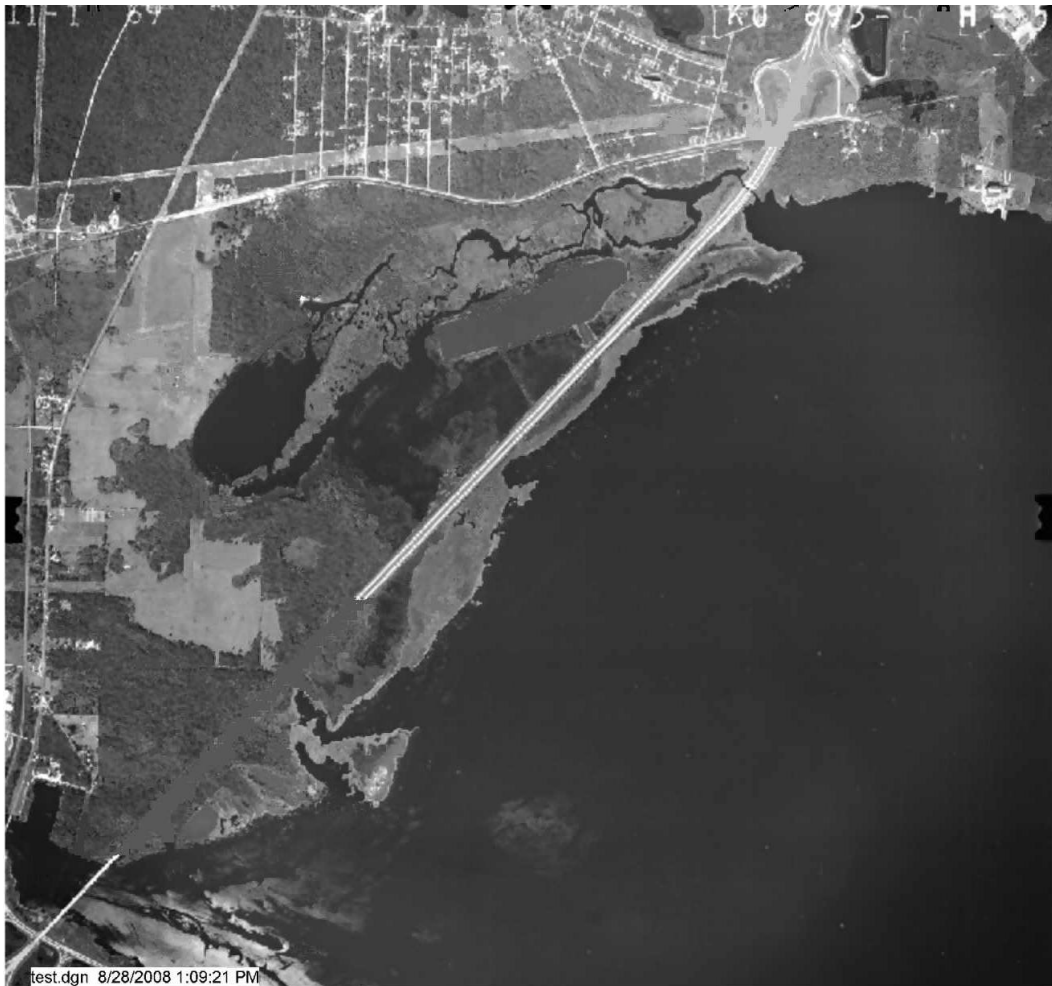
Figure 12. Aerial photograph, 1969, DeBary Bayou and Lake Monroe, stage 5.5 ft. Image following I-4 construction, prior to development of River Oaks Estates. Image not to scale in this reproduction.

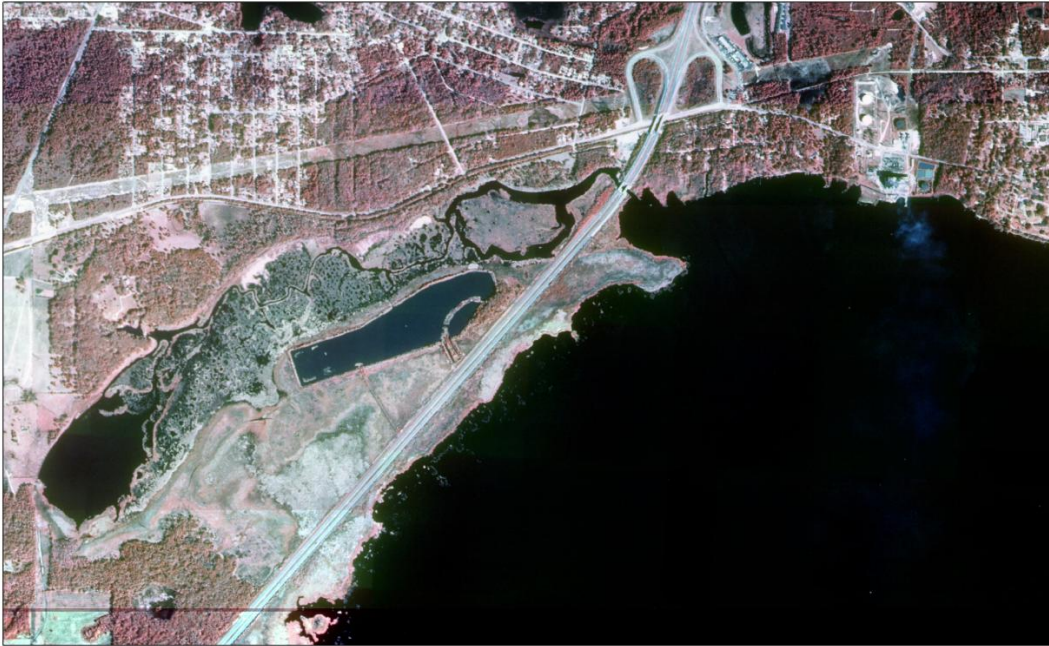
Figure 13. Aerial photograph, 1984, DeBary Bayou and Lake Monroe, stage 2.07 ft. Image following I-4 construction, prior to development of River Oaks Estates, prior to six laning of I-4. Image not to scale in this reproduction.

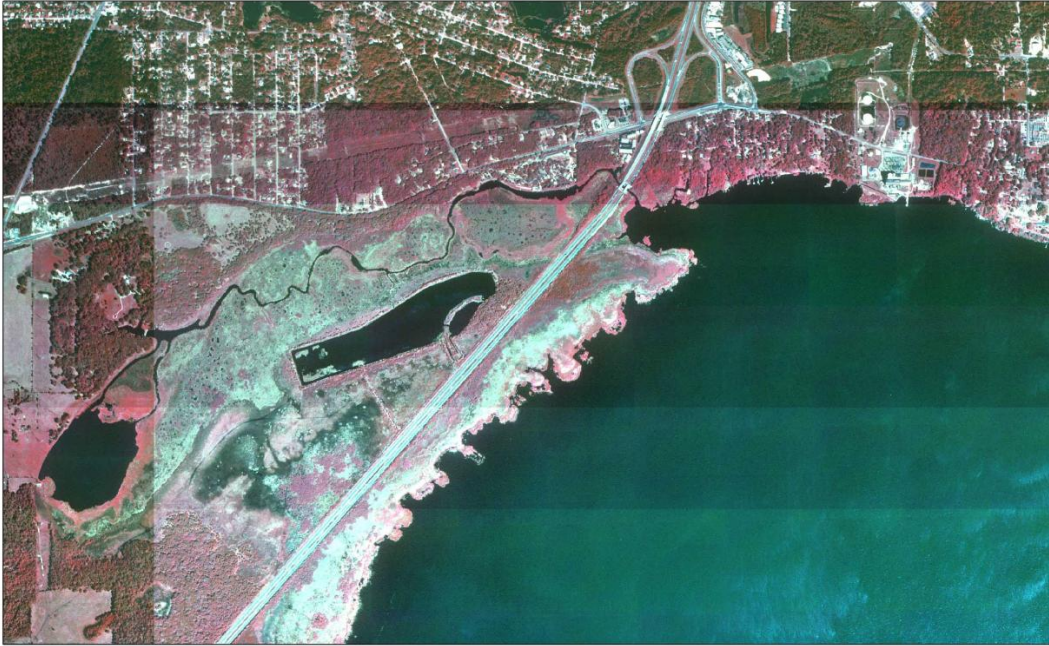
Figure 14. Aerial photograph, 1995, DeBary Bayou and Lake Monroe, stage 1.79 ft. Image following I-4 construction, during development of River Oaks Estates, prior to six laning of I-4. Image not to scale in this reproduction.

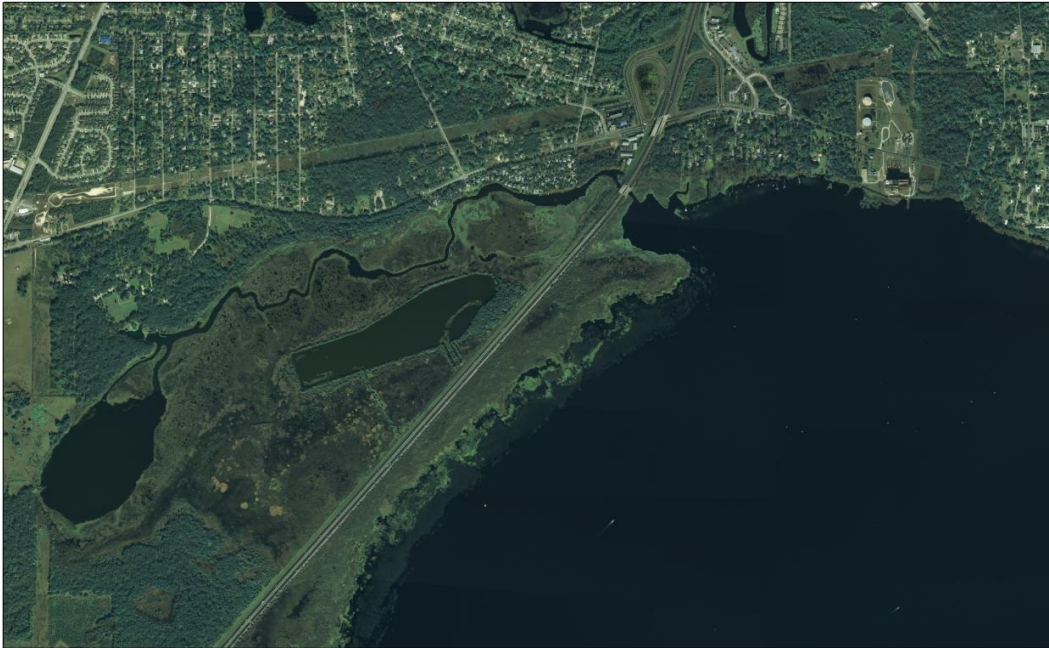
Figure 15. Aerial photograph, 2006, DeBary Bayou and Lake Monroe. Image following I-4 construction, development of River Oaks Estates, and six laning of I-4. Image not to scale in this reproduction.

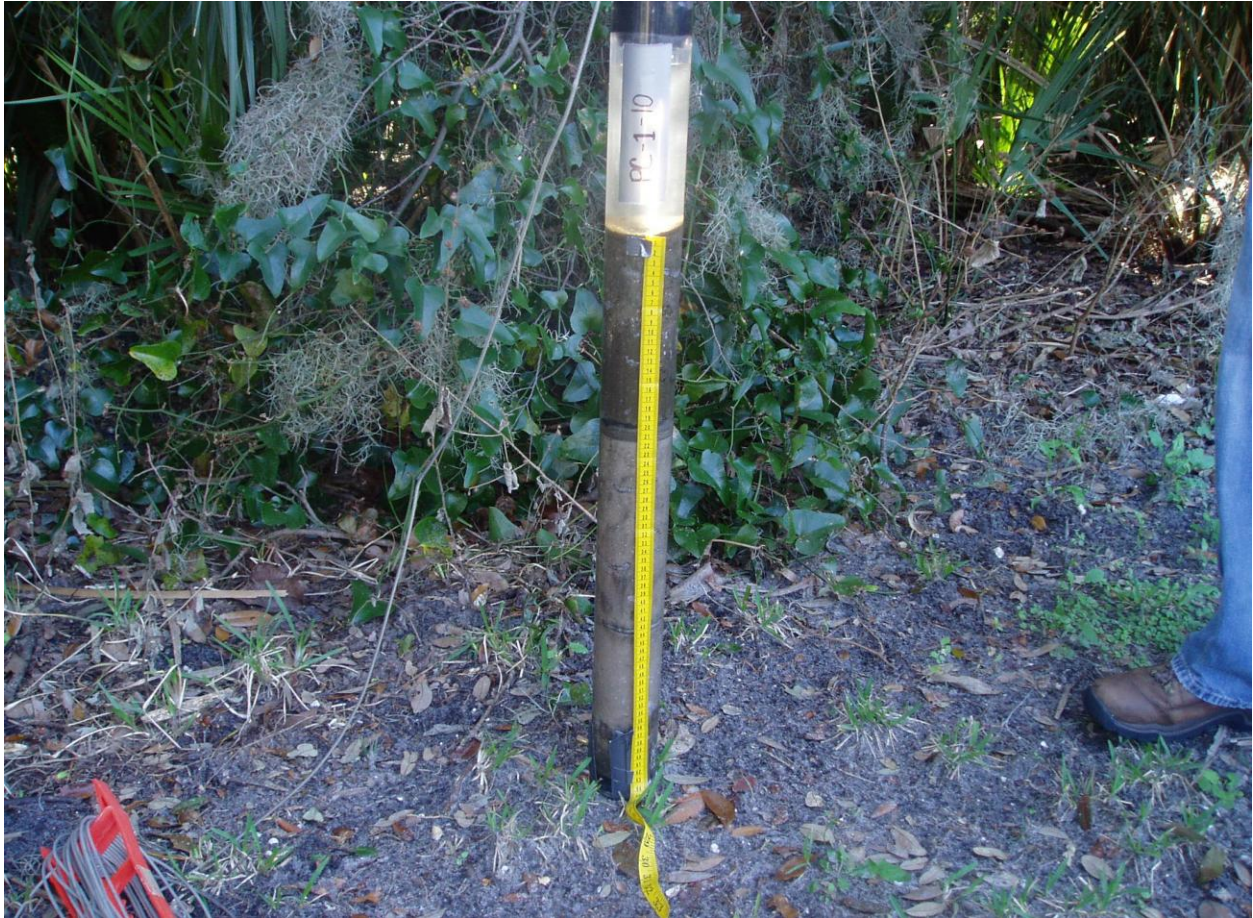
Photo 1. Frank Smith holds the core from site 1 in Padgett Creek

Photo 2. Close-up of the sediment core from site 1 in Padgett Creek

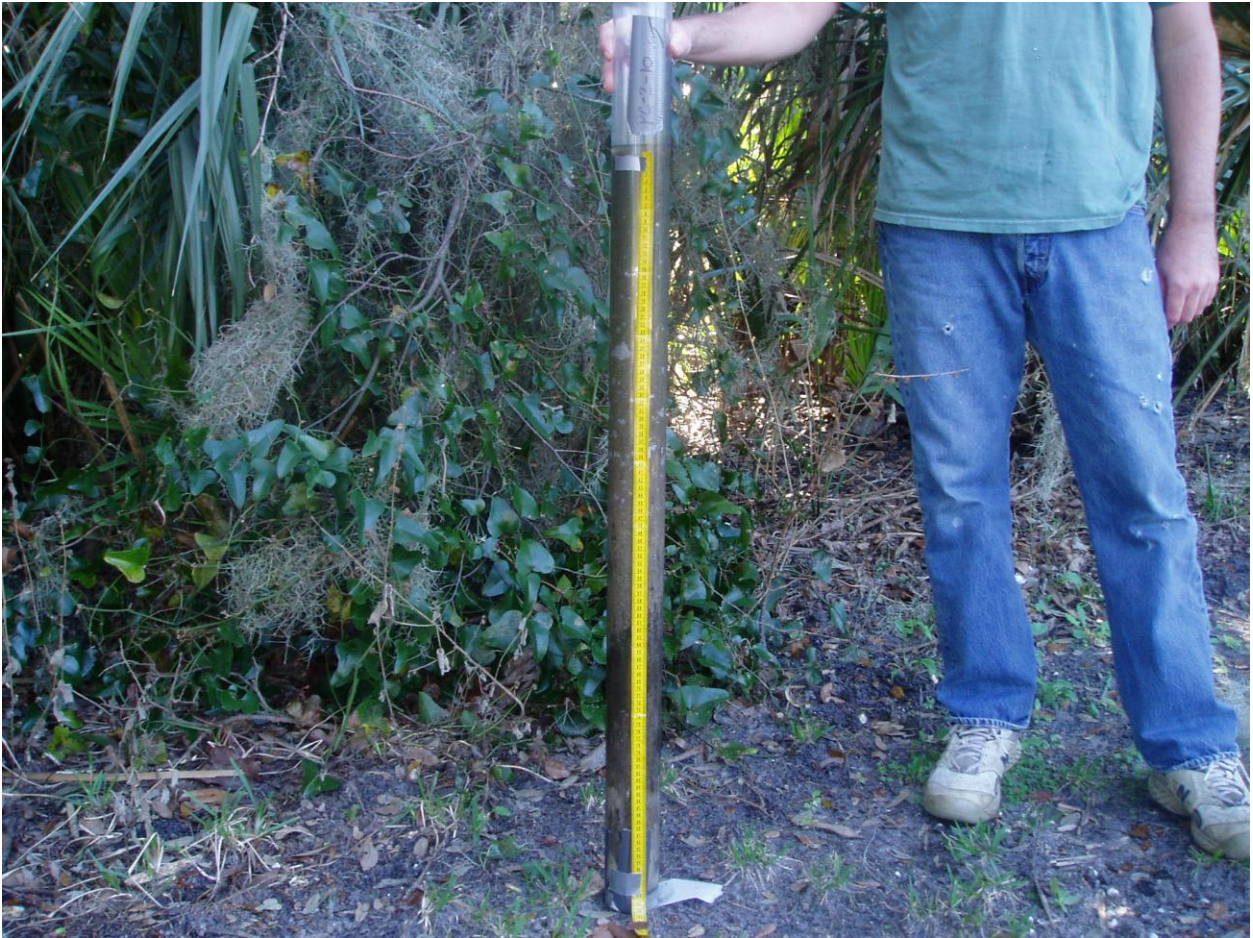
Photo 3. Close-up of the core from site 2 in Padgett Creek

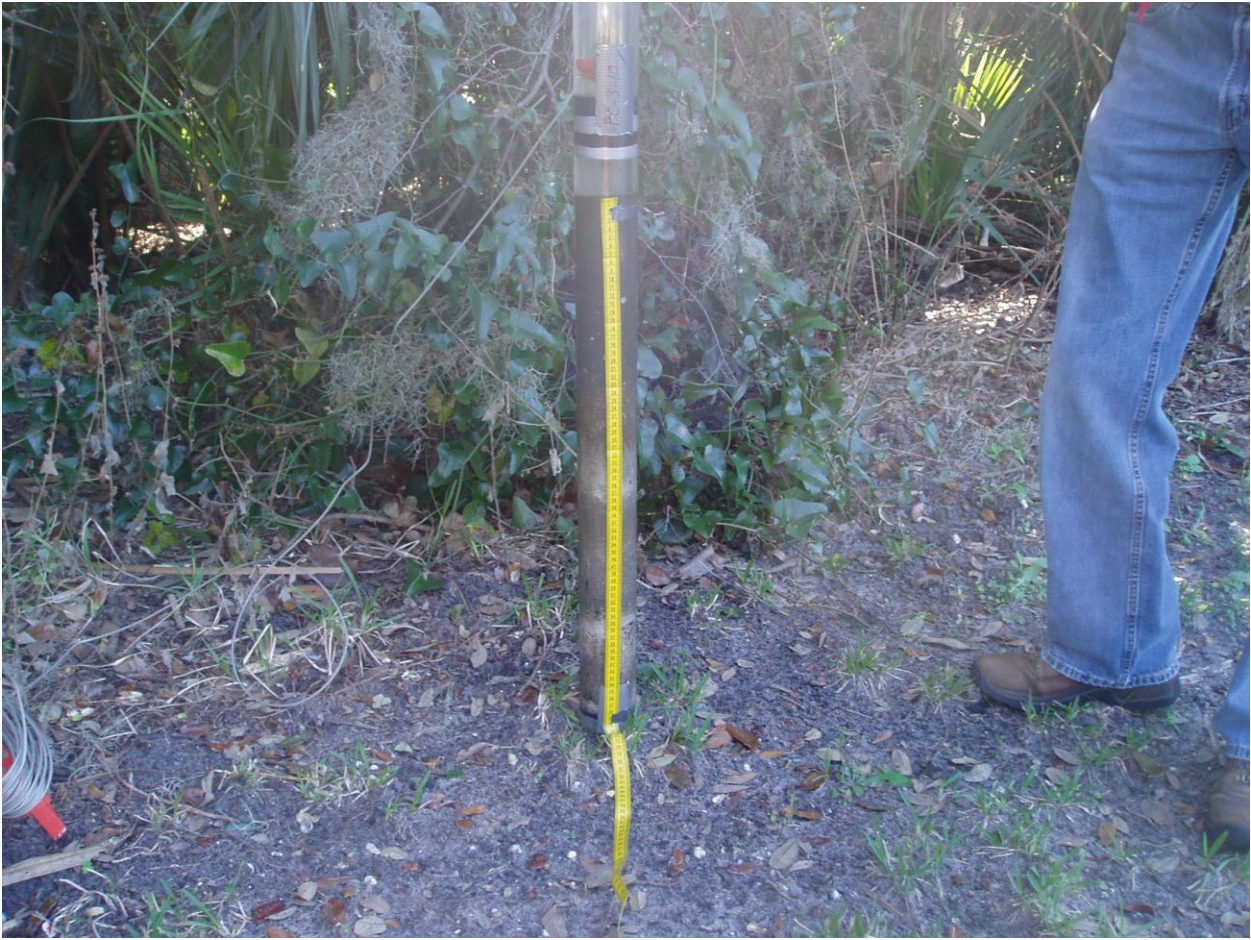
Photo 4. Frank Smith holds the core from site 3 in Padgett Creek

Photo 5. Close-up of the core from site 3 in Padgett Creek
