# Rooftop Equipment Maintenance and Attachment in High-Wind Regions

HURRICANES IRMA AND MARIA IN PUERTO RICO

Recovery Advisory 1, April 2018

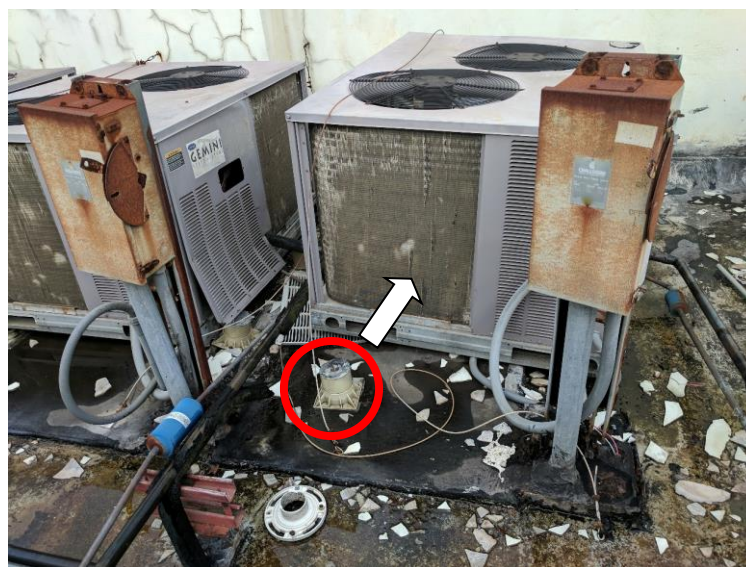
HVAC units and other rooftop equipment being blown off its curbs, stands, or other mountings (Figure 1) was a commonly observed problem. To anchor small HVAC units, exhaust fans, and relief air hoods, the minimum attachment schedule provided in Table 1 is recommended. For HVAC units that are larger than the units listed in Table 1, unit-specific wind loads should be calculated and appropriate connections specified. The attachment of the curb or other mounting to the roof deck also needs to be designed and constructed to resist wind loads.

**Figure 1.** HVAC unit moved by wind. The unit was inadequately attached to the plastic pedestal (red circle).

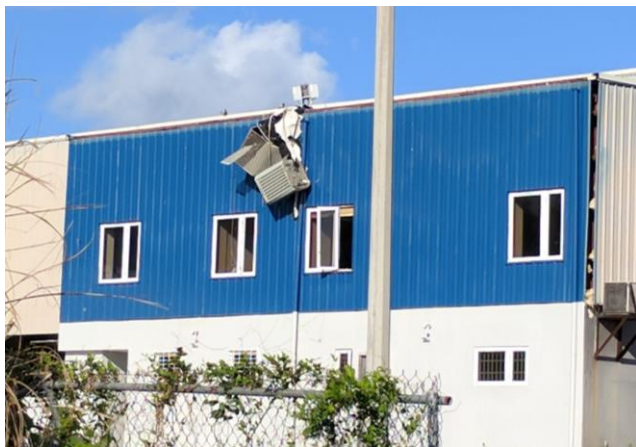
**Figure 2. HVAC unit blown off a roof.**

At the commercial facility shown in Figure 2, an HVAC unit blew off the roof. Blown-off equipment can injure people or damage lower roofs, adjacent buildings, vehicles, or other rooftop equipment (Figure 3). Although people are normally not outdoors during a hurricane, it is not uncommon for people to go to a hurricane-evacuation shelter or hospital during a hurricane.

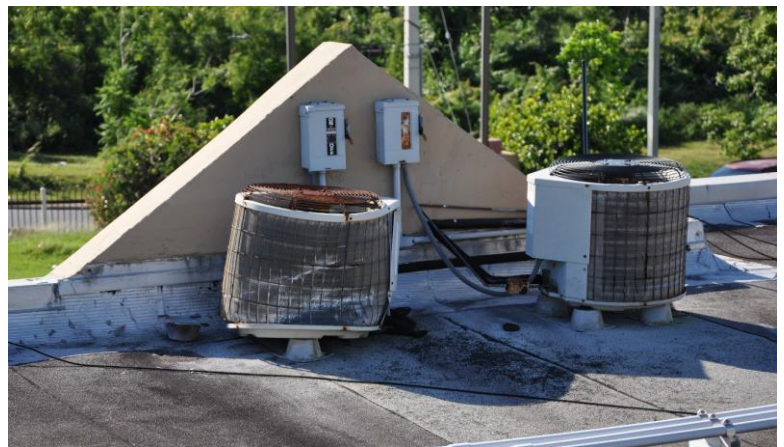
**Figure 3. Rooftop AC condenser damaged by impact.**

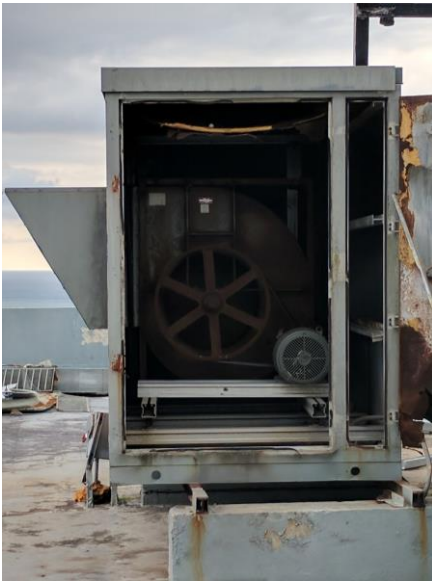
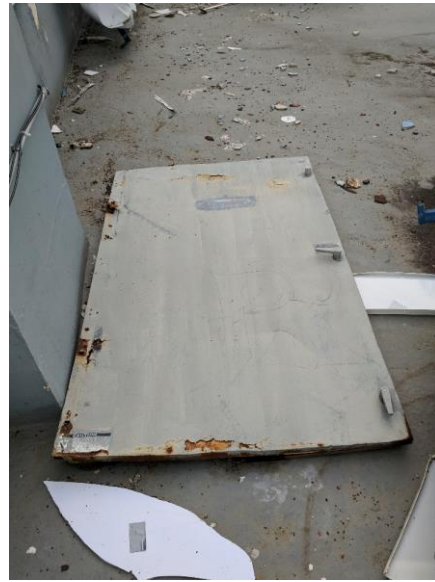
**Figure 4. Left, HVAC unit with blown-off access panel; right, a blown-off filter access panel.**

Another common HVAC unit is blow-off of access panels (Figure 4). Blown-off panels commonly puncture and tear roof membranes and become airborne debris. Unless the equipment manufacturer specifically engineers the panel attachment to resist the design wind load, the following from problem FEMA P-424, Chapter 6 is recommended:

*Job-site modifications, including attaching hasps and locking devices like carabiners, are recommended. The modification details need to be customized. Detailed design may be needed after the equipment has been delivered to the job site. Modification details should be approved by the equipment manufacturer (FEMA P-424, 2010 6.101).*

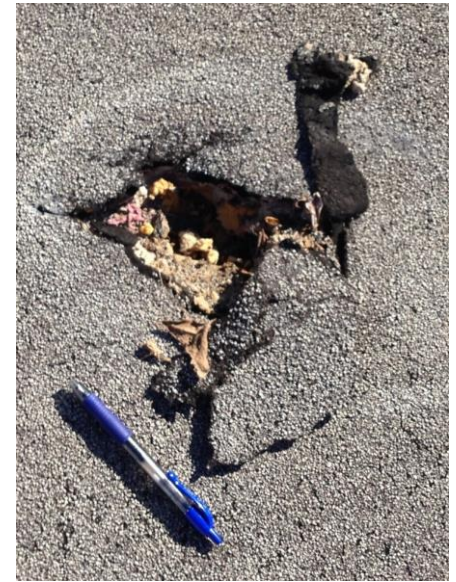
**Figure 5. Punctured roof, pen for scale.**

The sheet metal unit enclosure (cabinet) may also be blown away. Access panels and cabinets, along with other rooftop equipment and components, can puncture roofs (Figure 5) and tear roof membranes (Figure 6). At the medical clinic in the U.S. Virgin Islands pictured in Figure 6, a tear several feet long was observed near HVAC equipment from which the enclosure had been blown off. Smaller tears and punctures can be difficult to see.

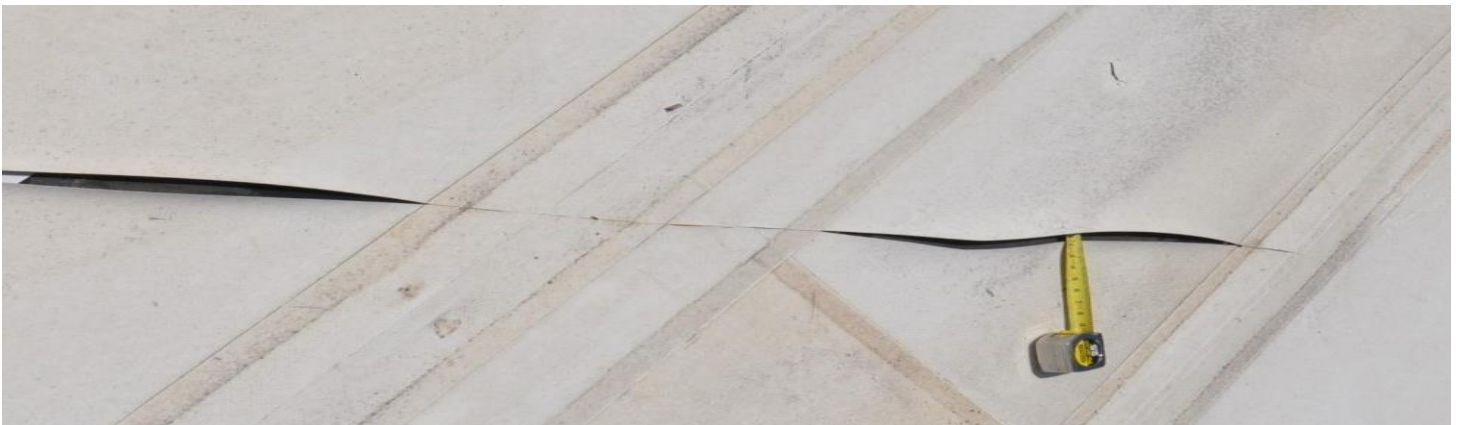
**Figure 6. A tear several feet long in a roof membrane. Hurricanes Irma and Maria, U.S. Virgin Islands.**

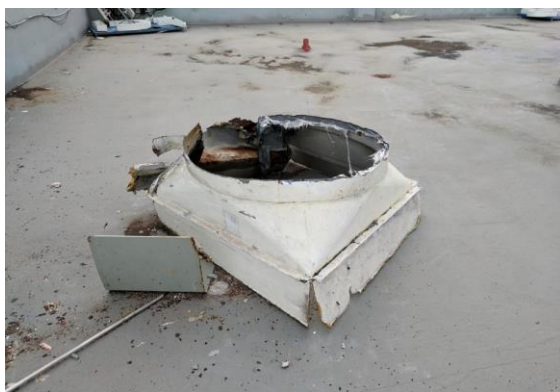
**Figure 7. Blown off fan cowl resting on the roof membrane at a hospital.**

Exhaust fans and fan cowlings were frequently blown off their curbs because they were inadequately secured (Figure 7). Table 1 provides an attachment schedule to adequately secure fans and other equipment. Blown-off fans and cowlings can tear roof membranes. Unless the fan manufacturer specifically engineered the cowling attachment to resist the design wind load, FEMA P-424 recommends job-site installation of cable tie-downs, although metal straps can also be used. The cable used should be  $\frac{1}{8}$  inch for cowlings less than four feet in diameter and  $\frac{3}{16}$  inch otherwise. Two cables are recommended where basic design wind speeds are less than 165 mph and four cables otherwise; however, using four cables or straps is a best practice for reducing the chance of equipment blow-off for all design wind speeds. Cables should be anchored to the curb rather than the roof to avoid leakage, and the attachment of the curb should be designed and specified.

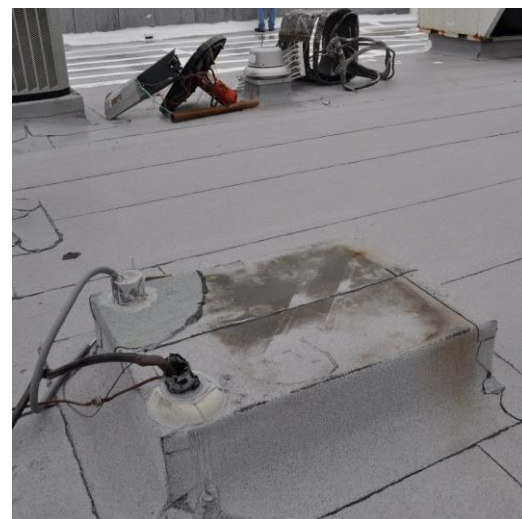
In lieu of placing rooftop-mounted condensers on wood sleepers resting on the roof, condensers should be anchored to metal equipment stands or curbs made of concrete, sheet metal, or wood to avoid blow-off (Figure 8). Additionally, it is recommended that mechanical fasteners be used to attach the condensers rather than adhesive. At a school in the U.S. Virgin Islands, several condensers were attached with adhesive to plastic pedestals (Figure 9); all the condensers were blown over, and some were blown off the roof.

**Figure 8. The condenser at this hotel simply rested on the curb. Hurricanes Irma and Maria, U.S. Virgin Islands.**

In addition to anchoring the base of the condenser to the stand or curb, FEMA P-424 recommends installation of tie-down straps (cables may also

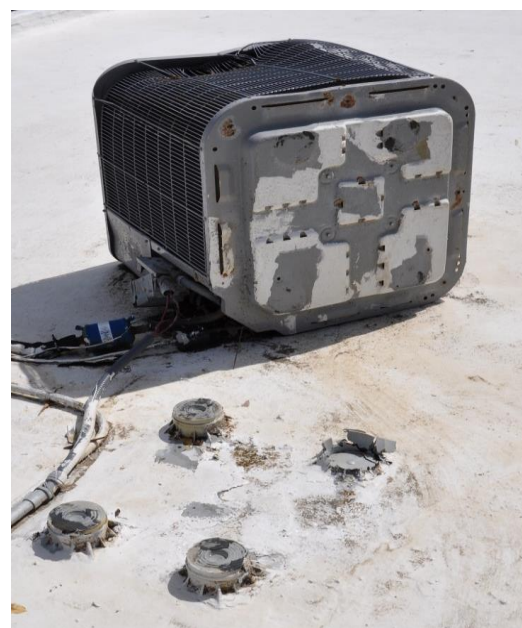
**Figure 9. This condenser was blown off the plastic pedestals to which it was attached. One of the pedestals was broken (red arrow).**

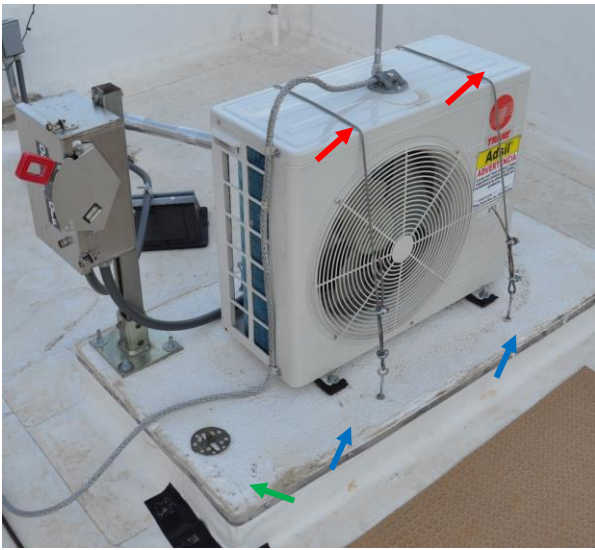
**Figure 10.** This condenser was bolted to a curb (blue arrows) and had tie-down cables (red arrows). The LPS conductor is no longer secured by its connector (green arrow).

be used). Figure 10 shows a condenser with enhanced attachment, similar to the guidance in FEMA P-424. Grade-mounted condensers should also be mechanically attached to their support slab or platform.

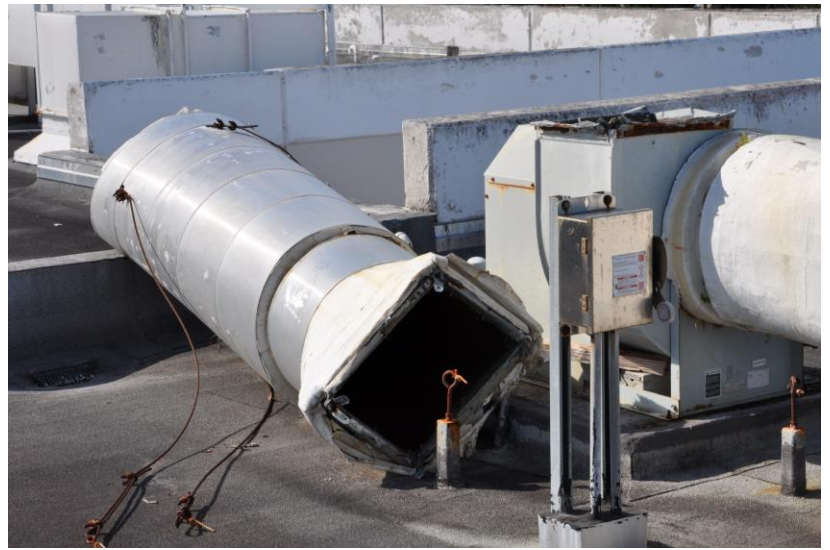
**Figure 11.** Toppled exhaust stack at a high school in Loíza.

Toppled stacks (Figures 11) can allow water to enter the building at the stack penetration, damage the roof membrane, and become wind-borne debris. FEMA P-424 recommends that wind loads on stacks be calculated and guy wires designed and constructed to resist the loads. Additionally, it recommends that the building owner have guy wires inspected annually to confirm that they are taut.

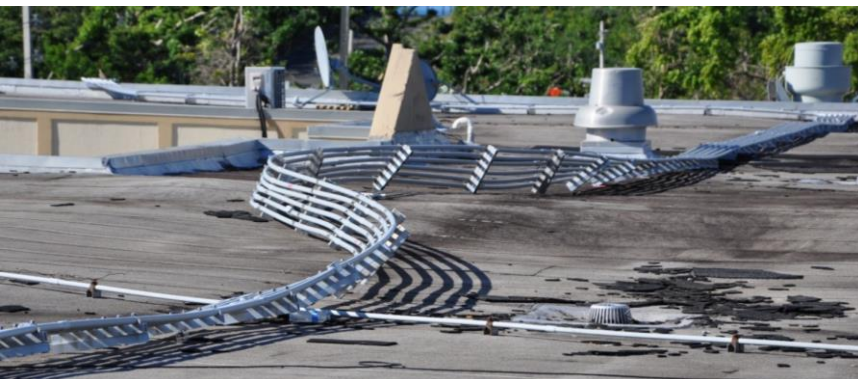
Rooftop natural gas lines, condensate drain lines, and conduit supports often do not provide lateral or uplift resistance (Figure 12). FEMA P-424 provides an example of a gas line support detail that provides lateral and uplift resistance (Figure 13). In this example, at periodic gas line supports, a steel angle was welded to a pipe that was anchored to the roof deck. A strap was looped over the gas line and bolted to the support angle. This detail is also applicable to anchorage of condensate drain lines and conduits. As much as possible, the conduit should be run

**Figure 12.** This conduit carried conductors from a rooftop solar array on the roof of a hospital in Vieques. It was inadequately secured to the roof and failed.

below the deck rather than above the roof membrane.

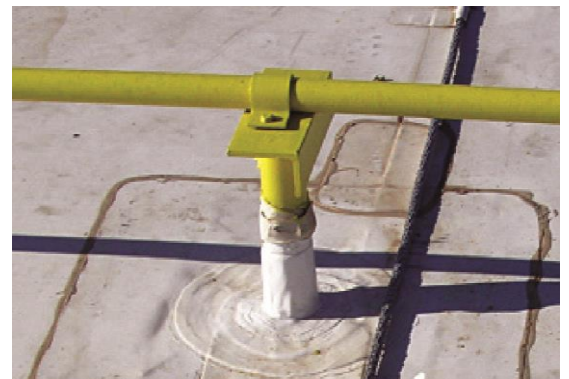
**Figure 13.** Enhanced gas line support detail. From FEMA P-424 (Figure 6-100).

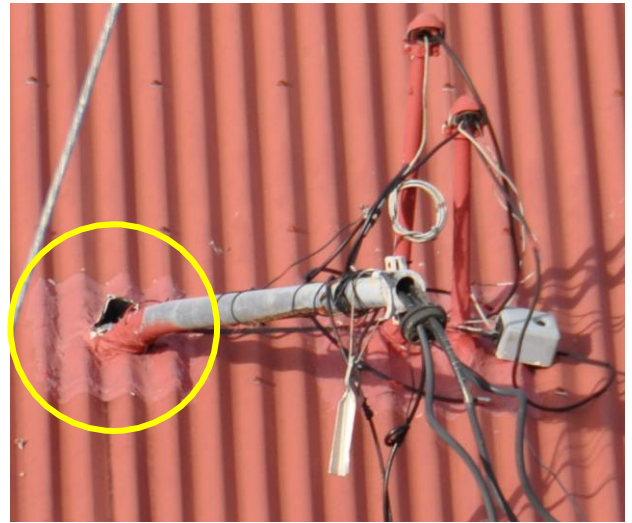
At the electrical service mast shown in Figure 14, the overhead power line collapsed and pulled on the service mast, which resulted in rupture of the mast flashing. FEMA P-424 recommends using underground service. Where overhead service is provided, it recommends that the owner seek the services of an architect or engineer for locating and designing the mast. The following are recommended:

**Figure 14. A collapsed overhead power line pulled over this service mast, which caused flashing rupture. Hurricanes Irma and Maria, U.S. Virgin Islands.**

In all cases, a sag in the power line is recommended to reduce tension on the mast during a hurricane.

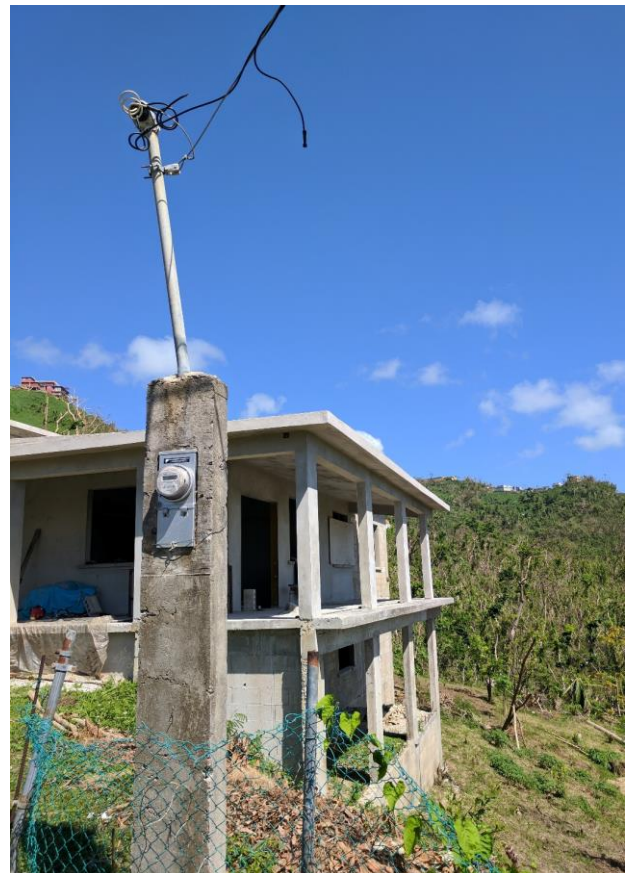
1. A best practice is to anchor the service mast to a concrete or CMU pylon as shown in Figure 15. The overhead service line runs to the mast and underground to the house. With this type of installation, a collapse of the overhead line will not result in property damage. This configuration will also reduce the risk of fire damage in case the power line breaks.
2. For concrete roofs, the mast may be installed on the roof with proper design and detailing.
3. For light gage roofs, such as corrugated metal roofs, the mast should be side-mounted on an exterior wall with proper design and detailing. If the mast is to be roof mounted, it should not penetrate the roof so as to prevent water leakage at the ruptured flashing. It is recommended to have the mast supported on an equipment stand or concrete curb with proper flashing and sealant detailing.

**Figure 15. Power delivery pylon for the electrical service mast for a house under construction. The FEMA MAT frequently observed this installation method in Puerto Rico.**

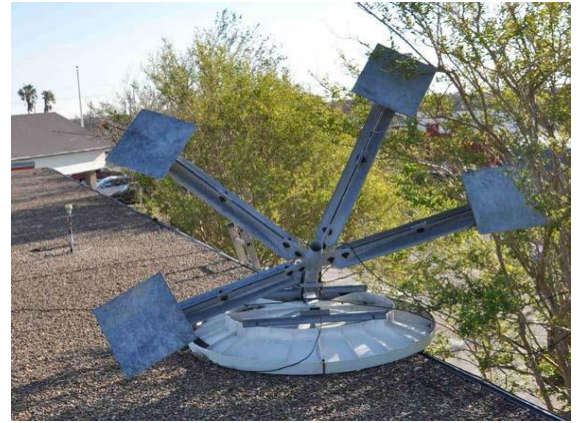
As shown in Figure 16, the base plates of the satellite dish support legs were ballasted with solid CMUs, which provided inadequate wind resistance. Displaced dishes can rupture roof membranes and cause other damage or injury. FEMA P-424 recommends that ballast not be used to anchor satellite dishes in high-wind areas. Rather, the dish wind load should be calculated, and a suitable mechanical attachment to the roof deck or structure should be designed.

**Figure 16.** The satellite dish at this hospital was nearly blown off the roof. Hurricane Harvey, Texas.

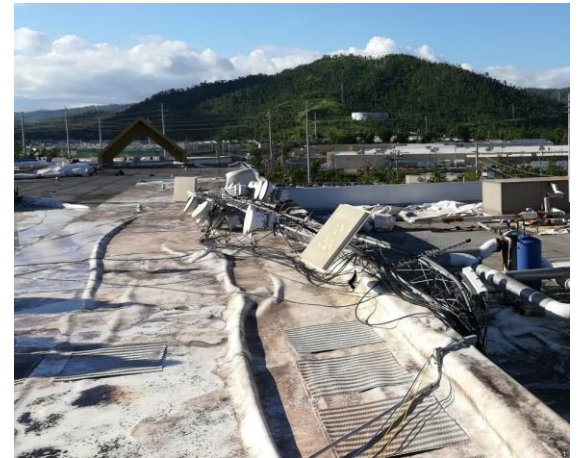
Collapse of communication towers and antennae mounted on the roof or penthouse walls is common during high-wind events (Figure 17). These failures often result in complete loss of communication capabilities. In addition to the disruption of communications, collapsed towers can puncture roof membranes. FEMA P-424 provides guidance on determining design wind loads and determining wind resistance of existing towers.

**Figure 17.** Collapsed roof-mounted antennae which had been inadequately secured to the roof using CMUS as ballast.

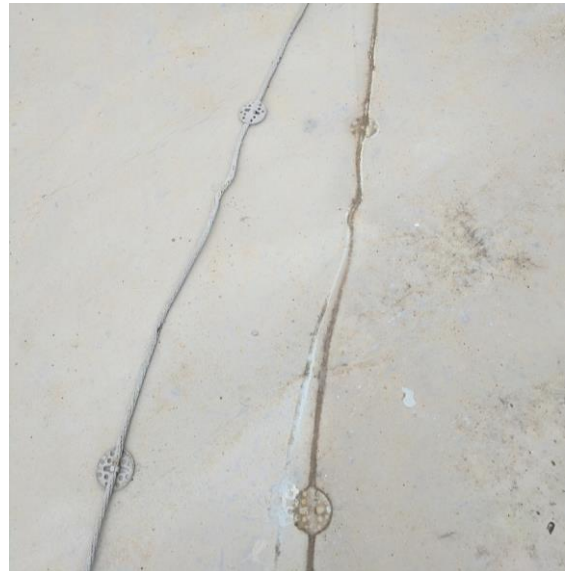
LPSs frequently become disconnected from rooftops during hurricanes (Figure 18). Displaced LPS components can puncture and tear roof coverings, allowing water to leak into buildings. Prolonged and repeated slashing of the roof membrane by loose conductors (“cables”) and puncturing by air terminals (“lightning rods”) can result in lifting and peeling of the membrane. When displaced, the LPS is no longer capable of providing lightning protection to the area around the displaced conductors and air terminals.

**Figure 18.** Detached LPS conductor that had been inadequately attached using adhesive.

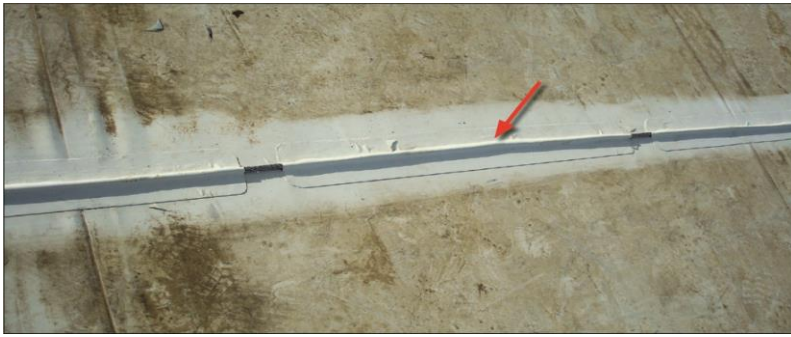
Current LPS standards do not require enhanced attachment of LPSs in high wind regions. FEMA P-424 provides enhanced attachment guidance for several types of roof systems, including parapet attachment methods and the use of membrane flashing strips (Figure 19).

Figure 19. Enhanced LPS attachment, using intermittent roof membrane flashing strips from FEMA P-424 (Figure 6-114).

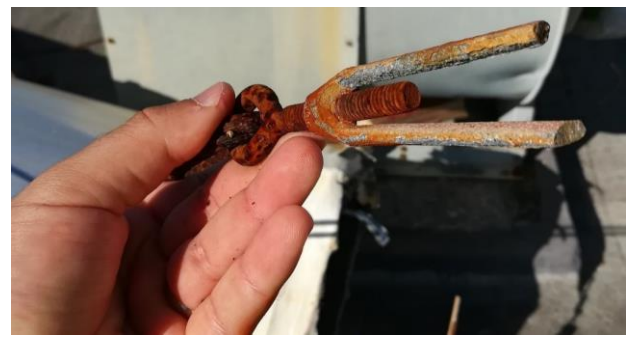
Figure 20. This corroded turnbuckle failed, allowing the boiler stacks shown in Figure 11 to topple.

Corroded rooftop equipment was frequently observed to have failed in Puerto Rico following Hurricanes Irma and Maria (Figure 20). FEMA P-424 recommends that equipment bodies, stands, anchors, and fasteners be made of “nonferrous metals, stainless steel, or steel with minimum G-90 hot-dip galvanized coating” (FEMA P-424 6.97). The *Building Performance Assessment Team (BPAT) Report - Hurricane Georges in Puerto Rico* (FEMA 339, 1999) noted that an aluminum-zinc alloy coating greatly enhanced corrosion protection for galvanized metal, particularly near salt water. Attachment failure and resulting building damage in a high-wind event can be reduced by using materials that are less susceptible to corrosion.

coating has worn away. Corroded fasteners can fail in a high-wind event (Figure 20).
