Washington Briefing
Deepwater Horizon Interim Incident Investigation

24th May 2010

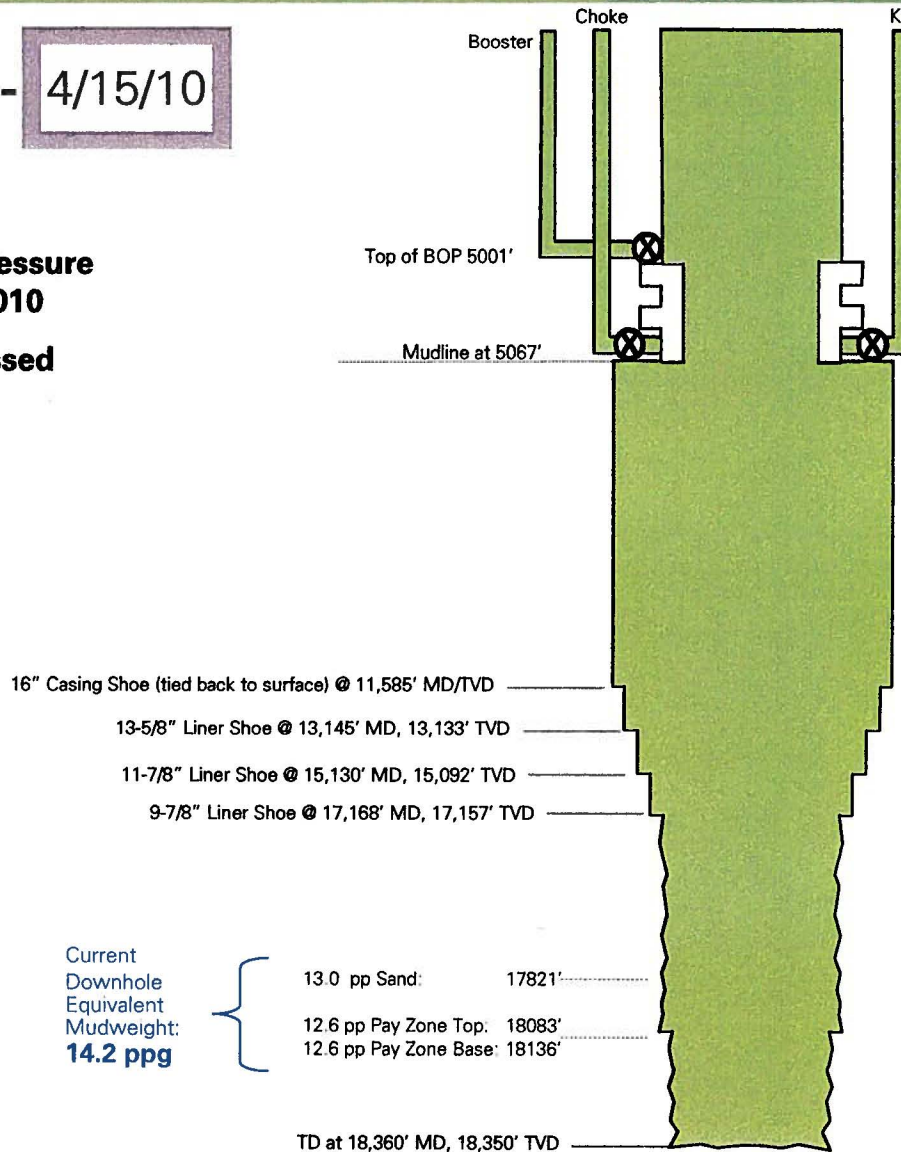
Last BOP pressure test: 4/10/2010
All tests passed

- Finish drilling
 - 9-7/8" x 8-1/2" open hole
 - 14.0 ppg mud inside and out
- Trip out with drilling assembly
- Wireline log for 4 days

- Hole stable

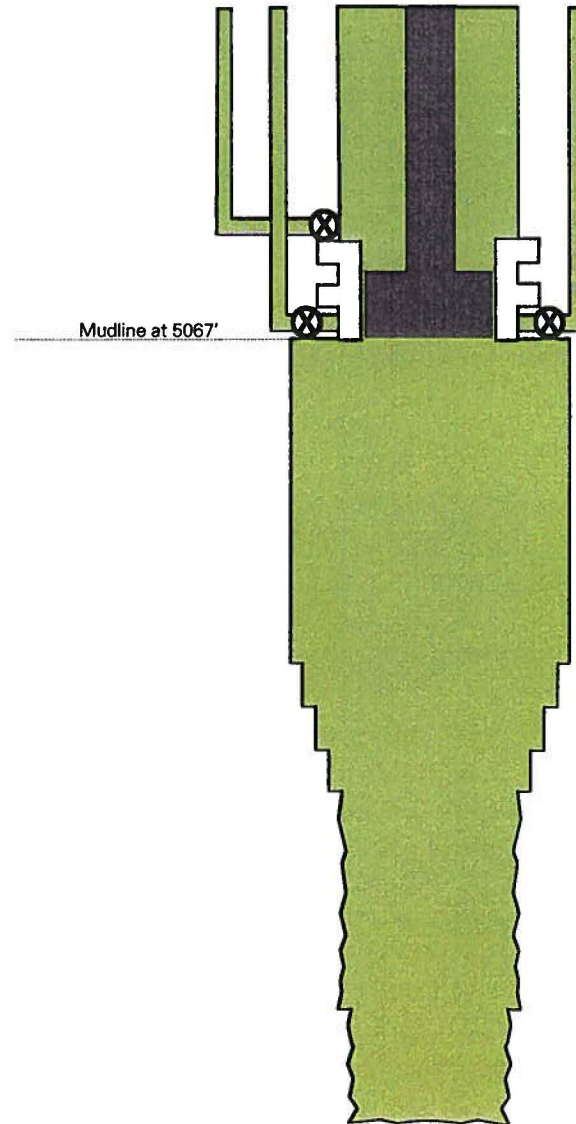
Retrieve Wear Sleeve

Function test BSR
4/17/10 23:00

<u>Data</u>
<ul style="list-style-type: none">• Make trip to retrieve wear sleeve<ul style="list-style-type: none">- Retrieval successful

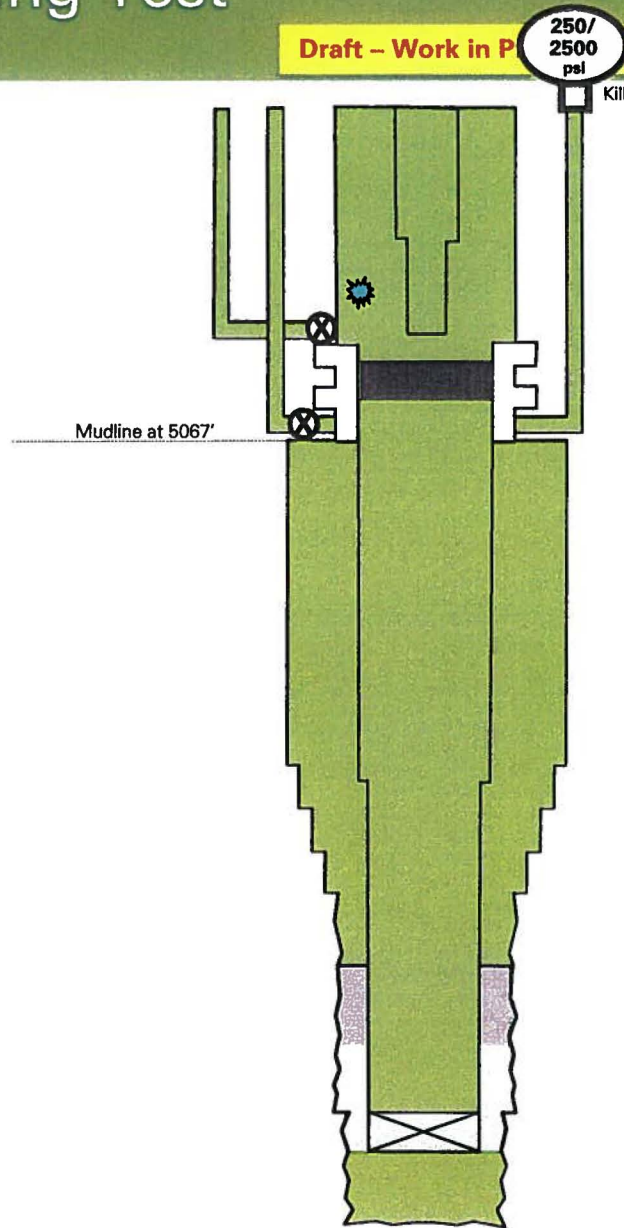
12:00 – Close BSR. Pump down kill line to test casing to 250/2500 psi for 30 min

Data
<ul style="list-style-type: none">• Run in with tapered string for cement plug:<ul style="list-style-type: none">– 6-5/8" x 5-1/2" x 3-1/2" drill pipe• Stop at 4700' (above BOP)• Close blind shear rams• Positive test casing to 250 and 2500 psi

Interpretation
<ul style="list-style-type: none">• Positive casing test is successful<ul style="list-style-type: none">– Pressures and volumes are as expected

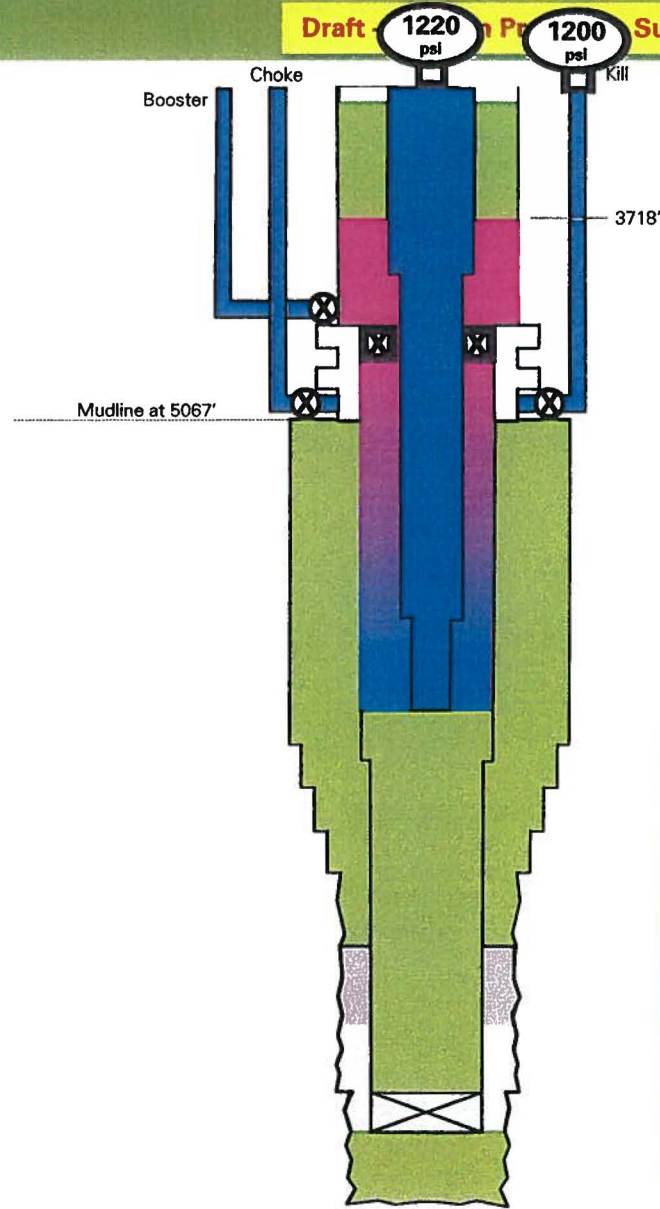
- Bleed drill pipe pressure from 2325 psi to 1220 psi to equalize with kill line

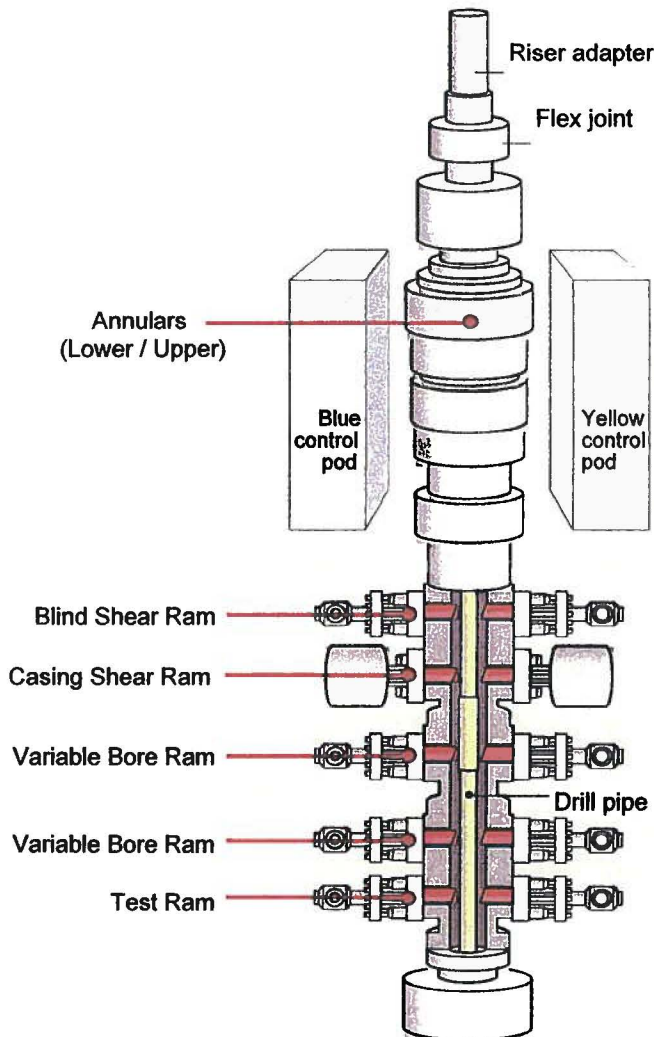
BOP Function Description

- **UAP** Upper Annular Preventer used in normal drilling operations for well shut-in rated 10K.
- **LAP** Lower Annular Preventer with Casing Stripping Element.. Used for casing stripping purposes, down rated to lower wellbore retaining pressure 5K.
- **BSR** Blind Shear Rams Cuts drill pipe and seals the well.
- **CSR** Casing Shear Rams Non-Sealing, cuts drill pipe and casing; is not designed to seal the wellbore.
- **UPR** Upper Pipe Rams Ram packers can close on a range of drill pipe from 3 ½" OD to 6 5/8" OD and seal up to 15K wellbore pressure.
- **MPR** Middle Pipe Rams Ram packers can close on a range of drill pipe from 3 ½" OD to 6 5/8" OD and seals up to 15K wellbore pressure, can also be stripped through to hang-off drill pipe up 600K
- **LPR** Lower Pipe Rams . Test Ram seals up to 15K pressure from above.
