EXTERIOR DESIGN PROPOSED MODIFICATIONS

SFO NO. VA-101-13-I-0004 INTEGRATED VA/DA HEALTH CARE CENTER ΟΙΝΤ

MONTEREY, CALIFORNIA

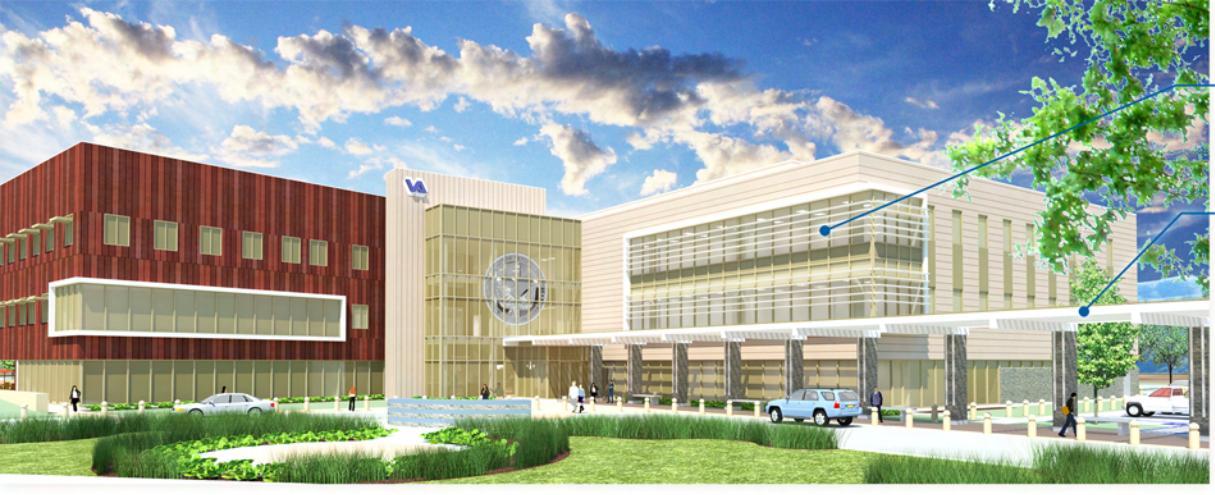
Why: The adjustable metal shade louvers allow control of solar heat gain on the south-facing exposure, while allowing natural light to enter the building. Views to the exterior are preserved.

ancement: Extended roof at walkway.

Why: The covered walkway has been widened to provide maximum protection for visitors exiting vehicles at the drop-off area. Additionally, the walkway roof now provides coverage for all entry/exit doors at the front of the building, and is visually connected to the building.

Enhancement: Window shape/light shelf.

Why: The solar heat gain on the south-facing windows can be controlled/limited, reating more comfortable work areas. The shade elements penetrate the glazing plane, providing a "light shelf" which reflects natural light deeper into the room, thereby educing artificial lighting requirements and lowering energy costs.

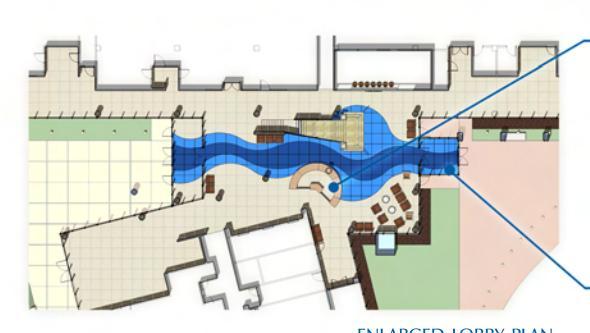
ENLARGED LOBBY PLAN

Why: An information desk re-located as shown has the following benefits:

a. Improved visibility for guests entering the lobby from east or west doors. b. The curved/circular shape appears more user-friendly, while increasing work area.

c. Locating the information desk under the second floor provides a more secure location for staff, provides more options for lighting the work area, and is closer to the elevators (for giving directions to visitors).

d. People descending the grand stair will no longer 'look down' on information desk staff, or over their shoulder (HIPPA issues).

d. Improved HVAC control/comfort for staff at information desk.

f. Increased security by allowing staff to view patients and visitors ascending the stair.

Why: Made of multiple colors of terrazzo, the meandering path is a curvilinear way-finding device, leading visitors to the information desk or to the grand stair. The multi-shade 'river' through the lobby also creates a visually soothing and calming element within the spacious lobby and leads to nearby exterior meditation/quiet areas,
