Subj: ENGINEERING SERVICE REQUEST TO STUDY THE WATER SYSTEMS AT THE
MCAS NEW RIVER AND CAMP GEIGER

ENGINEERING SERVICE REQUEST
TO STUDY THE POTABLE WATER SYSTEMS
AT THE MCAS NEW RIVER AND
CAMP GEIGER, CAMP LEJEUNE, NORTH CAROLINA

MARCH 1987

ENVIRONMENTAL QUALITY BRANCH
UTILITIES, ENERGY, AND ENVIRONMENTAL DIVISION
ATLANTIC DIVISION, NAVAL FACILITIES ENGINEERING COMMAND
NORFOLK, VIRGINIA 23511-6287

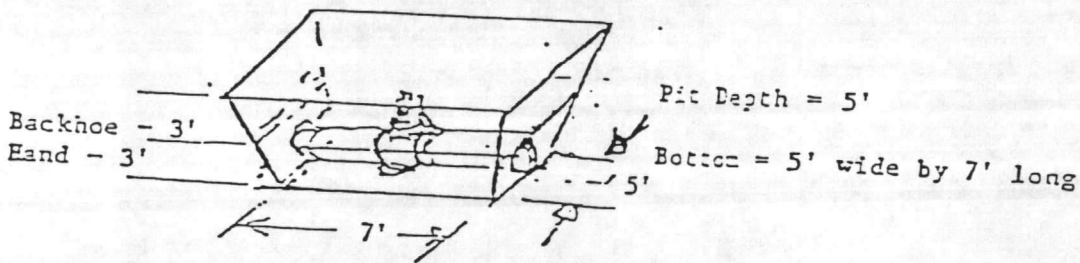
Pit excavation for valve work and pipe examination

Cost/Pit = \$88

For bituminous pavement removal and replacement add \$455

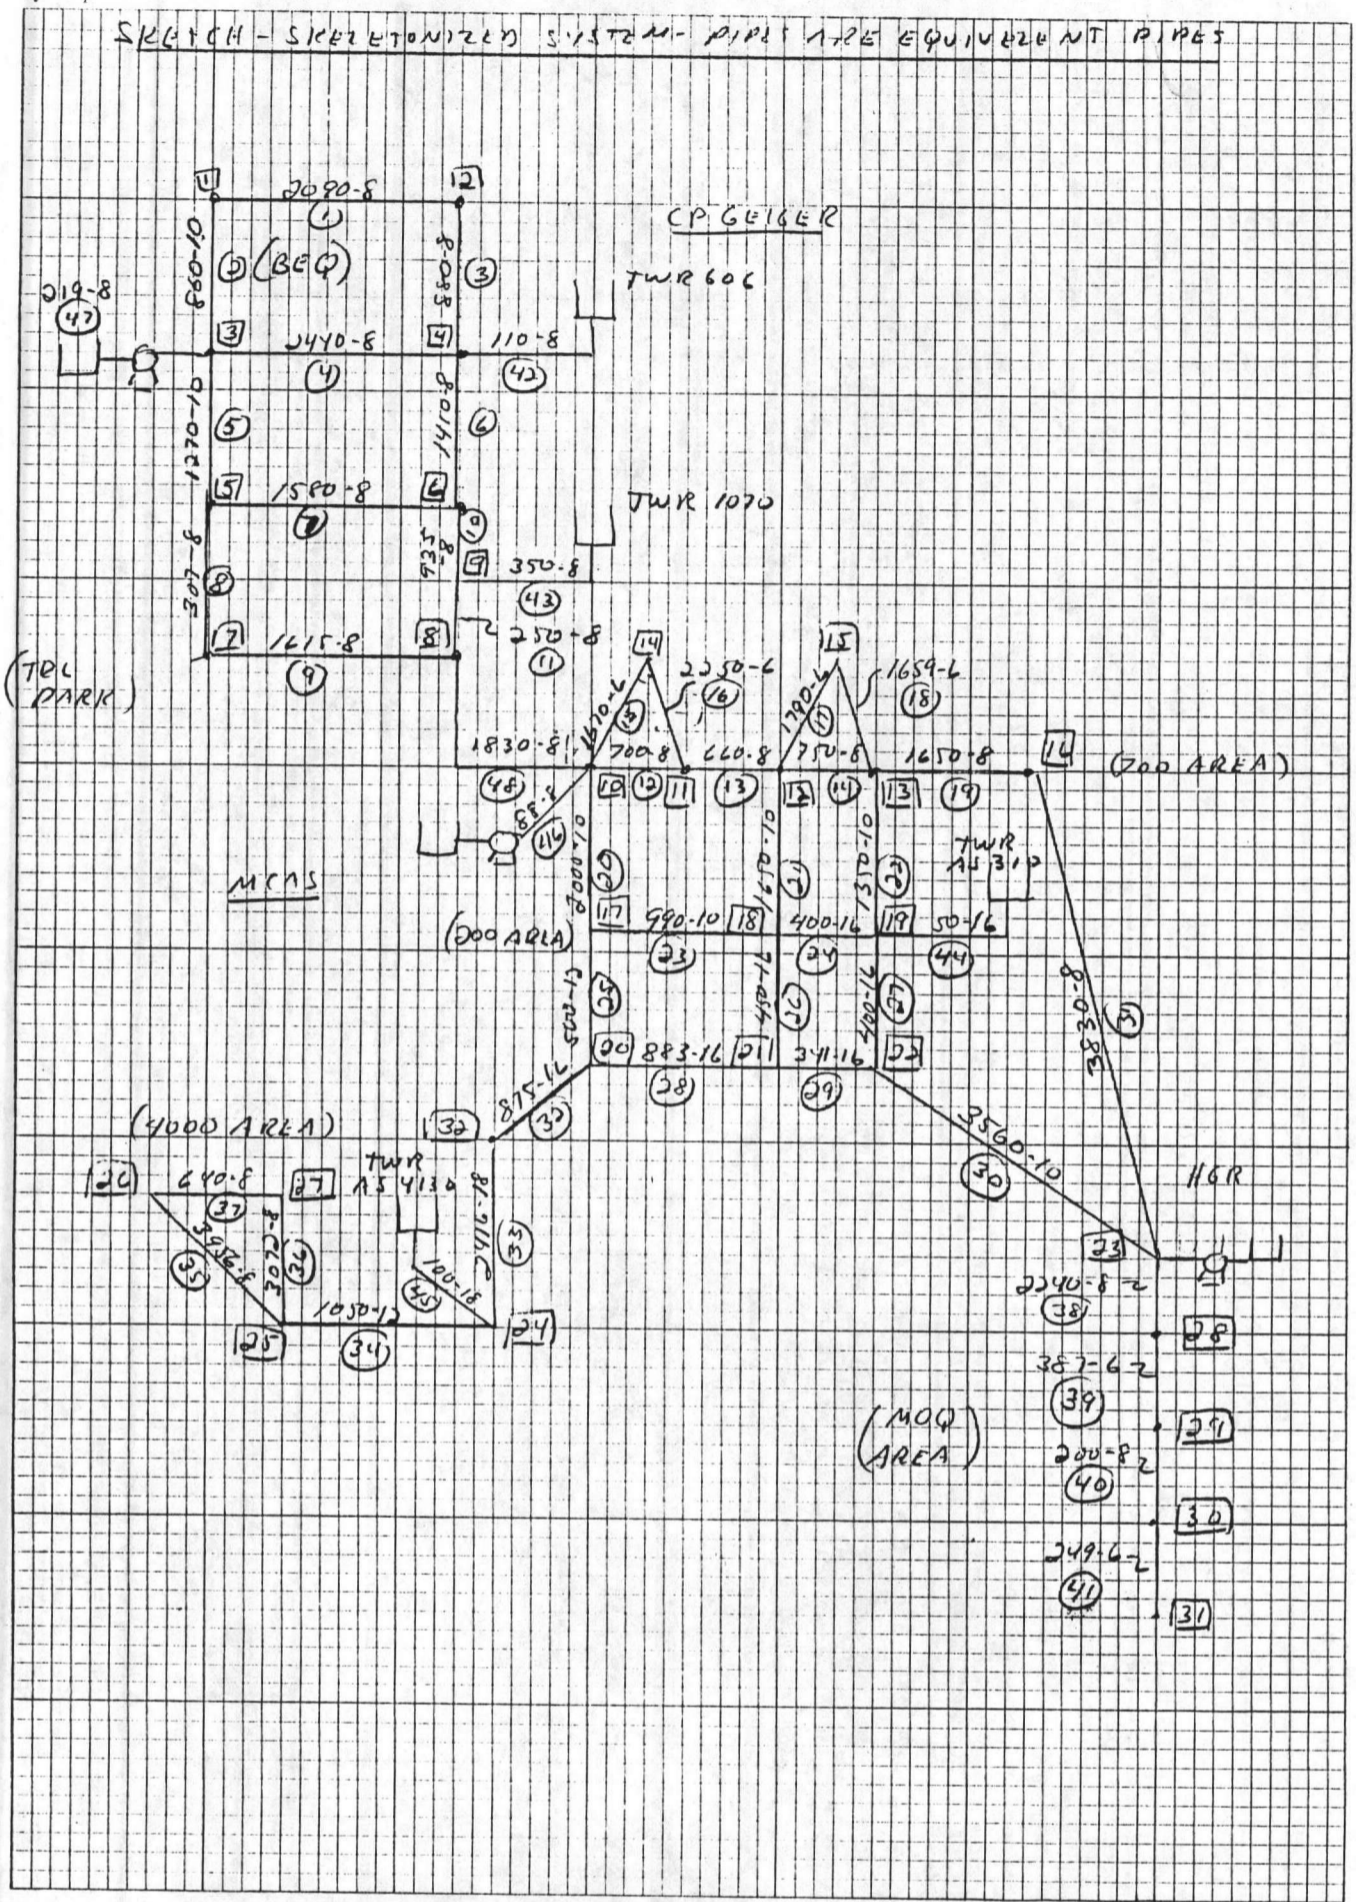
SKETCH - SKELETONIZED SYSTEM PIPES AND EQUIPMENT PIPES

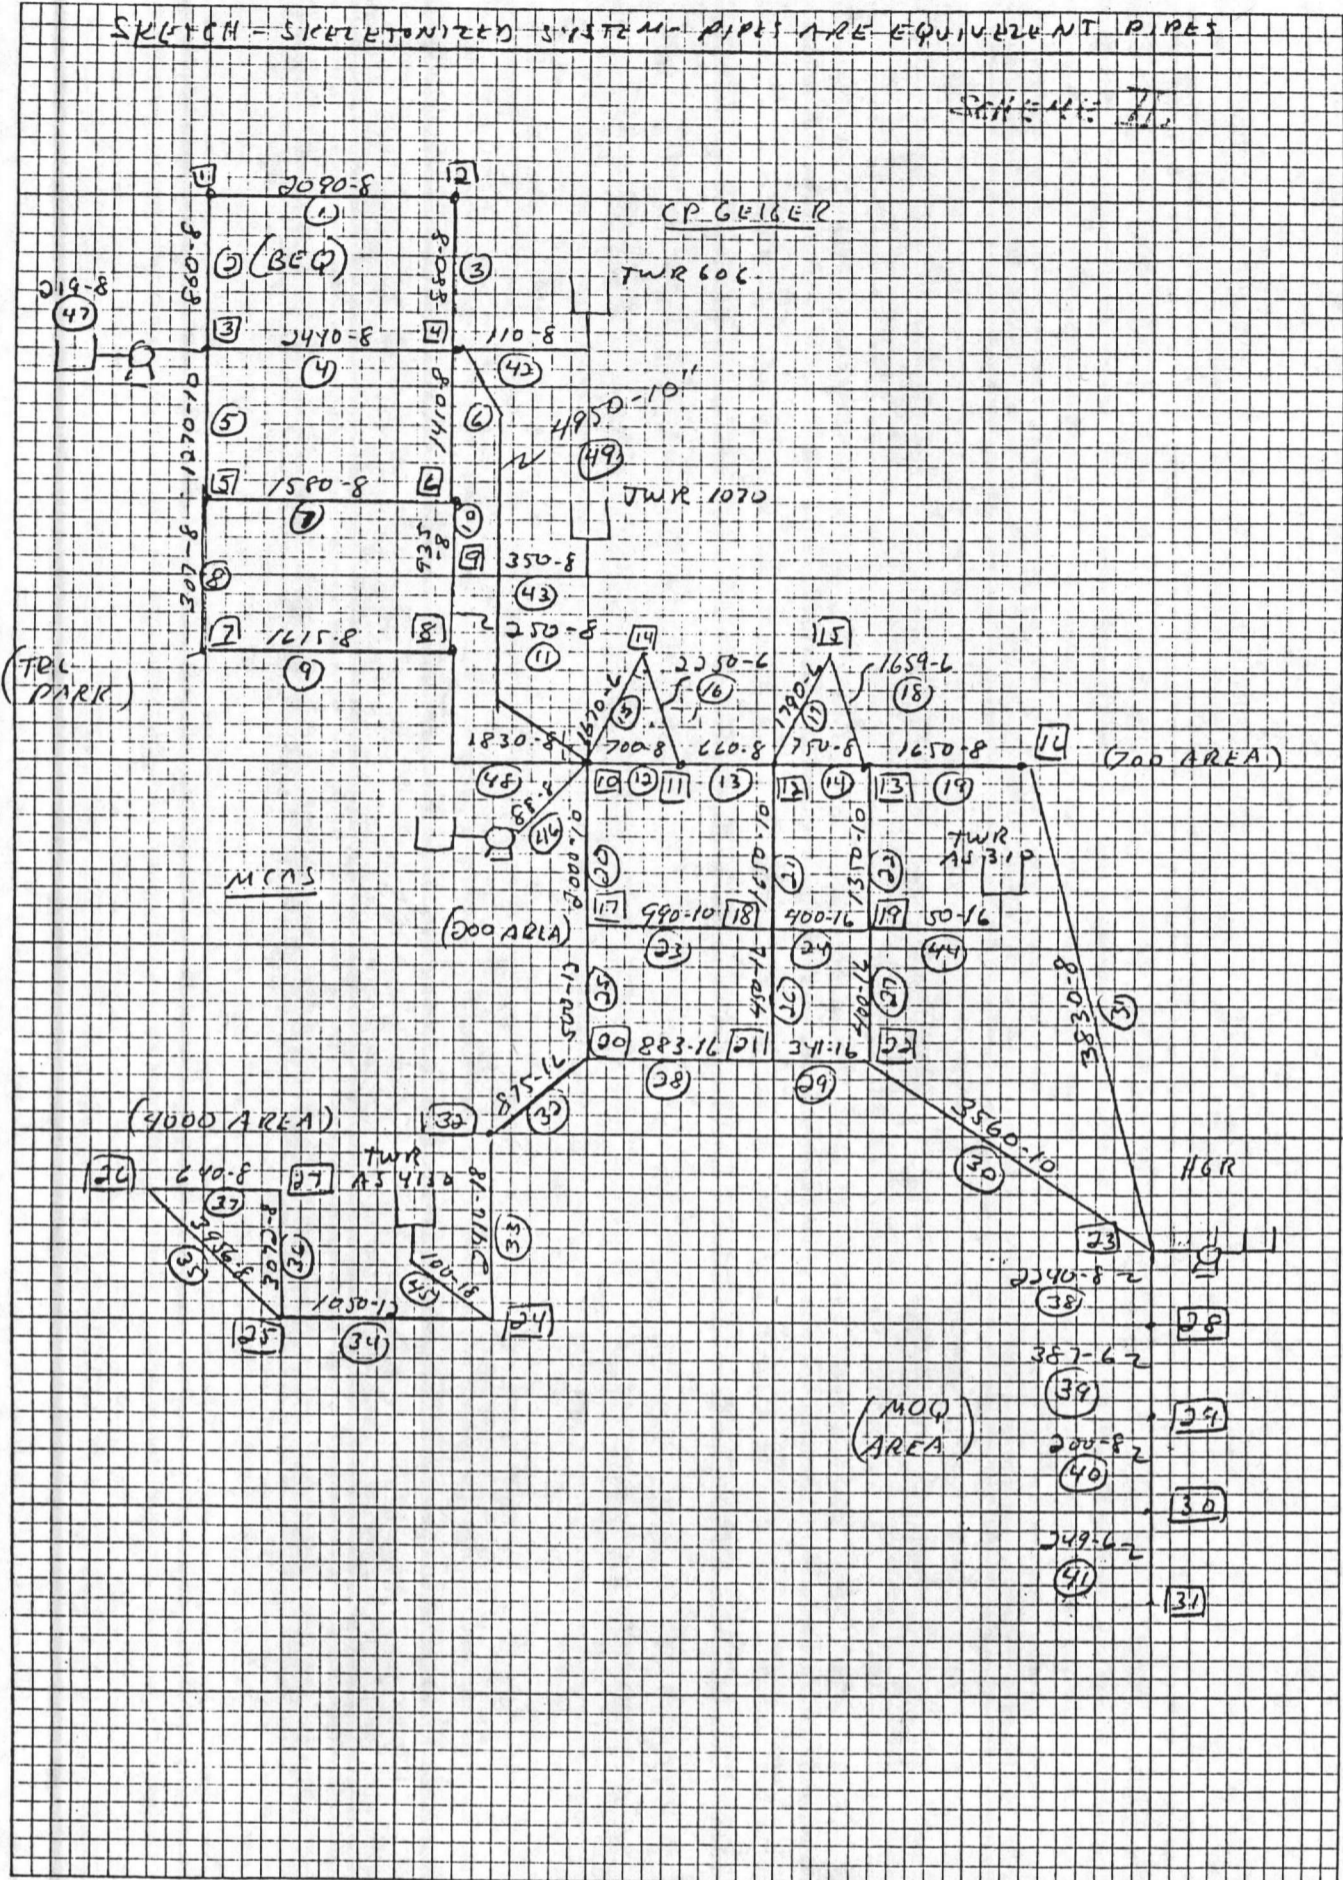
SKETCH - SKELETONIZED SYSTEM - PIPES ARE EQUIVALENT PIPES

SCALE: 1" = 71'

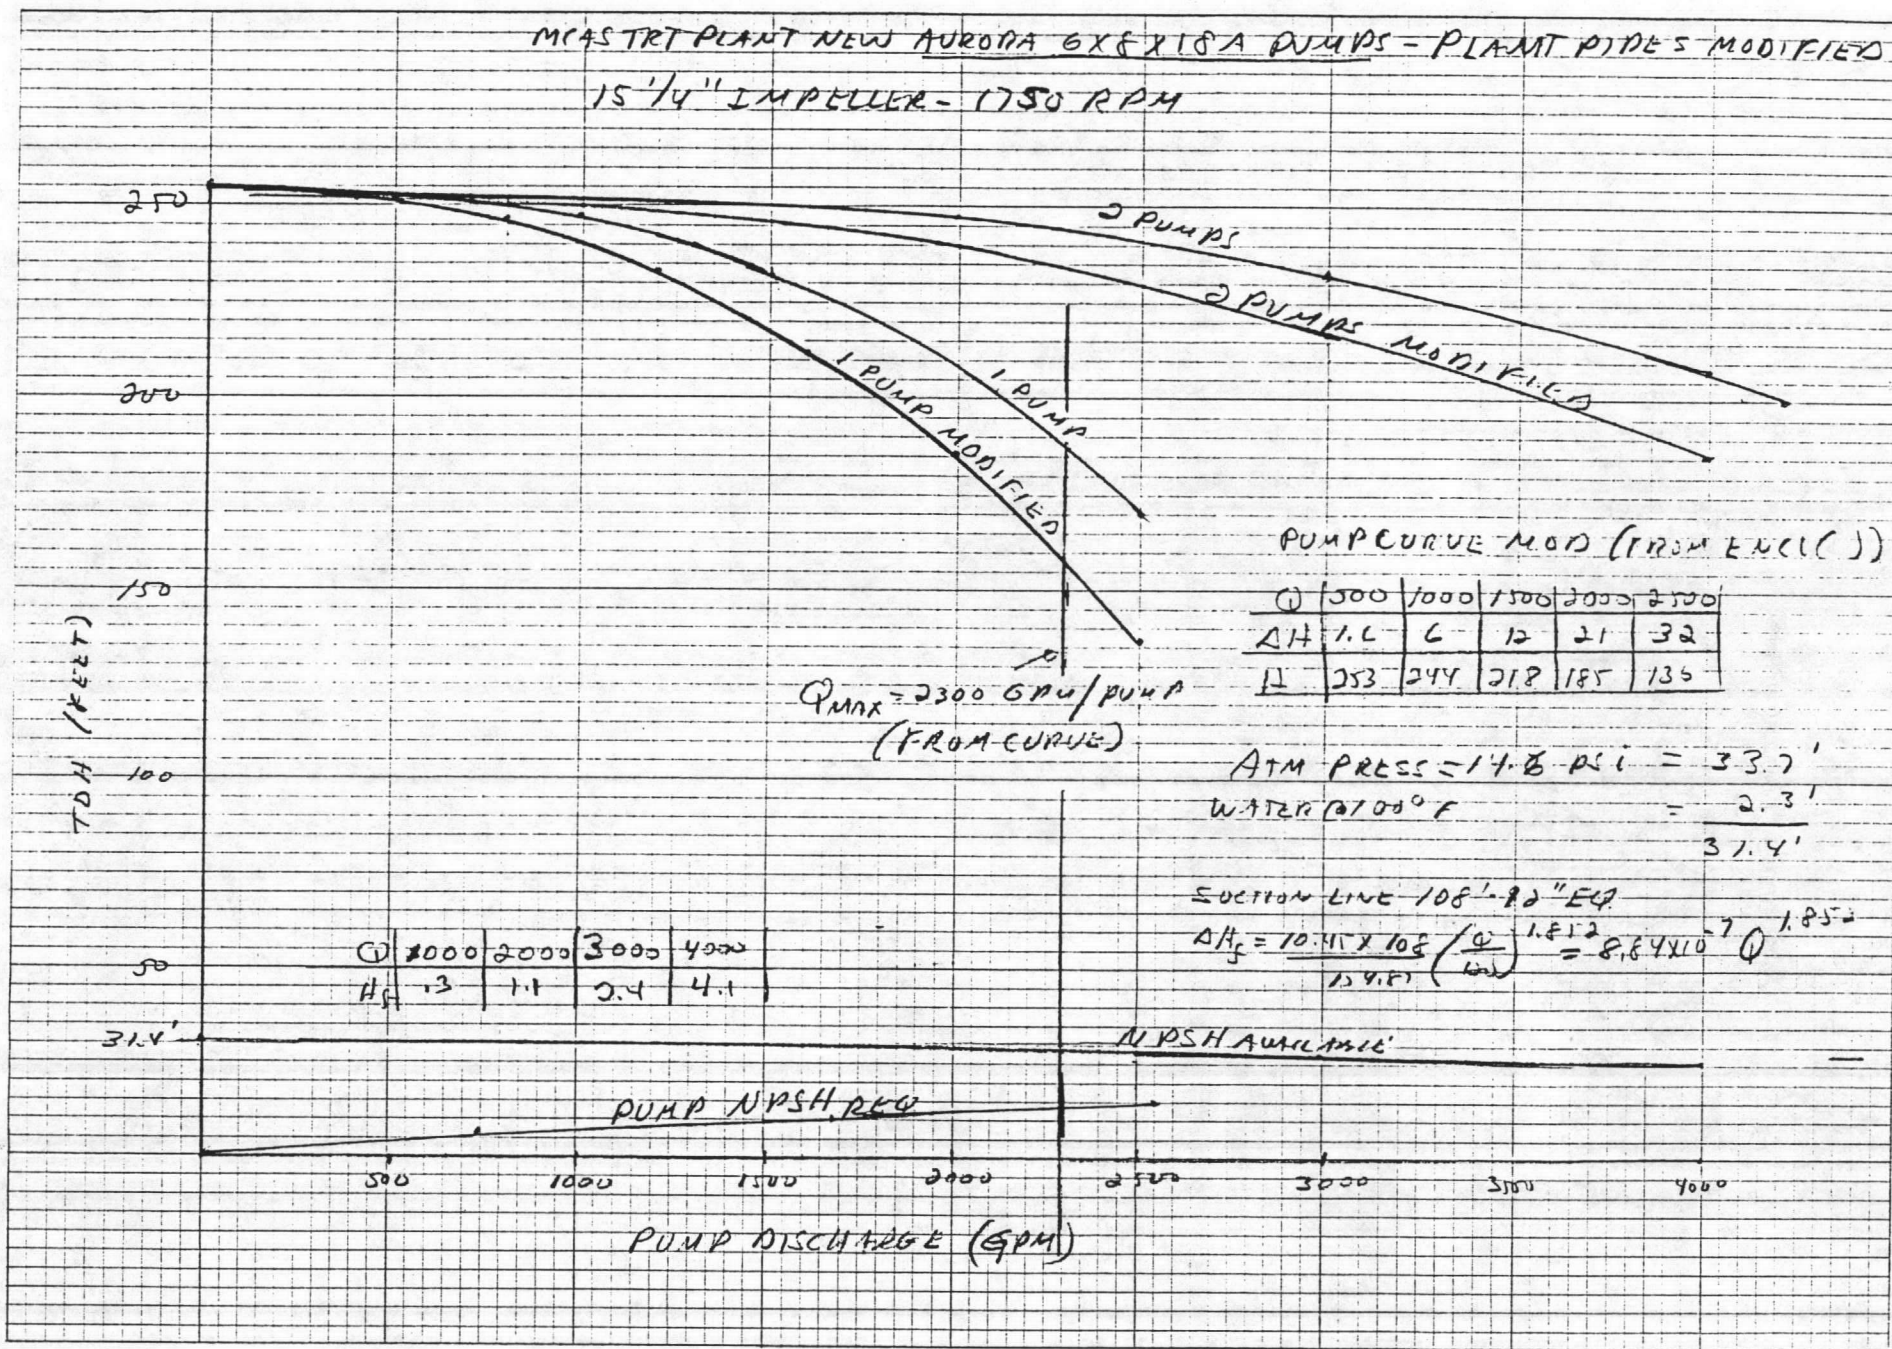
MCAS TRT PLANT NEW AURORA 6X6X18A PUMPS - PLANT PIPES MODIFIED
 15 1/4" IMPELLER - 1750 RPM

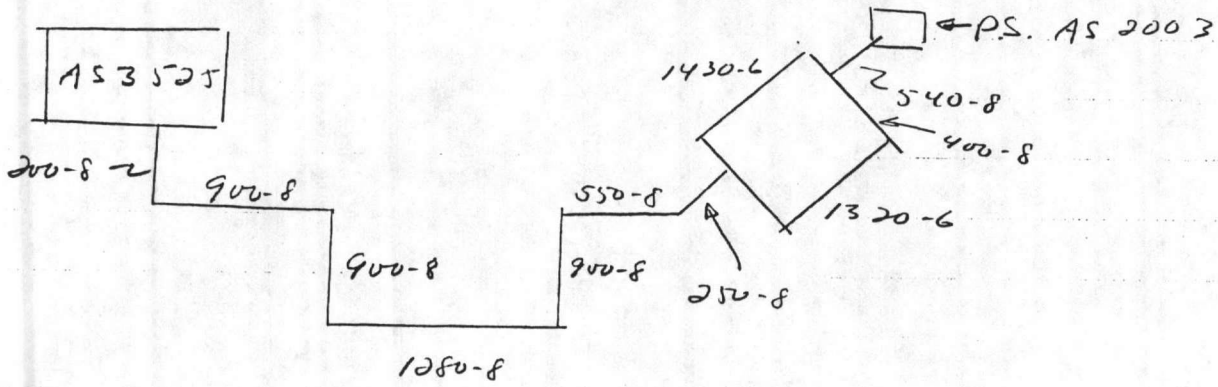
EQUIVALENT 8" PS AS 2003 TO WHSE AS 3525

$$\left\{ \left[\left(\frac{8}{C} \right)^{4.87} \times 1430 \right]^{-1.54} + \left[400 + \left(\frac{8}{C} \right)^{4.87} \times 1320 \right]^{-1.54} \right\}^{-1.852} + 250 + 550 + 900 + 1080 + 900 + 900 + 200 + 540$$
