**REPORT  
ON  
THE VIA VERDE PROJECT OF THE ELECTRIC ENERGY AUTHORITY  
TITLED GASODUCTO DE PUERTO RICO: A TECHNICAL EVALUATION**

**Dr. Pedro Jimenez Quinones, P.E., F-ASCE  
Consulting Engineer – Geotechnics**

**Submitted to:  
Mr. Carl-Axel P. Soderberg, P.E.  
Director  
Caribbean Environmental Protection Division  
United States Environmental Protection Agency  
Office of Regional Counsel  
Centro Europa Building Suite 207  
1400 Ponce de León Avenue, Stop 22  
San Juan, Puerto Rico 00907-4127**

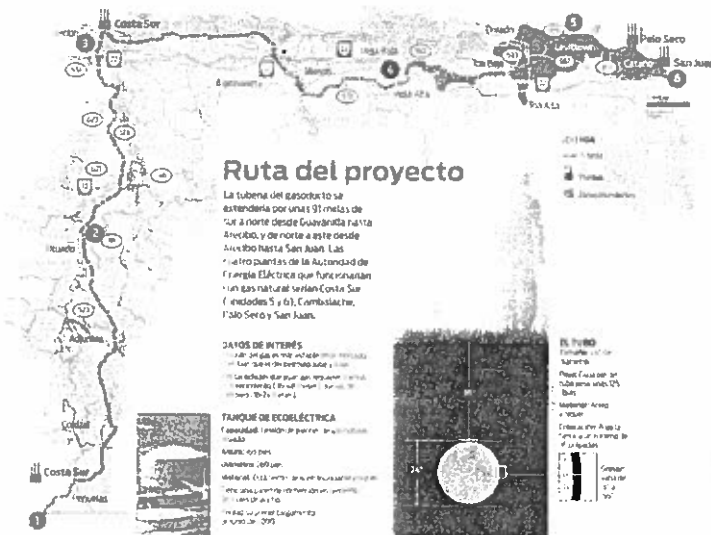
**Figure 1.** Map of the Gas Line, "Gasoducto" Project extending for 91 miles from Costa Sur electric plant in Penuelas to Arecibo and then east to Guaynabo. The gas line is a 24 inch steel pipe located at a depth of 5 feet below the ground surface as shown in the cross section presented above.

This report covers the technical engineering evaluation of the Gasoducto de Puerto Rico, a 91-mile natural gas line project running from Peñuelas on the south to Arecibo on the north and Guaynabo on the East. This technical evaluation is my analysis, as a civil engineer that can serve as a guideline to specialists, the people of Puerto Rico and the Federal Agencies in forming a learned opinion on the implications of such a project. Figure 1 shows the route of the Gasoducto as it was presented by Eng. Miguel Cordero in the newspaper *El Nuevo Día* of September 10, 2010.

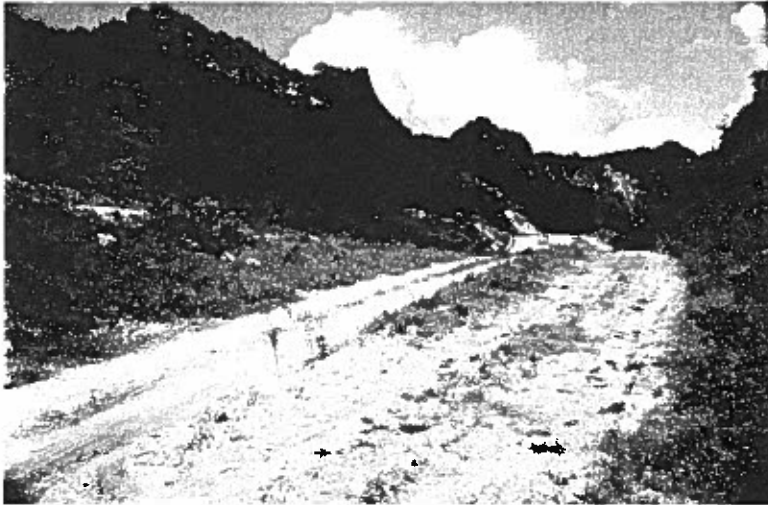
**Figure 2.** The photograph shows PR-10 under construction. On the background Lares limestone cliffs are shown..

In 1985 my consulting services to the Highway and Transportation Authority covers the solution of landslide problems during the construction of highway PR-10, specifically projects AC-001084, AC-001081 and AC-001029 from Arecibo to Utuado<sup>1</sup>. The construction of PR-10 represents a very good example for the study of geotechnical engineering problems and its relationship with the construction of a highway in the geologic context of the island, one of the most complex in the world. On this site, the Lares limestone and extensive sinkholes are typical and the organic expansive clay of the San Sebastian Formation underlies the first and dips towards the North. Figure 2 shows a view of PR-10 during construction.

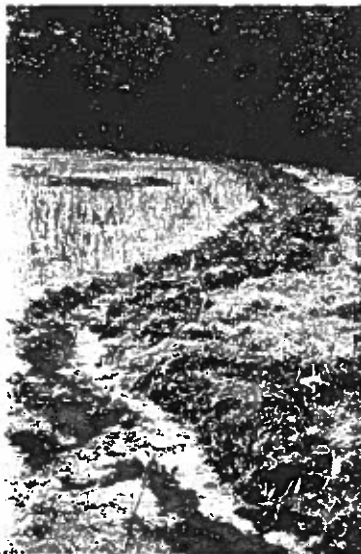
**Figure 3.** In the photograph is shown a sinkhole located between the limestone mogotes of AC-0081 project of PR-10. Note that water is seeping toward the walls of limestone.

The karst topography of the Lares limestone is characterized by mogotes and sinkholes. The annual rainfall of the area of Utuado and Arecibo is about 70 to 80 inches. The rainfall water rises to 10 and 15 feet in height in the sinkholes. Water seeps through the bottom and walls of the sinkholes since the Lares limestone is permeable. Figure 3 and 4 show sinkholes developed between the mogotes.

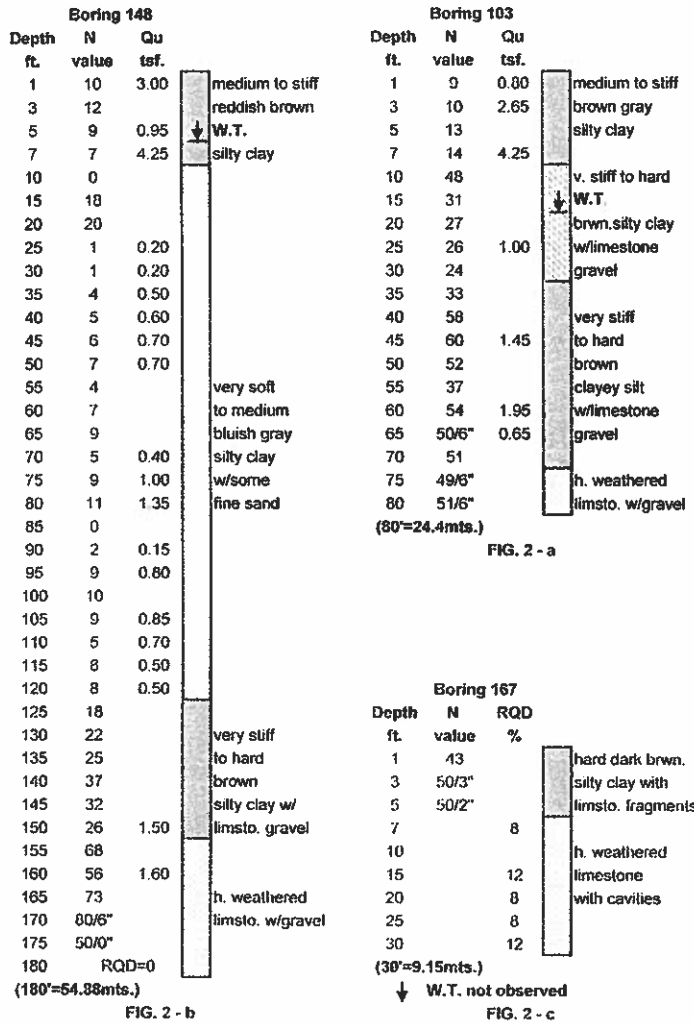
Figure 2. Soil Profiles for Borings 103, 148 and 167

Figure 15. Typical Soil Borings – Very soft to medium bluish gray clay

Soil borings drilled at the site of the Manati river bridge piers and abutments, clearly indicate that the subsoil on the majority consists of soft to medium silty clays. In the next page are shown three typical soil borings and a photograph of the bridge during construction.
