Protecting Windows and Openings in Buildings

HURRICANES IRMA AND MARIA IN PUERTO RICO

Recovery Advisory 5, April 2018

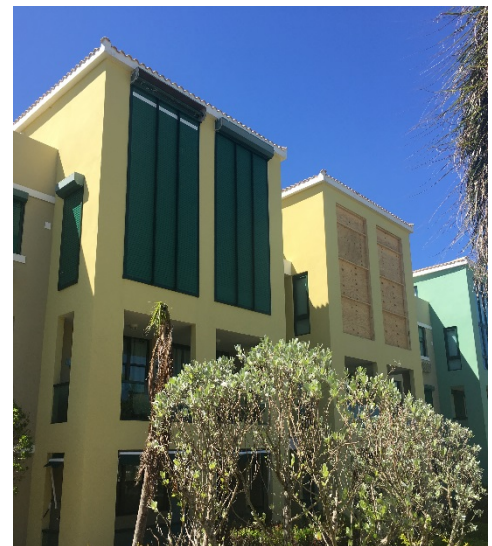
Figure 1. Residential windows protected (left) and unprotected (right). The unprotected windows were damaged and are temporarily covered with plywood.

1. Protecting glazed opening from failure (Figure 1) due to wind pressures and wind-borne debris improves overall building performance during hurricanes and other high wind events

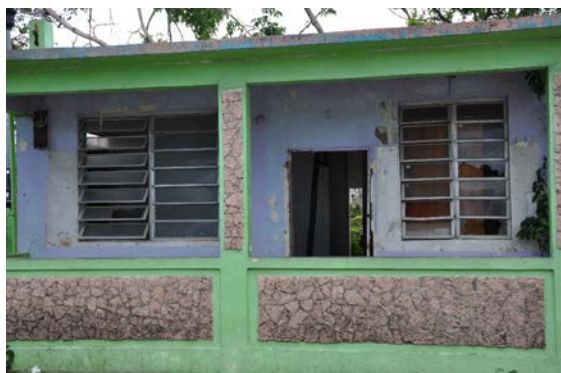
A jalousie opening has metal or glazed louvers that can be opened or tilted to control airflow. Jalousies are common in homes, schools, and other types of buildings in Puerto Rico. Figure 2 shows a home with glass jalousies that were not protected and were heavily damaged during Hurricane Maria; this was a common observation of the performance of glazed panel jalousies. Further, both the metal and glazed jalousies are very susceptible to wind-driven rain, even when the louvers are undamaged (Figure 3). Depending upon the floor and wall construction, finishes, and location of furniture, entrance of wind-driven rain may cause minimal damage or it may result in significant interior damage. If the magnitude and consequences of wind-driven rain infiltration associated with jalousies is unacceptable, fixed windows, or other types of operable windows, such as awning, casement, hopper, single-hung, or double-hung windows, can be specified.

Figure 2. Residence where unprotected glazing louvers were broken by wind-borne debris on the left and right sides of the entry door.

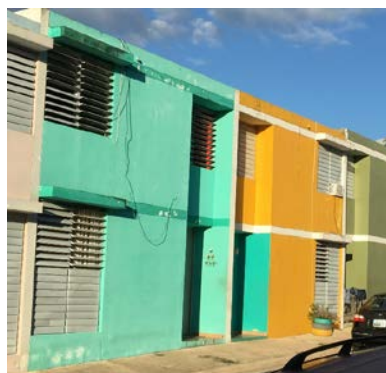
Figure 3. New secured housing units with metal jalousie openings.

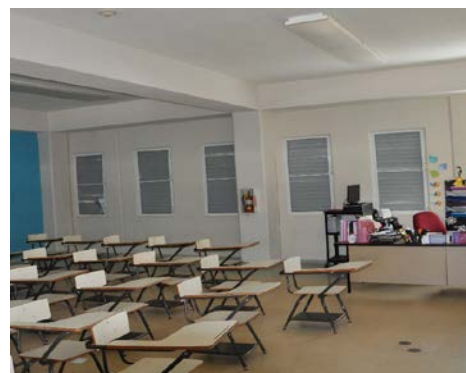
The school shown in Figure 4 had widespread use of Jalousie openings. The jalousies either had a screen or glazed panel behind them. The classrooms used screens while the offices, laboratories, or technical spaces (with computers) had glazed panels mounted inside the jalousies to prevent air flow and keep air conditioned space in those rooms. Even when the panels remain in place, interior water leakage can occur, because the panels are typically not sealed to the jalousie frame. Water intrusion occurred in the classroom shown in Figure 4 but resulted in limited damage to the hard surface finishes used. Common metal jalousie openings may be undamaged by low-momentum debris, but they can still be breached by wind-borne debris that is common during strong hurricanes. Neither the IBC nor IRC require metal jalousies to be wind-borne debris resistant. However, glass jalousies are required to be resistant to wind-borne debris or protected by a shutter system or opening protection device when used within the wind-borne debris region.

Figure 4. High school in a coastal community with metal jalousie openings. Screens were installed behind the jalousie openings.

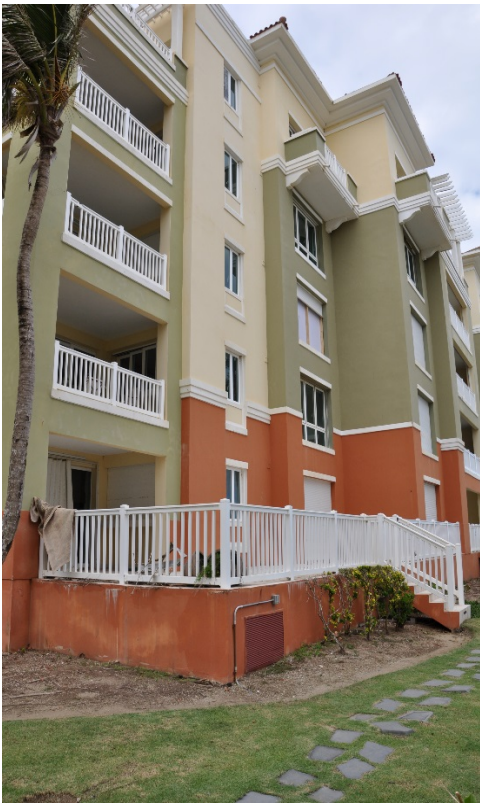
Figure 5. Numerous operable casement and awning windows were damaged due to wind pressures and wind-borne debris at this waterfront building.

continuity during submittal review. Approximately $\frac{1}{3}$ of the unprotected casement and awning window systems in a waterfront multi-family residential building (Figure 5) were damaged from wind pressures, wind-borne debris, or a combination of these forces.

With respect to wind-driven rain resistance of window assemblies, it is recommended that Performance Level 10 be specified according to the American Architectural Manufacturers Association (AAMA) *Voluntary Specification for Rating the Severe Wind-Driven Rain Resistance of Windows, Doors and Unit Skylights* (AAMA 520-12, 2012).² Even assemblies that meet Performance Level 10, to achieve successful performance, must be integrated into the wall system via robust design detailing (as discussed in FEMA P-424) and quality application in order to avoid entrance of wind-driven rain. It is recommended that ASTM E2112 and the *Homebuilder's Guide to Coastal Construction* (FEMA P-499), Fact Sheet 6.1 "Window and Door Installation" be considered. Where water infiltration protection is particularly important, it is recommended that on-site water infiltration testing be specified in accordance with the *Standard Test Method for Field Determination of Water Penetration of Installed Exterior Windows, Skylights, Doors, and Curtain Walls, by Uniform or Cyclic Static Air Pressure Difference* (ASTM E1105, 2015).

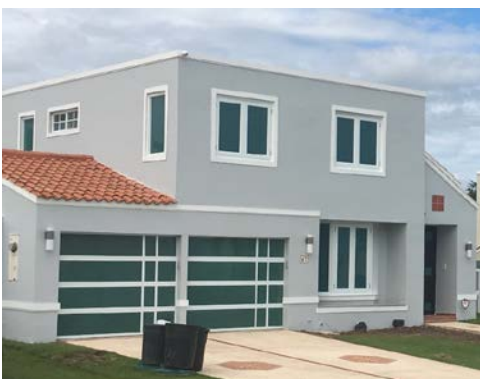
Figure 6. Fixed and operable window assemblies at a home performed without failure.

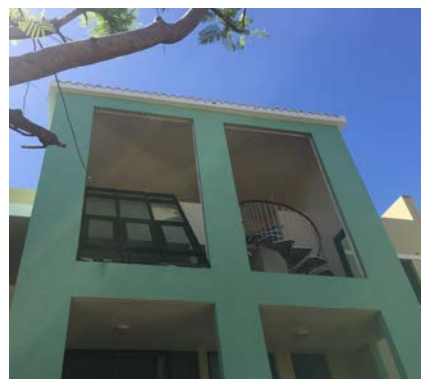
Figure 7. Two-story window assemblies (fixed and operable) failed at the frame-to-wall connection due to lack of proper fasteners.

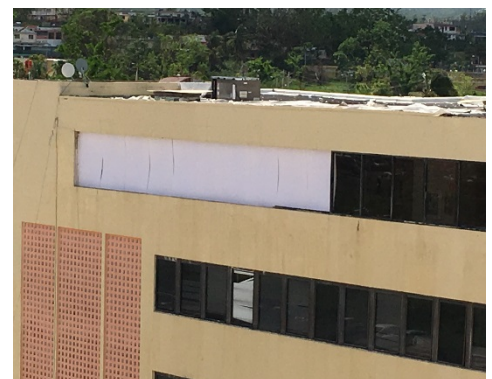
Figure 8. An entire bay of windows is missing from the upper floor of this hospital in Bayamon due to a lack of adequate fasteners.

in Figure 8, where a bank of windows on the upper floor of a building addition was secured by small fasteners and failed during the hurricanes. It is important for design professionals to be aware of and apply both ASTM E2112 and ASTM E1233 when addressing the wind forces and wind pressures from hurricanes. As a result, when hurricane winds impacted the homes, many units in this development experienced complete failure of the window systems due to wind pressure.

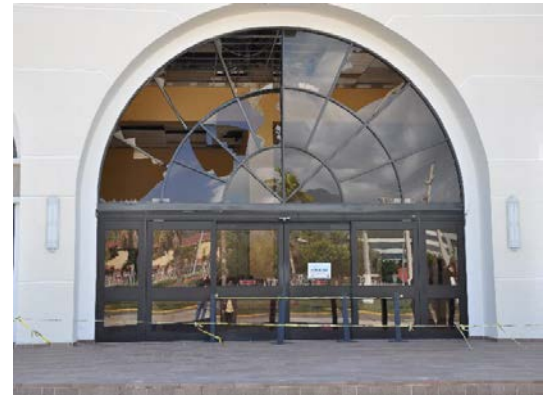
Figure 9. Glazing damage at the main entrance to a community building/convention center.

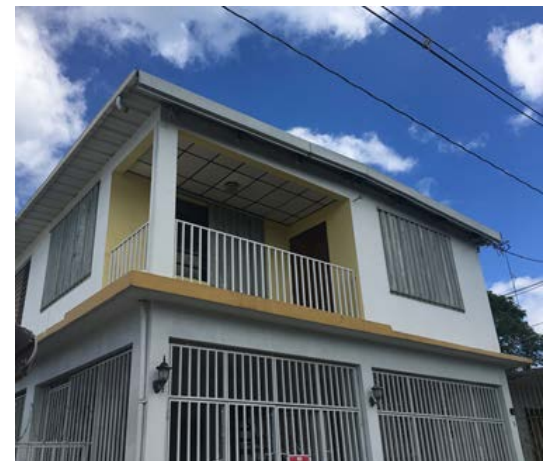
Figure 10. A two-story residence with windows and gill doors (upper porch) protected with metal panel shutters.

Vulnerable glazed openings on buildings are protected when these systems are installed on single-family homes; the appropriate lower floors of low-, mid-, and high-rise buildings; and critical and essential facilities. Common elements of impact-resistant systems that performed well during Hurricanes Irma and Maria include adequately mounted tracks for panels or accordion shutters to the building exterior (not mounted to the window frames) and well-maintained shutters or panels that were secured and properly attached/fitted within supporting tracks. Instances of properly deployed window protection systems are shown in Figures 10-12.

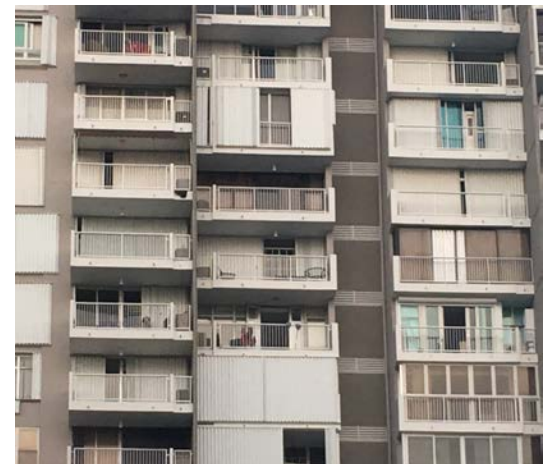
Figure 11. A high-rise residential tower where approximately 85% of units have a form of shutter or impact-resistant system in place that was installed as a retrofit.

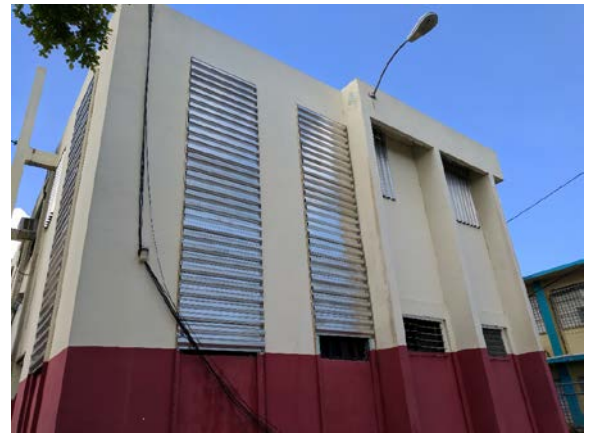
Figure 12. A fire station with metal panel shutter system deployed provided adequate protection for the facility.

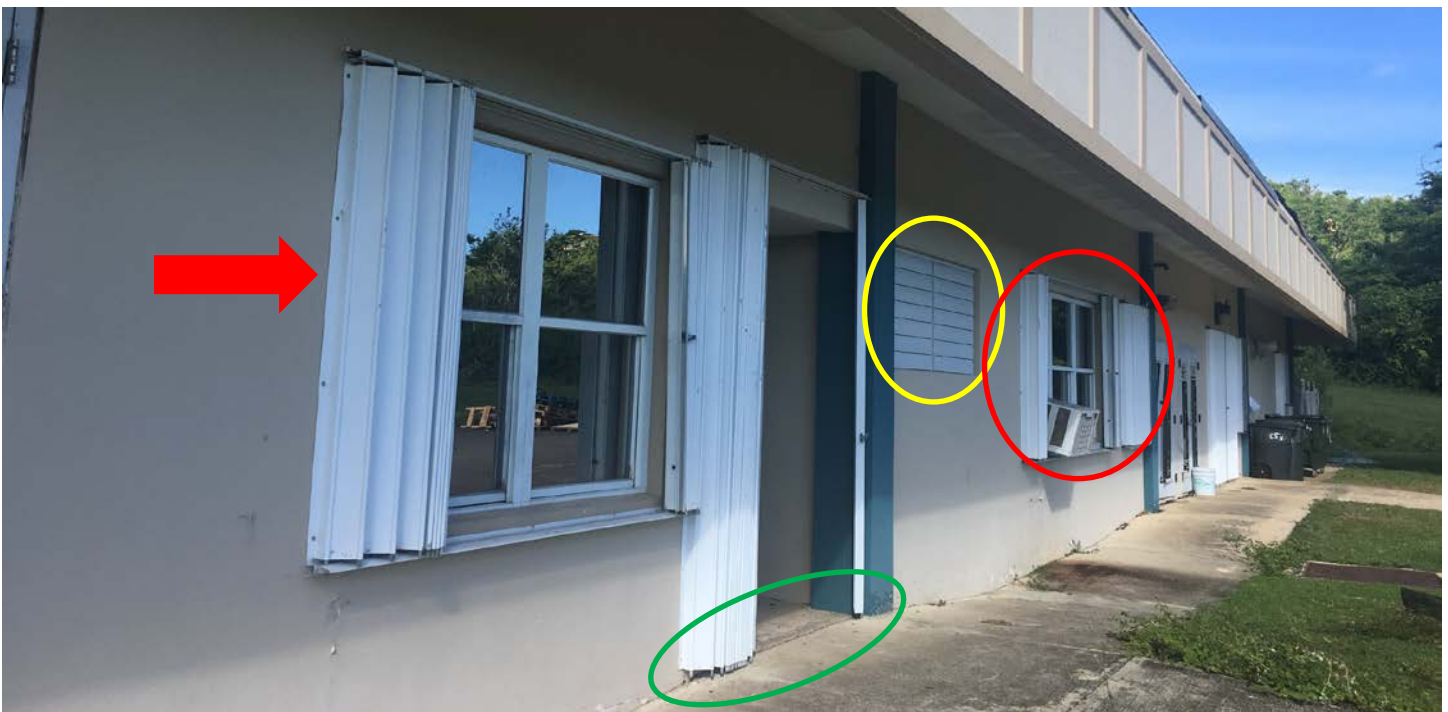
The building presented in Figure 13 illustrates challenges and inconsistencies that impact the ability of shutter systems to provide the impact resistance intended. While the red arrow identifies a properly installed shutter system, the following issues related to the installation of the shutters lower the level of protection and effectiveness of the shutters:

- Shutters for glazed door entry were not secured with a bottom track (green oval).
- Window air conditioner obstructed deployment of the shutter system (red circle).
- Metal jalousie openings do not require impact-protective systems per the PRBC, and the 2018 IBC and IRC, since it is not glazed; however, the metal panels provide less protection for this opening (yellow circle) as they are typically not rated for wind-borne debris impact resistance.

Figure 13. Installation issues that affected the performance of the impact-resistant systems include the lack of a bottom track (green oval), a window air conditioner preventing shutter deployment (red circle), and a metal jalousie opening with no impact-resistant system (yellow circle).

It is important that impact-resistant systems are installed properly to ensure glazed windows and doors are protected as intended. It is also very important that all sides of the building have glazing protected to the heights specified in the building codes. If only one or two sides of a building are protected, the unprotected sides may still be damaged by windborne debris, allowing water intrusion and further progressive damage to the building, most likely resulting in unnecessary facility downtime or damages after a high wind hazard event occurs.

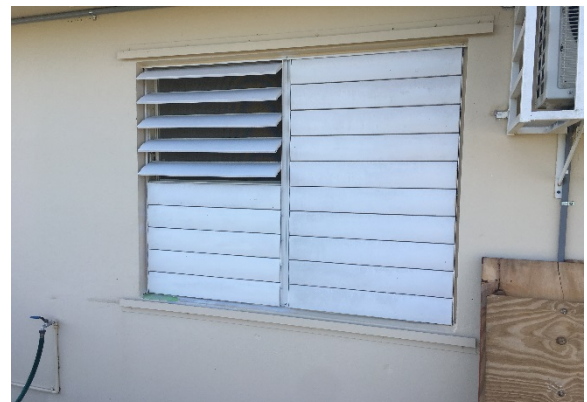
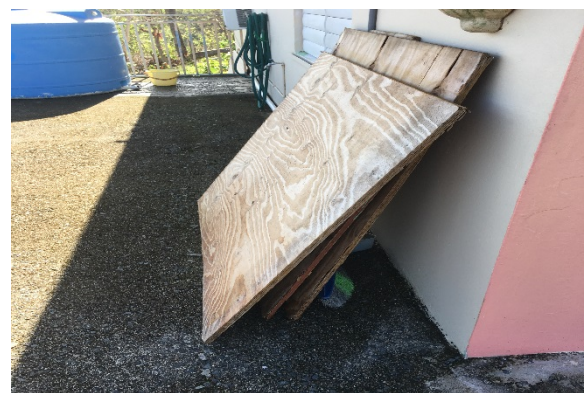
Figure 14 illustrates the successful uses of wood panels for an impact-resistant system. The homeowner had retrofitted the building with a plywood shutter system. This system used permanent tracks on the top and bottom to support and restrain pre-cut plywood panels. This simple and cost-effective solution provided protection for window

Figure 14. Top, metal louverie window that was protected from wind-borne debris by wood panels, bottom, during Hurricanes Irma and Maria.

openings on the home even though the window openings were metal panel jalousies. For larger commercial and other non-residential construction, the IBC does not permit wood panel shutters as an alternative for tested shutter assemblies. However, the IRC permits them up to a 45 foot mean roof height, when constructed and anchored in accordance with the IRC provisions. The Engineered Wood Association (APA) *Hurricane Shutter Design Considerations for Florida* (APA Form T460, 2013) provides guidance for constructing and installing wood panel shutters. If wood panels are installed, it is important to adequately anchor them so that they do not become wind-borne debris.

For additional information on the installation and use of plywood shutters to protect openings, see FEMA P-499, Fact Sheet 6.2 and documents such as APA Form T460. These documents provide guidance on the wood panels, the size and placement of connection points, and how to adequately design and install them so they remain in place to help protect your home during high-wind events such as hurricanes.
